Testing Biodegradable and Hybrid Methods for Shoreline Stabilization

Saco Watershed Collaborative

March 22, 2022

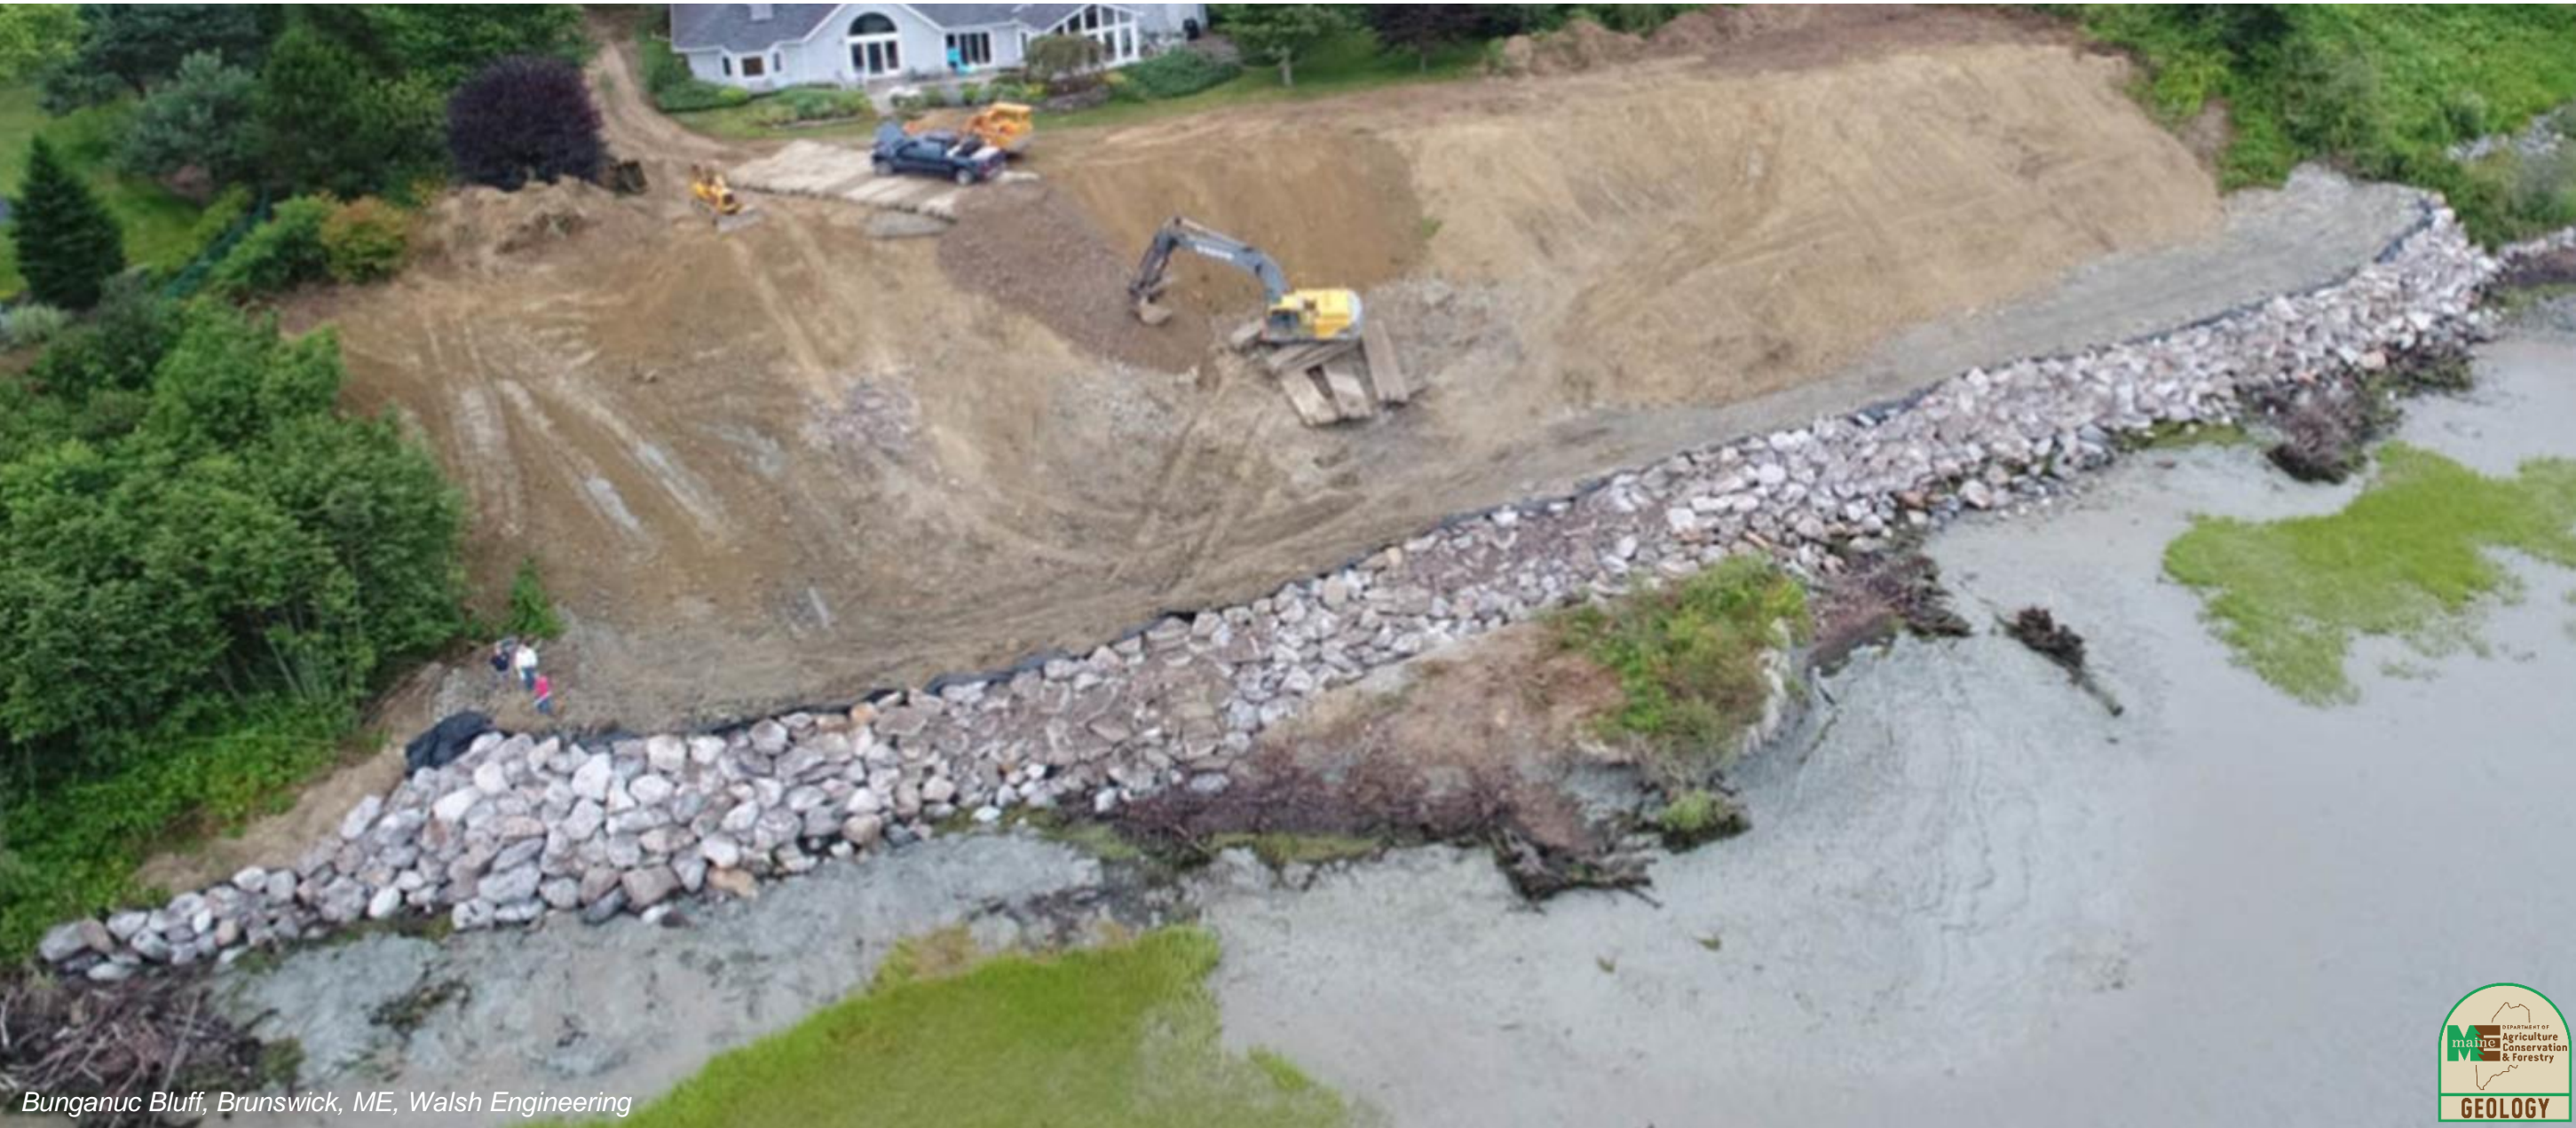
48% of the Maine coast is made up of erodible coastal bluffs and 1/3 are eroding and are being **armored at high rates**. *Armoring bluffs cuts off the supply of sediment to nearby mudflats and wetlands, which are natural living shorelines and serve as buffers for storm waves.*

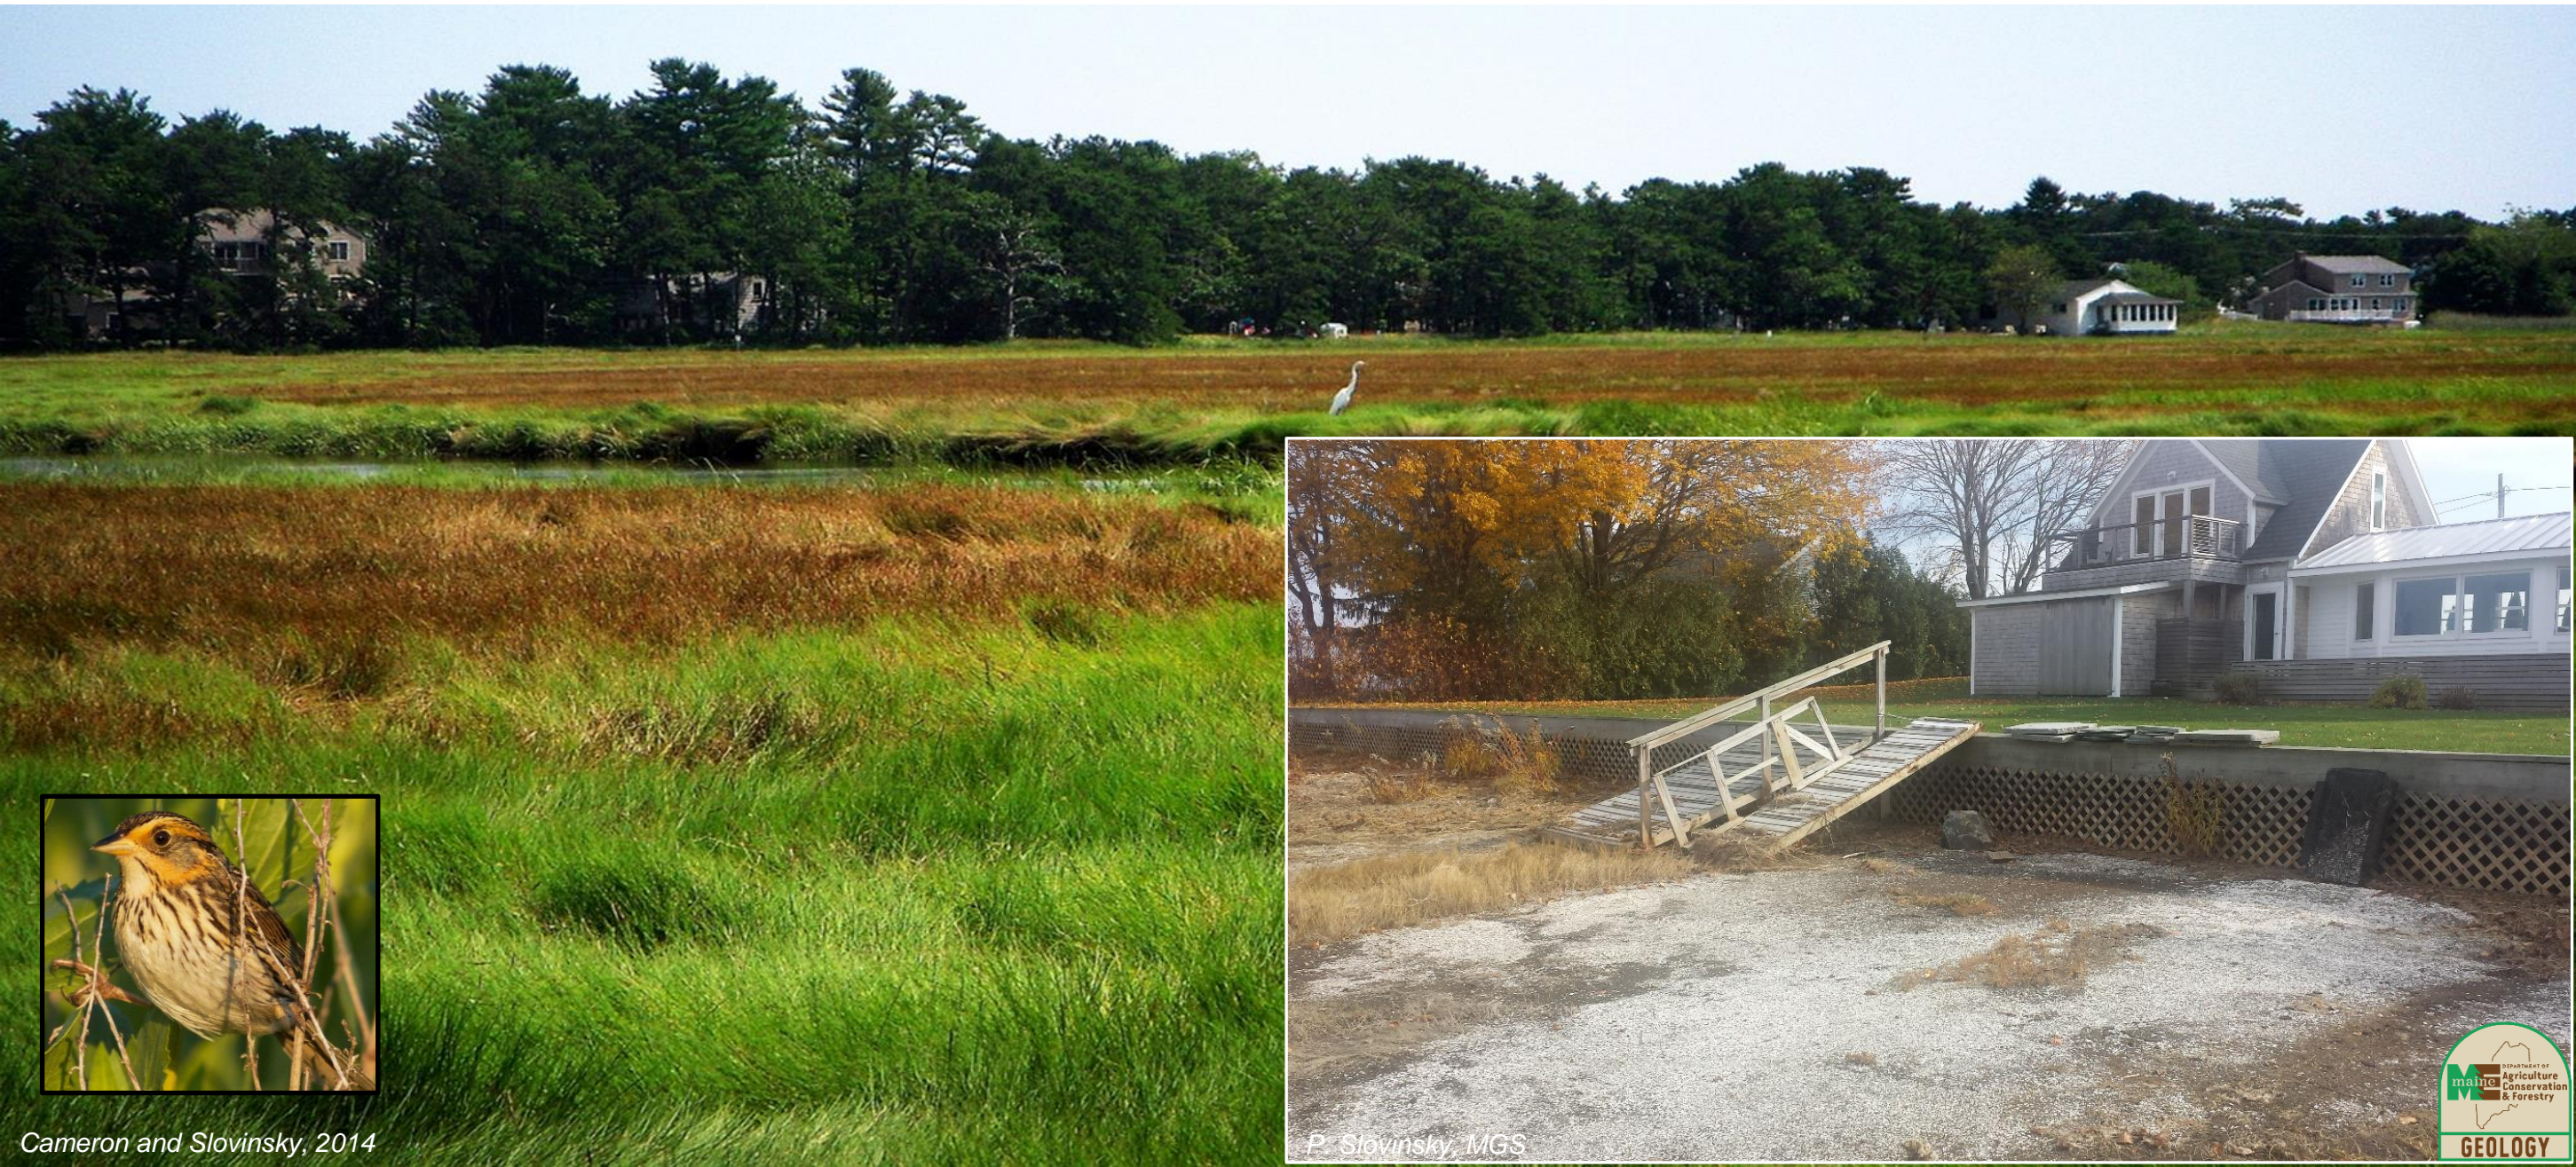
There are approximately 22,408 acres of tidal marshes in Maine*. **Shoreline armoring inhibits the natural landward migration of marshes, impacts sediment transfer to the marsh, and reduces habitat.**

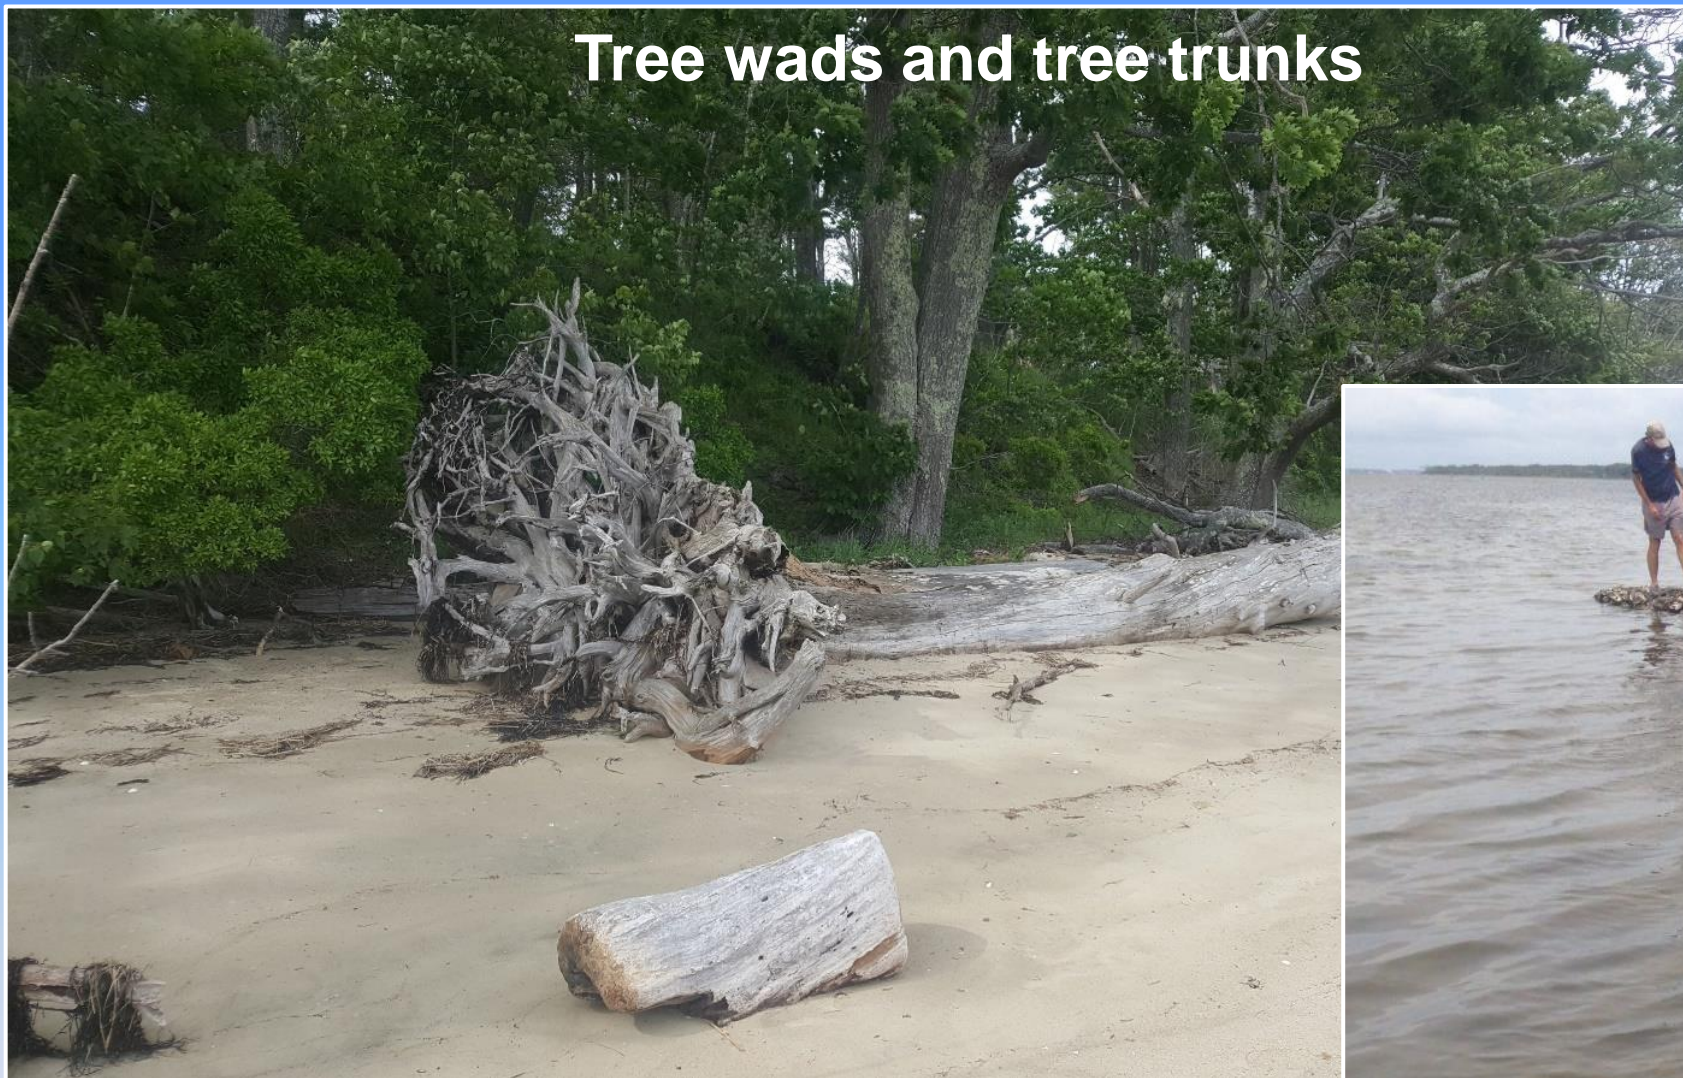
Tree wads and tree trunks

Can we implement low-cost biodegradable vs. synthetic treatments that *beneficially reuse naturally occurring materials* to mitigate coastal erosion along marsh edges and coastal bluffs?

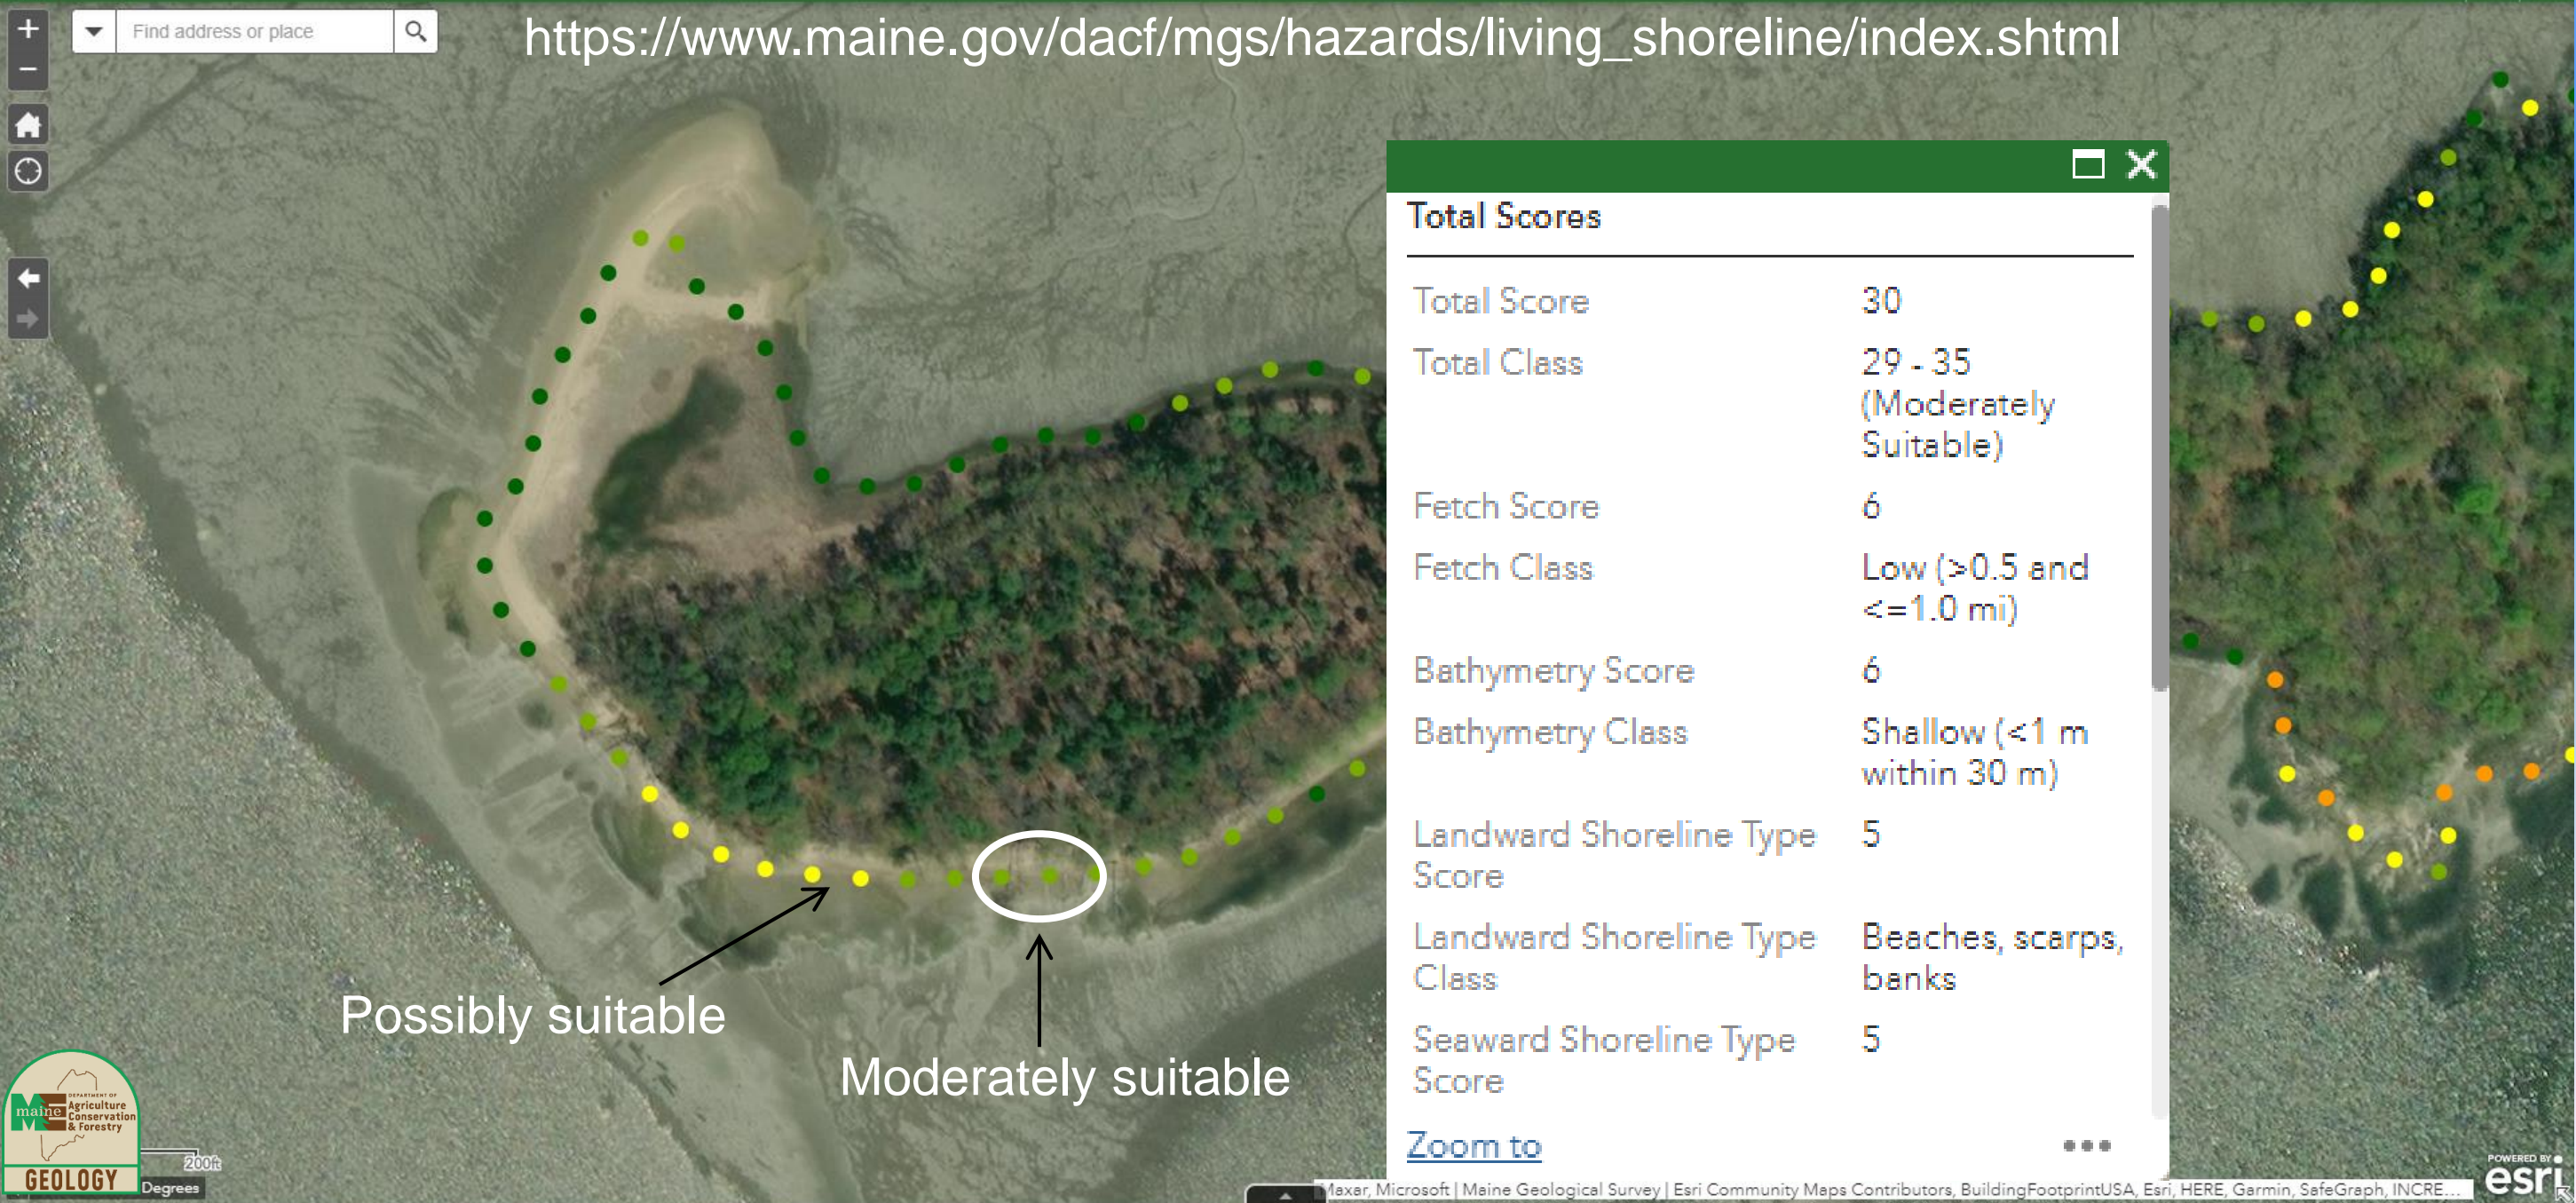
Lanes Island, Yarmouth – Low end of Moderately Suitable (30 - 31 out of 44)

Total Scores	
Total Score	30
Total Class	29 - 35 (Moderately Suitable)
Fetch Score	6
Fetch Class	Low (>0.5 and <=1.0 mi)
Bathymetry Score	6
Bathymetry Class	Shallow (<1 m within 30 m)
Landward Shoreline Type Score	5
Landward Shoreline Type Class	Beaches, scarps, banks
Seaward Shoreline Type Score	5

eroding bluff
(10-12 ft)

Proposed
treatment
location

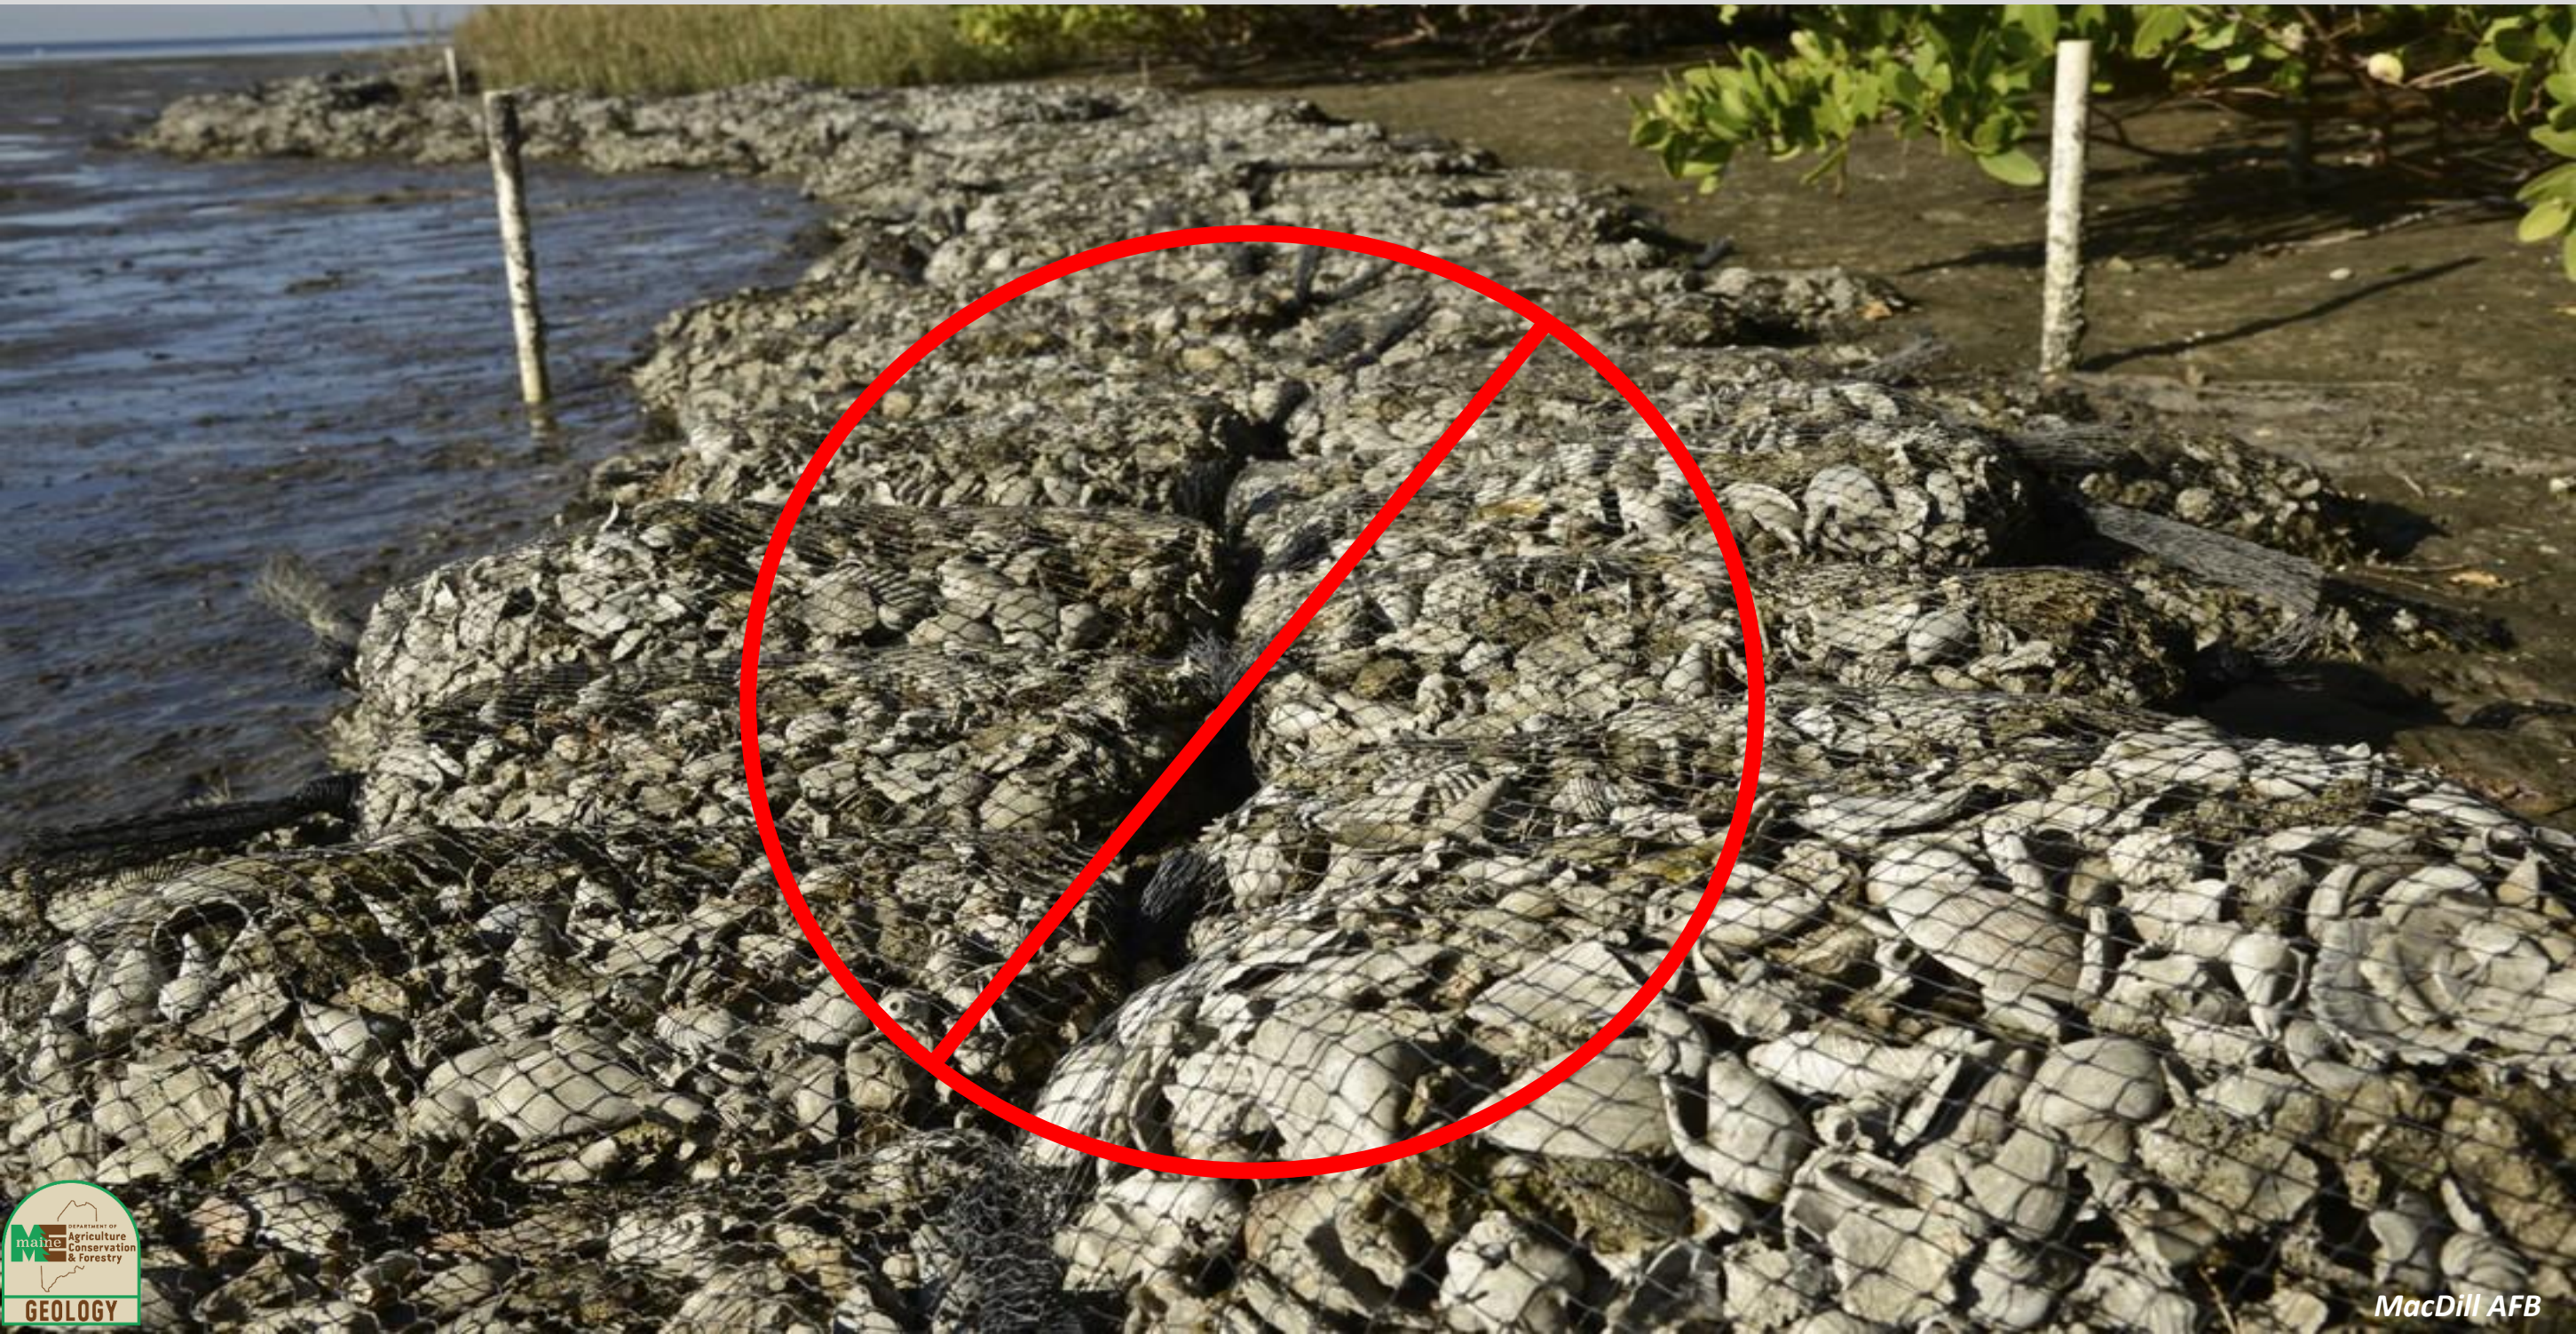
Challenge: regulatory concerns about easily *degradable* plastics

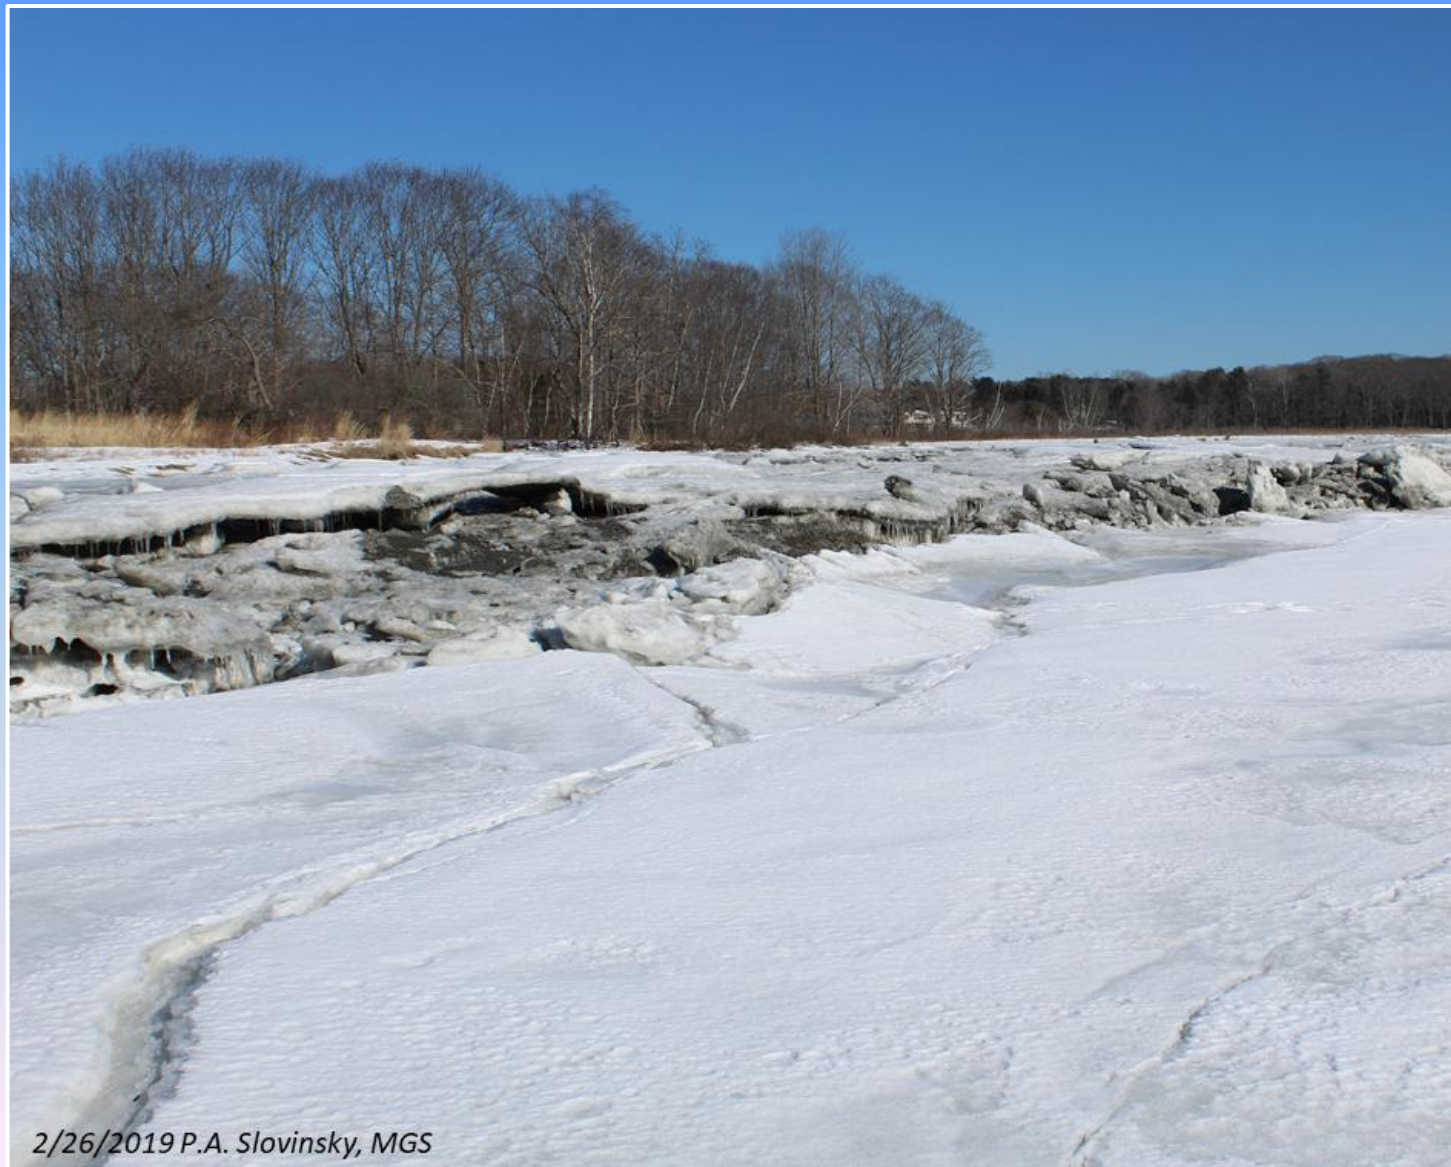
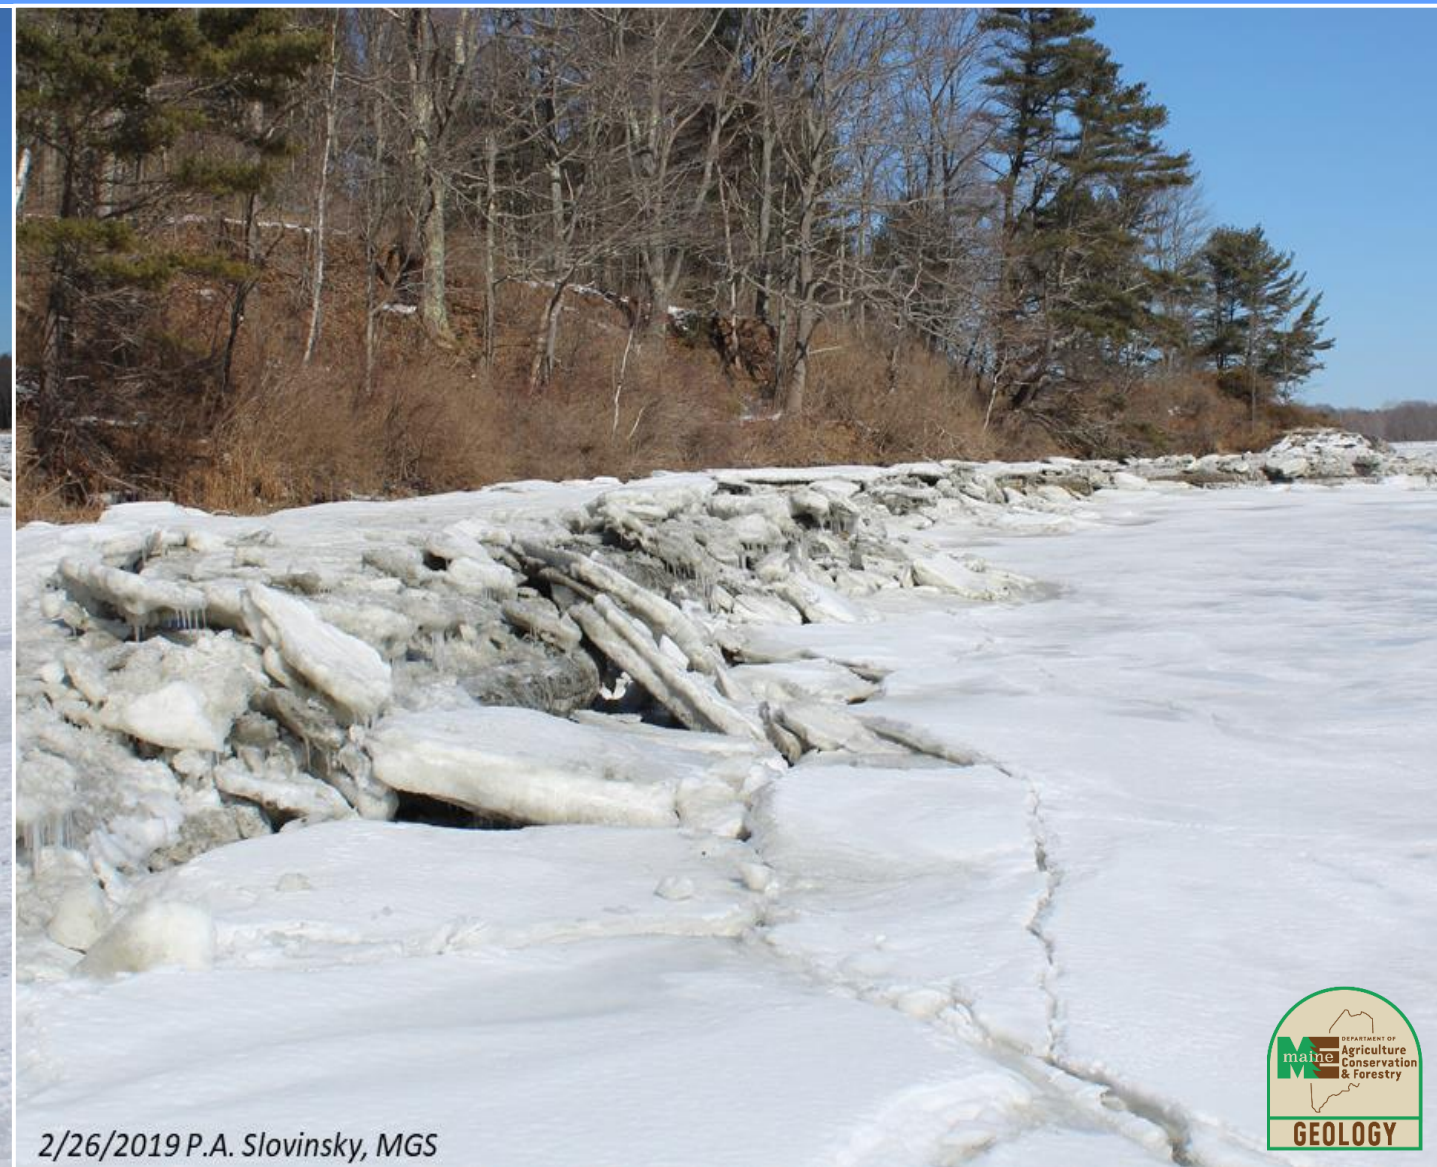
Challenge: Account for the impacts of ice

Wharton Point

Maquoit Bay Conservation Lands

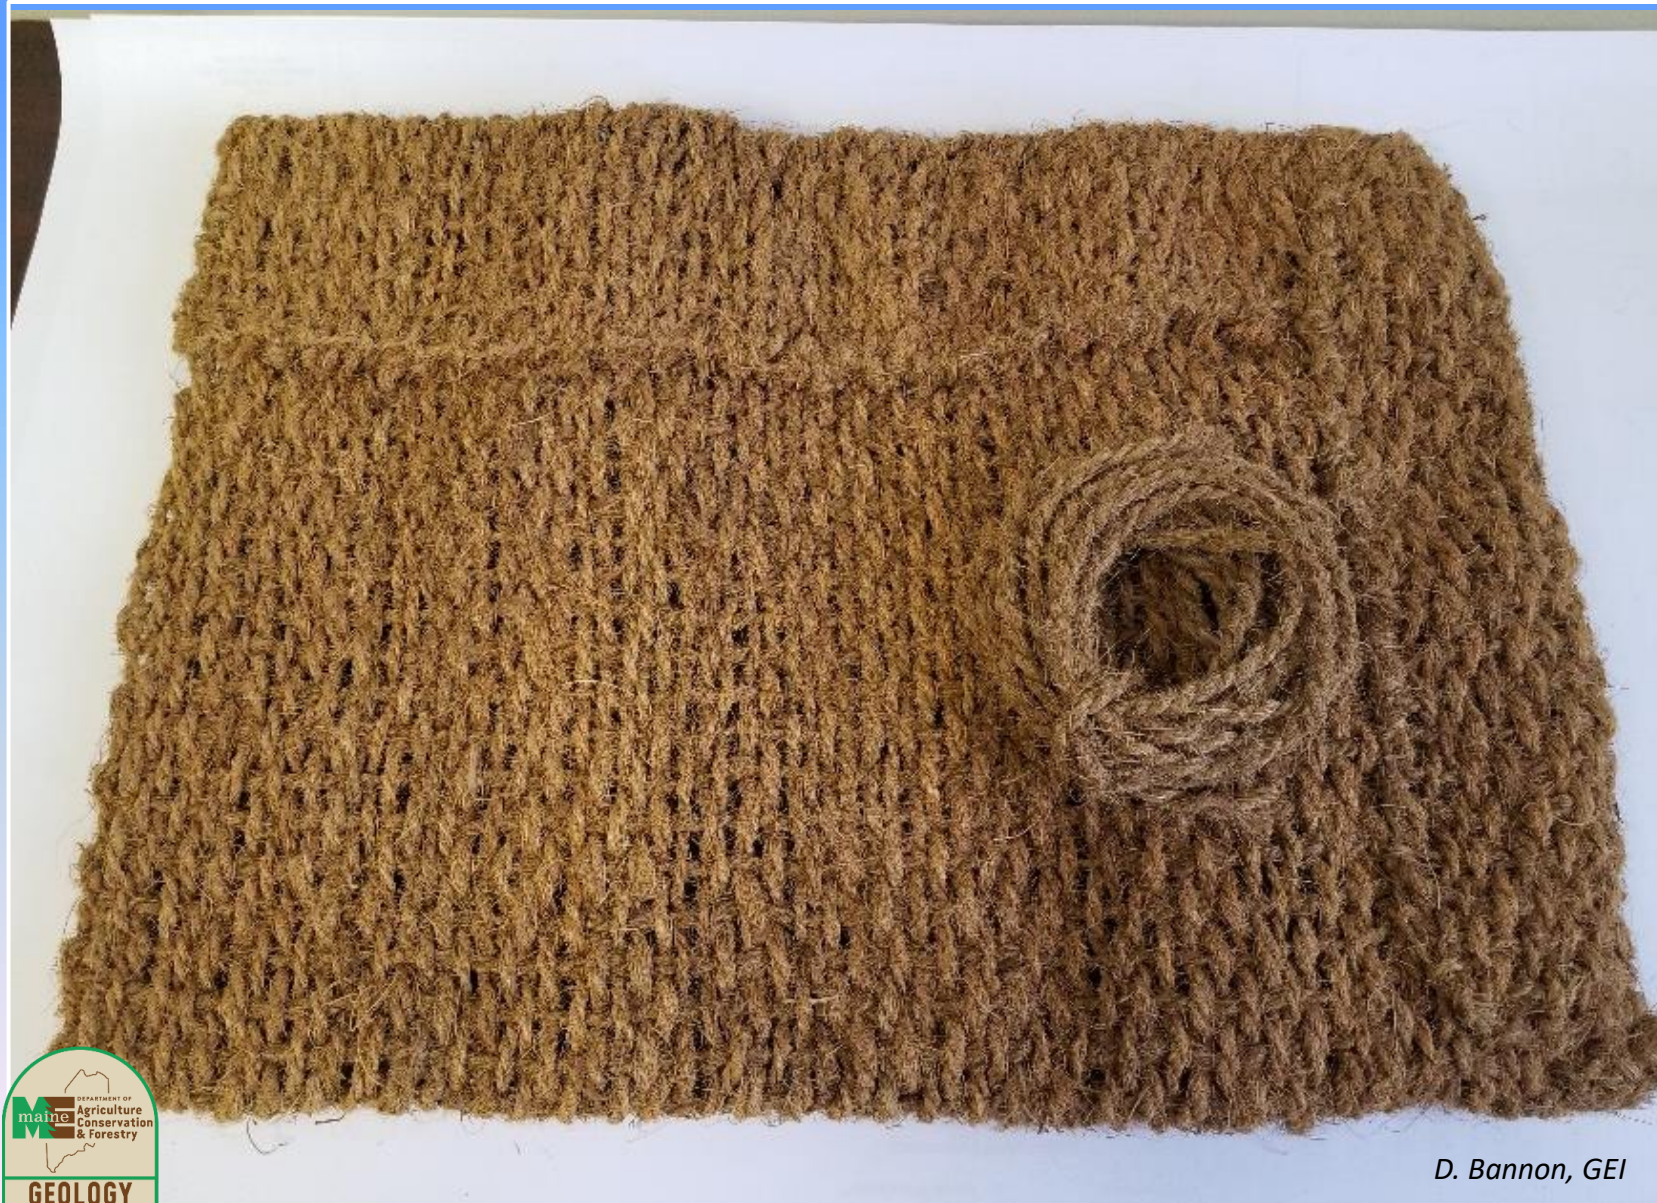
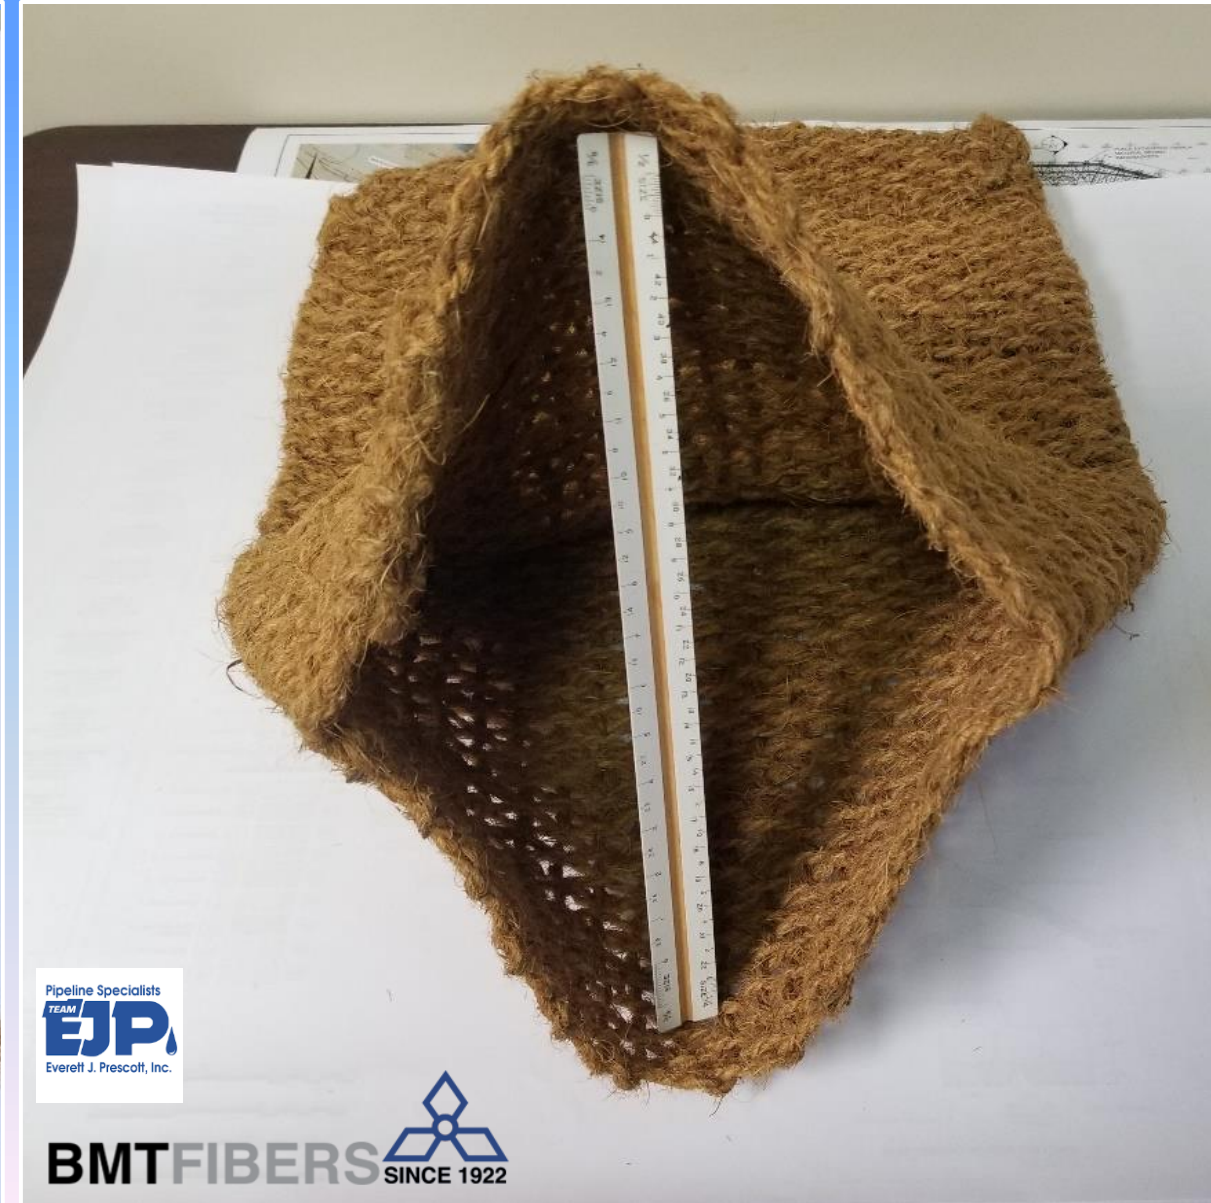
Solution: develop and test *new* heavy-fiber weave biodegradable oyster shell bags

- Biodegradable twine is *not adequate* for holding down bags. Once it gets wet, it stretches.
- Biodegradable bags, though easy to work with, are likely too light to hold up to storm events.
- Biodegradable bags, even when held in place, will fall apart in <2 years.
- We will implement **an adapted biodegradable design** to test for efficacy at the Wharton Point and MBCL sites. A **new staking approach** will also be implemented.
