Testing Biodegradable and Hybrid Methods for Shoreline Stabilization

Saco Watershed Collaborative

March 22, 2022

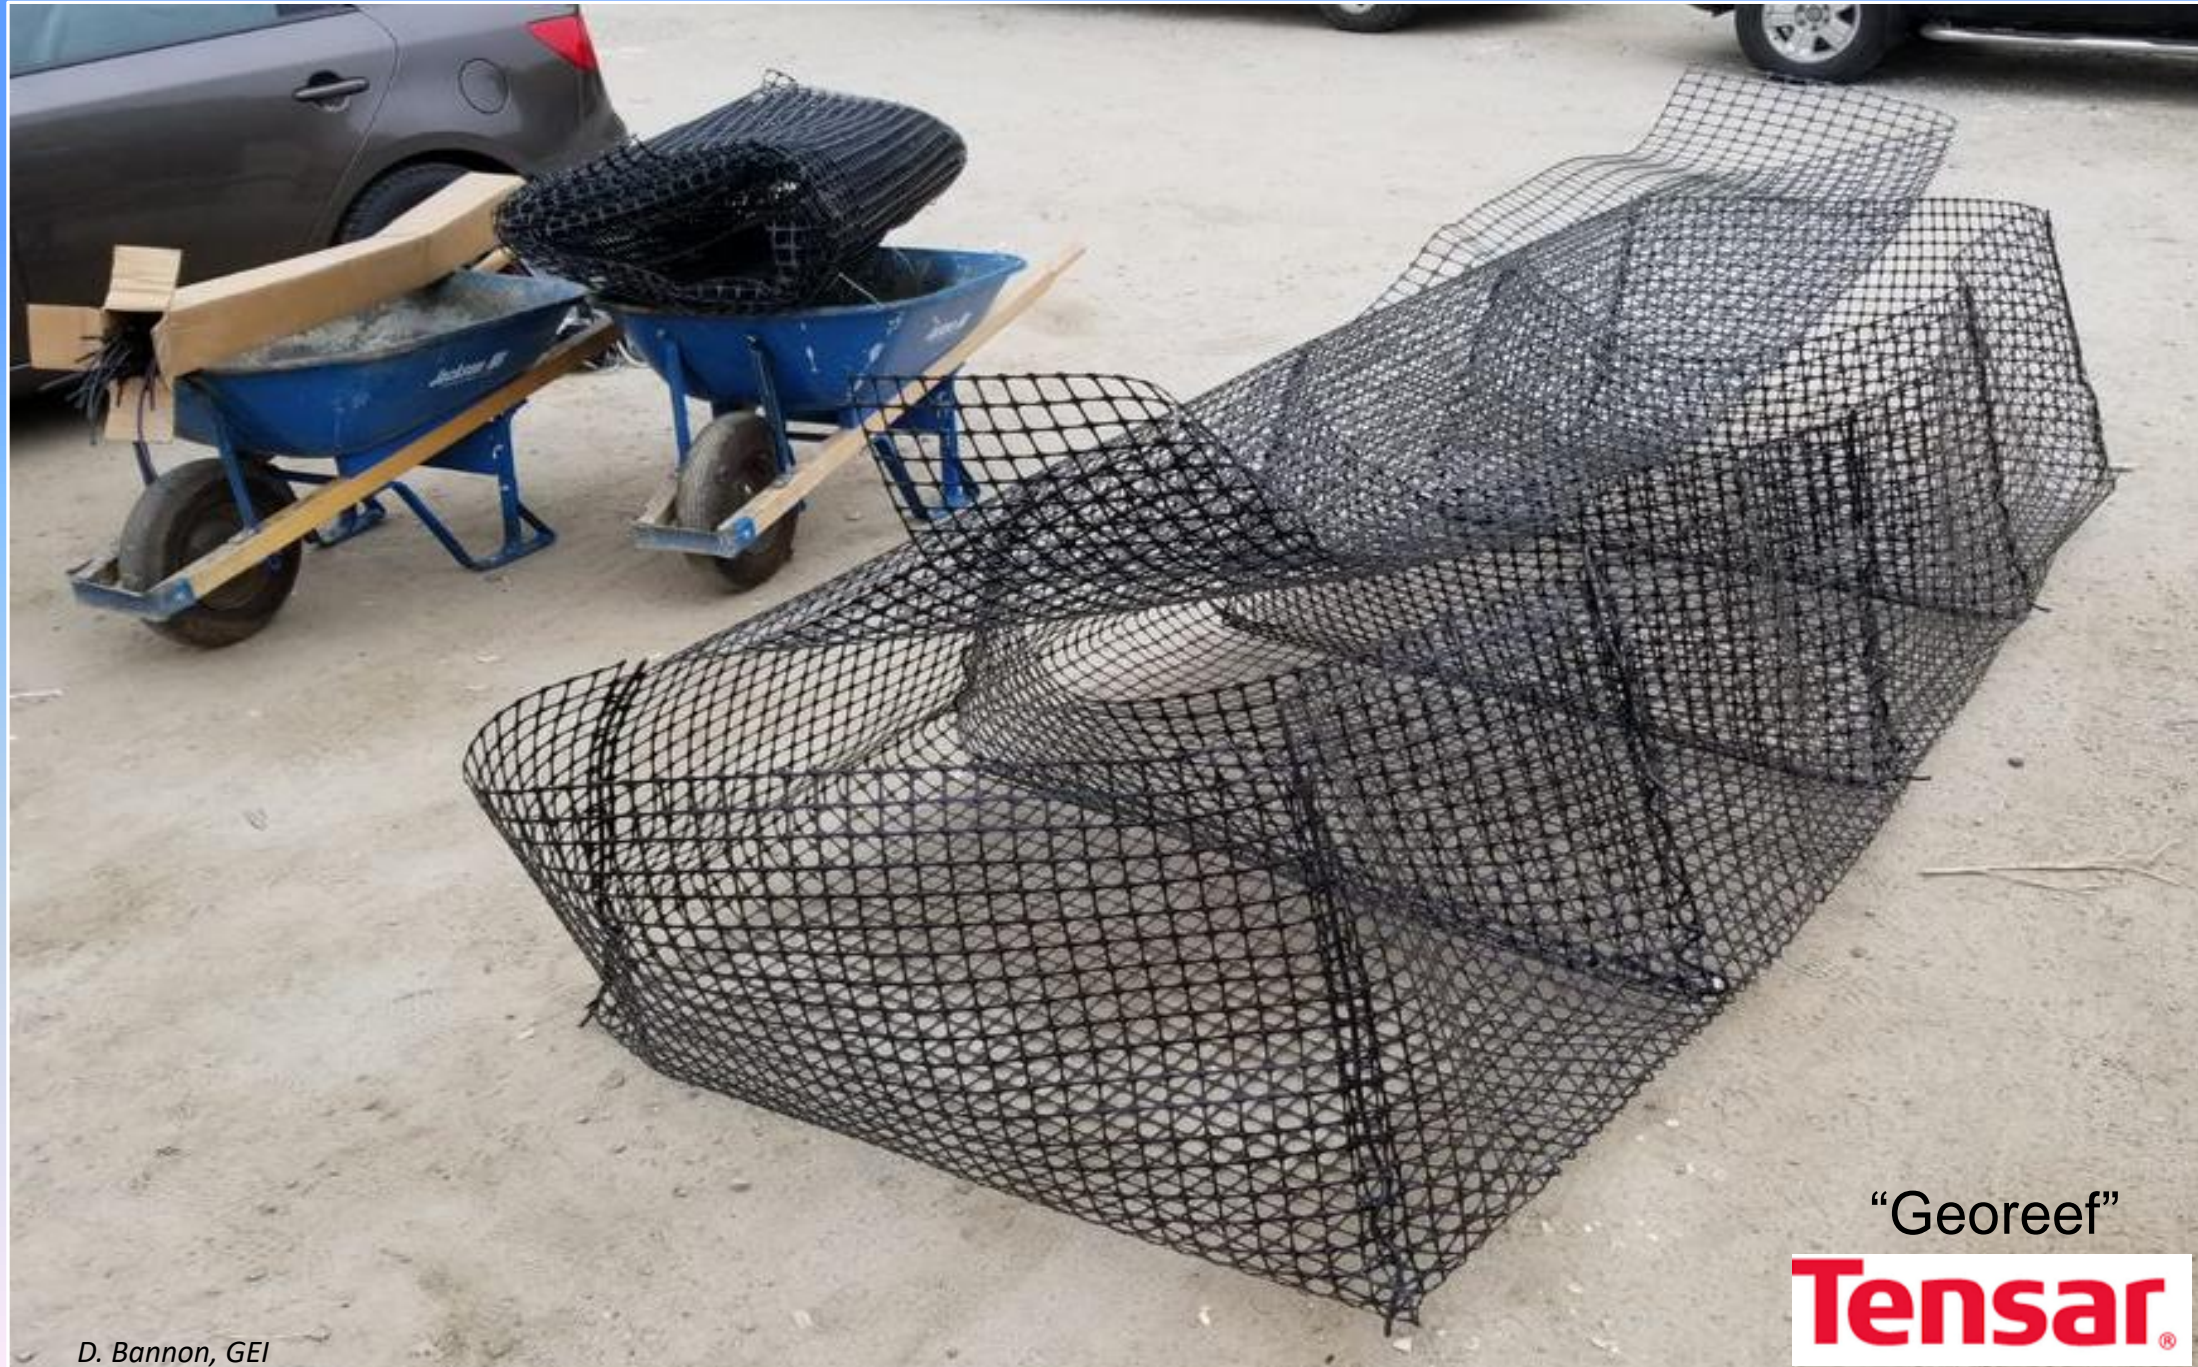
“Georeef”

Solution: test *new* UV and abrasion-resistant synthetic products

Tensar®

- Tensar GeoReef, especially at Wharton Point where the baskets were filled to create the rectangle shape, appears to be holding up very well in terms of shape, stability, ability to hold shell, and degradation.
- Tensar GeoReef at MBCL could have been filled with more shell to help retain shape, but it is very difficult to do this under the log runners.
- Shore parallel log at Wharton Point may not be high enough to efficiently break up wave energy so close to the installation. Shore perpendicular log runners at MBCL have performed relatively well.
- Recommend altering future attachment to tree runners using duckbills in future.

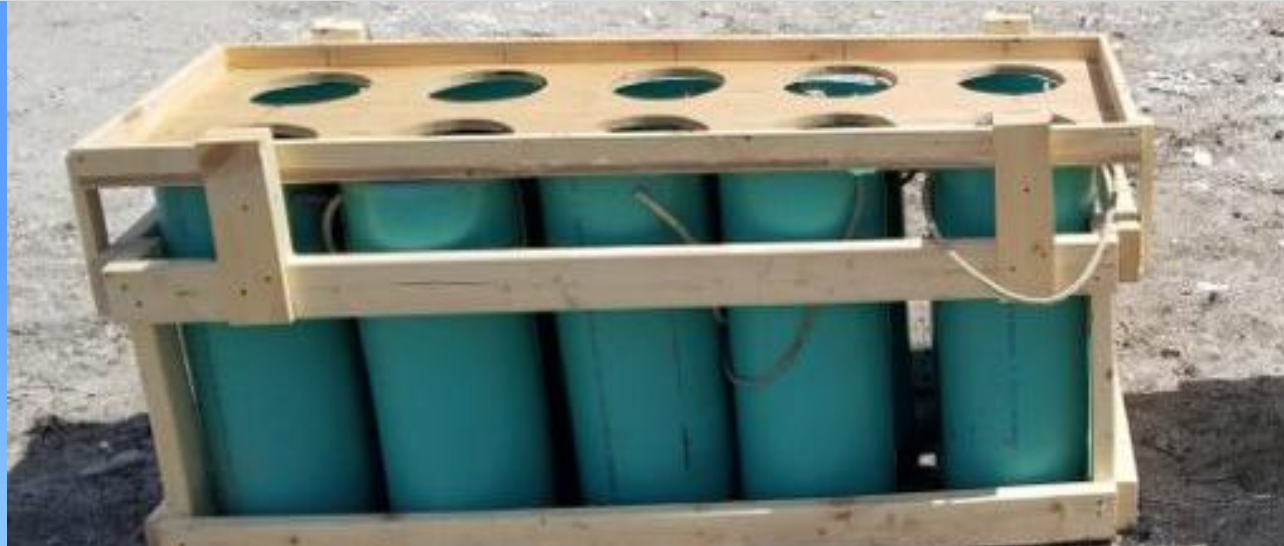
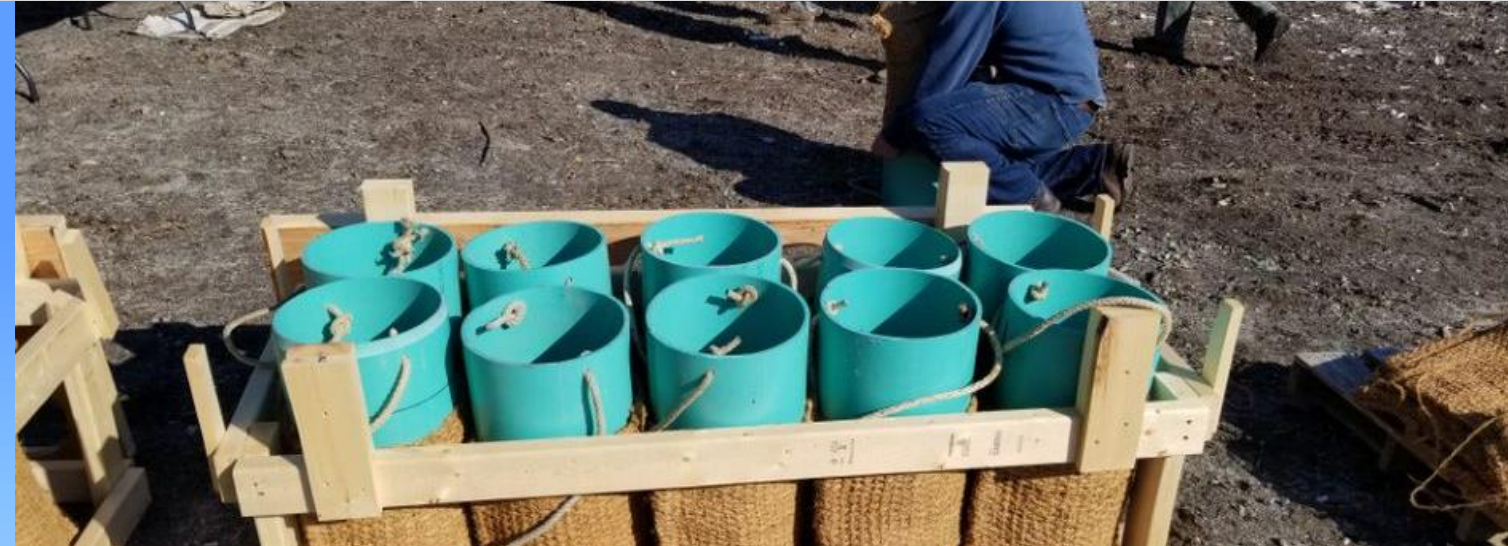
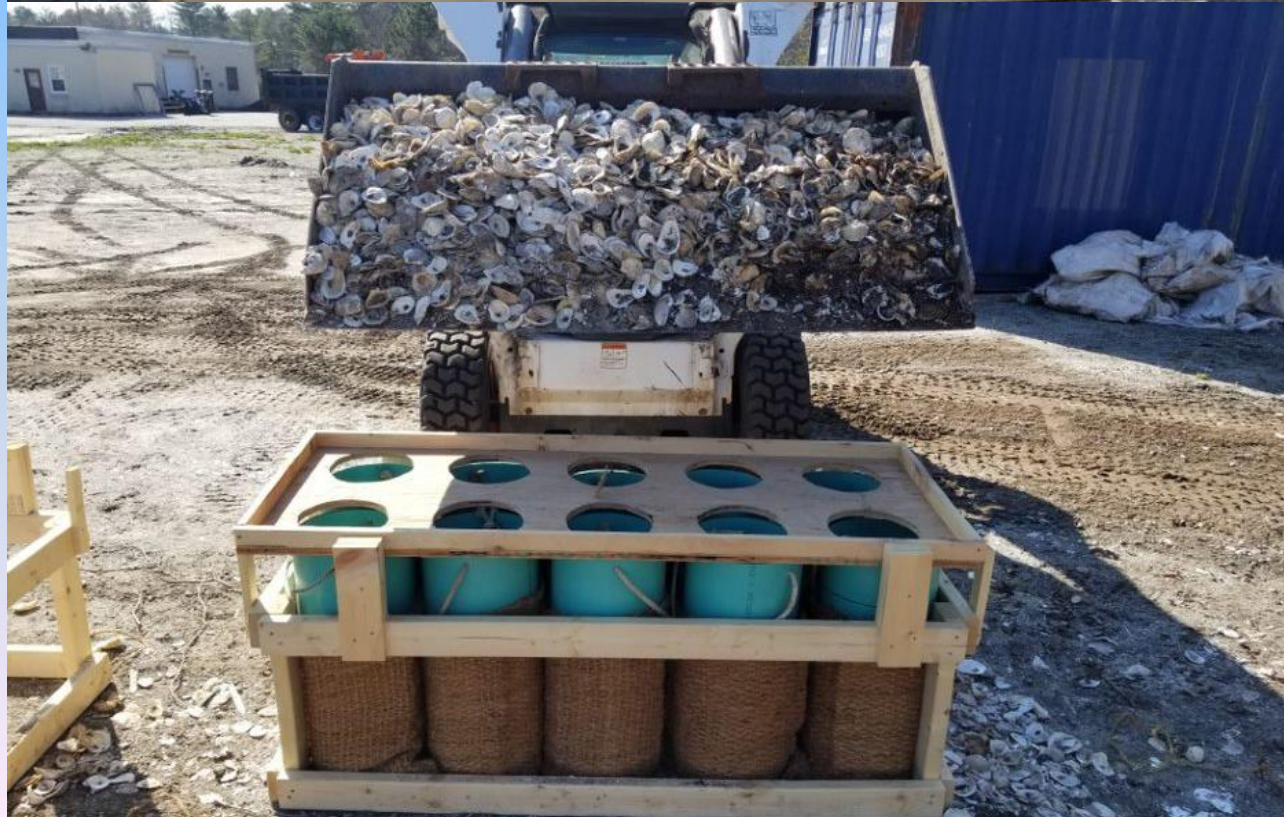
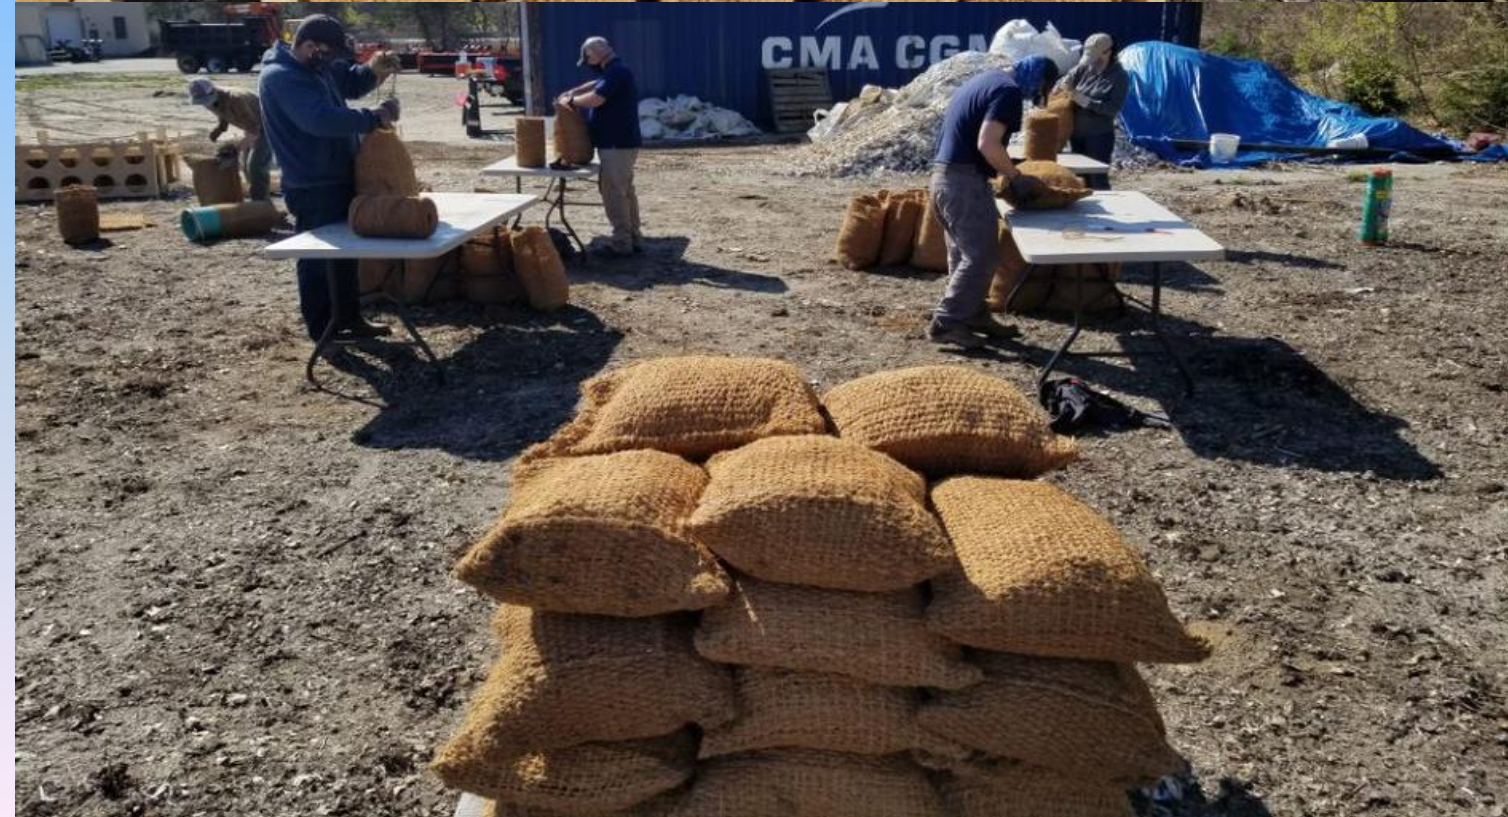
Challenge: Bagging oyster shell with volunteers (during a pandemic)

Solution: bagging stations, sewing stations, and dedicated volunteers

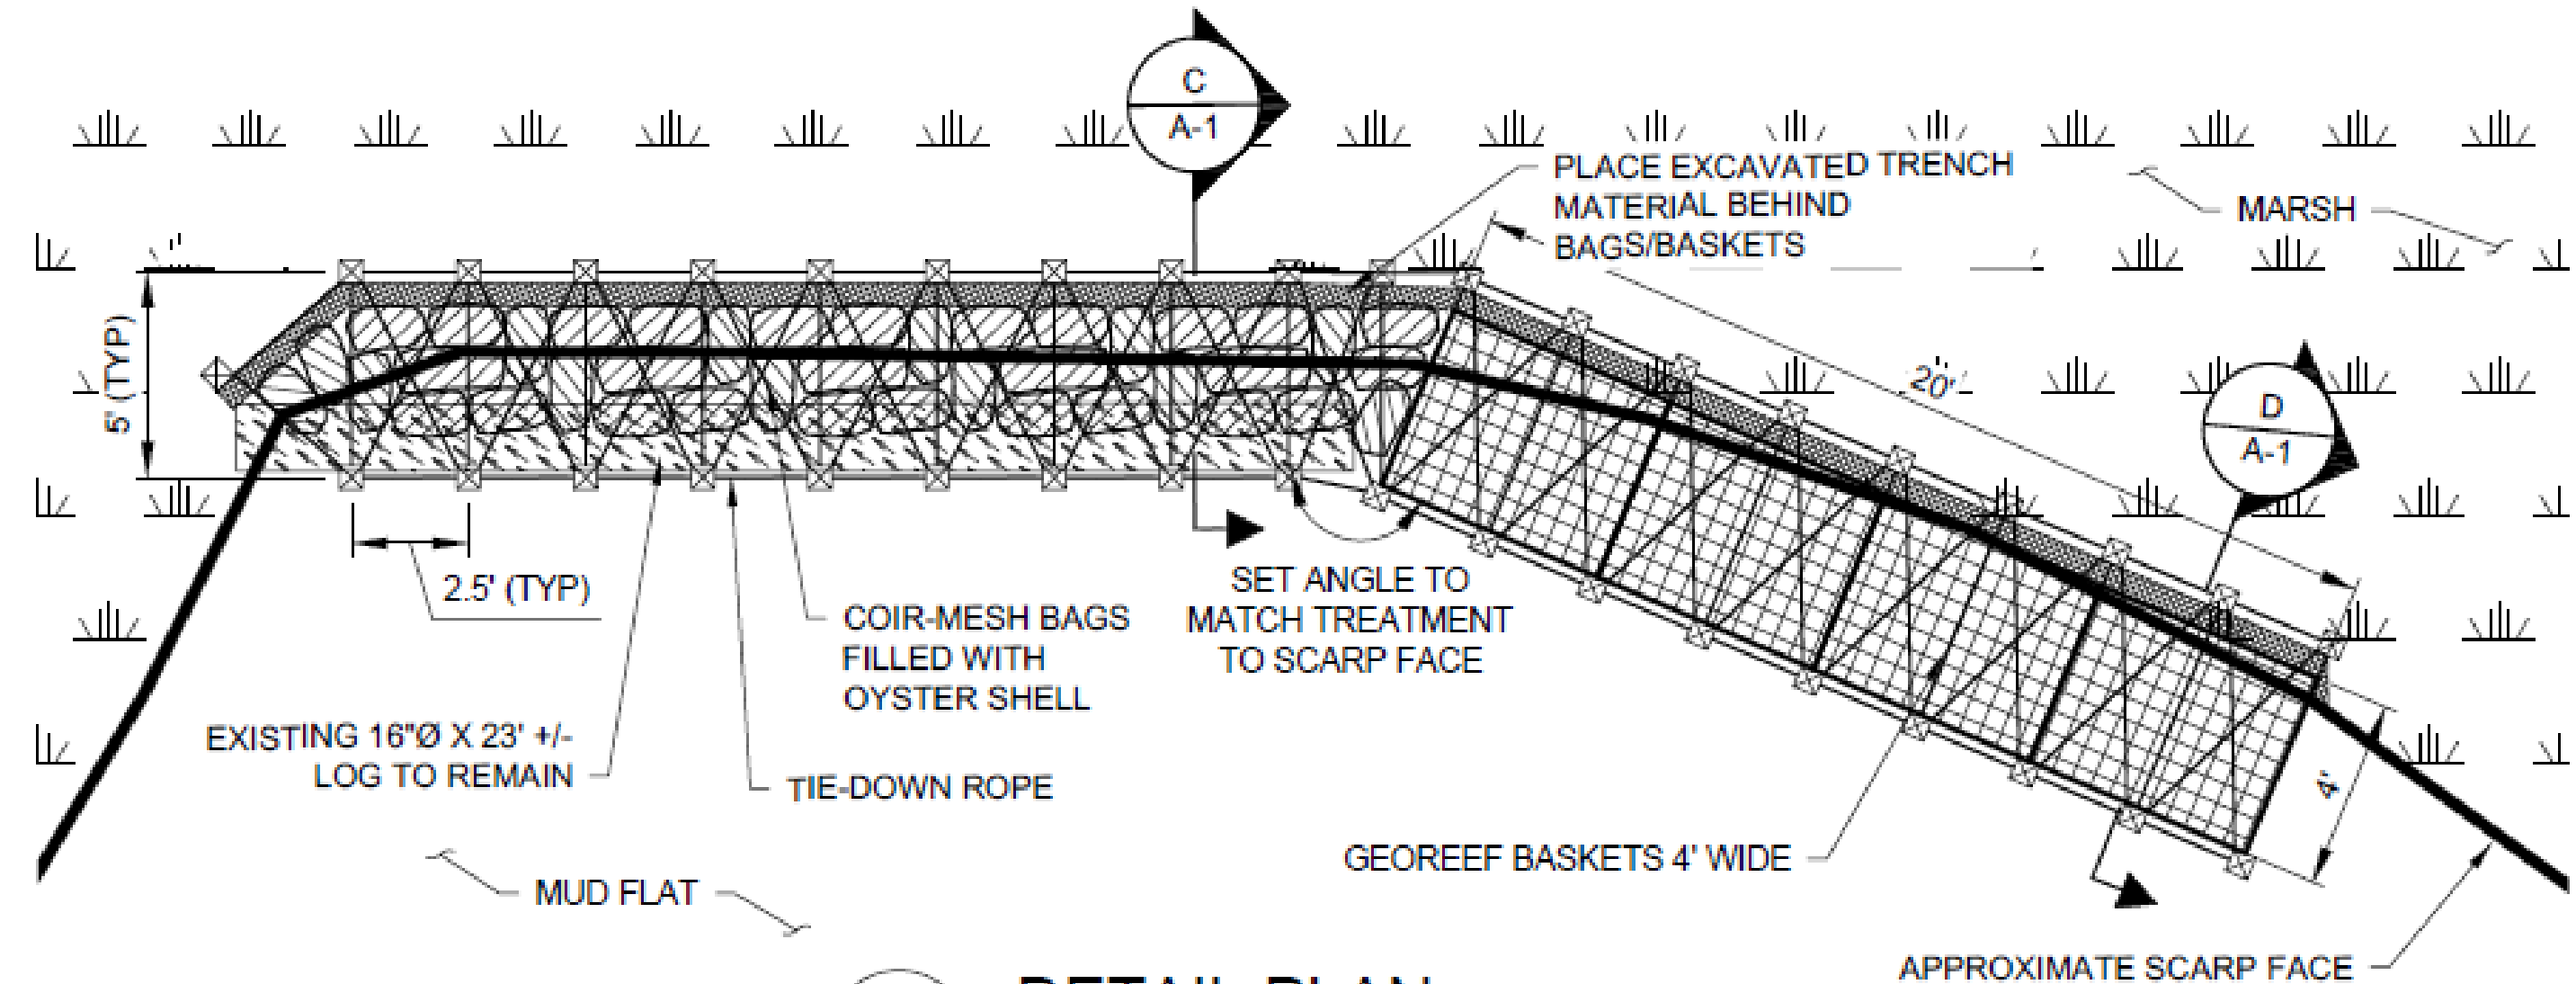
A DETAIL PLAN
A-1 SCALE: 1"=5'-0"

Integrate synthetic and biodegradable materials and trees

Wharton Point

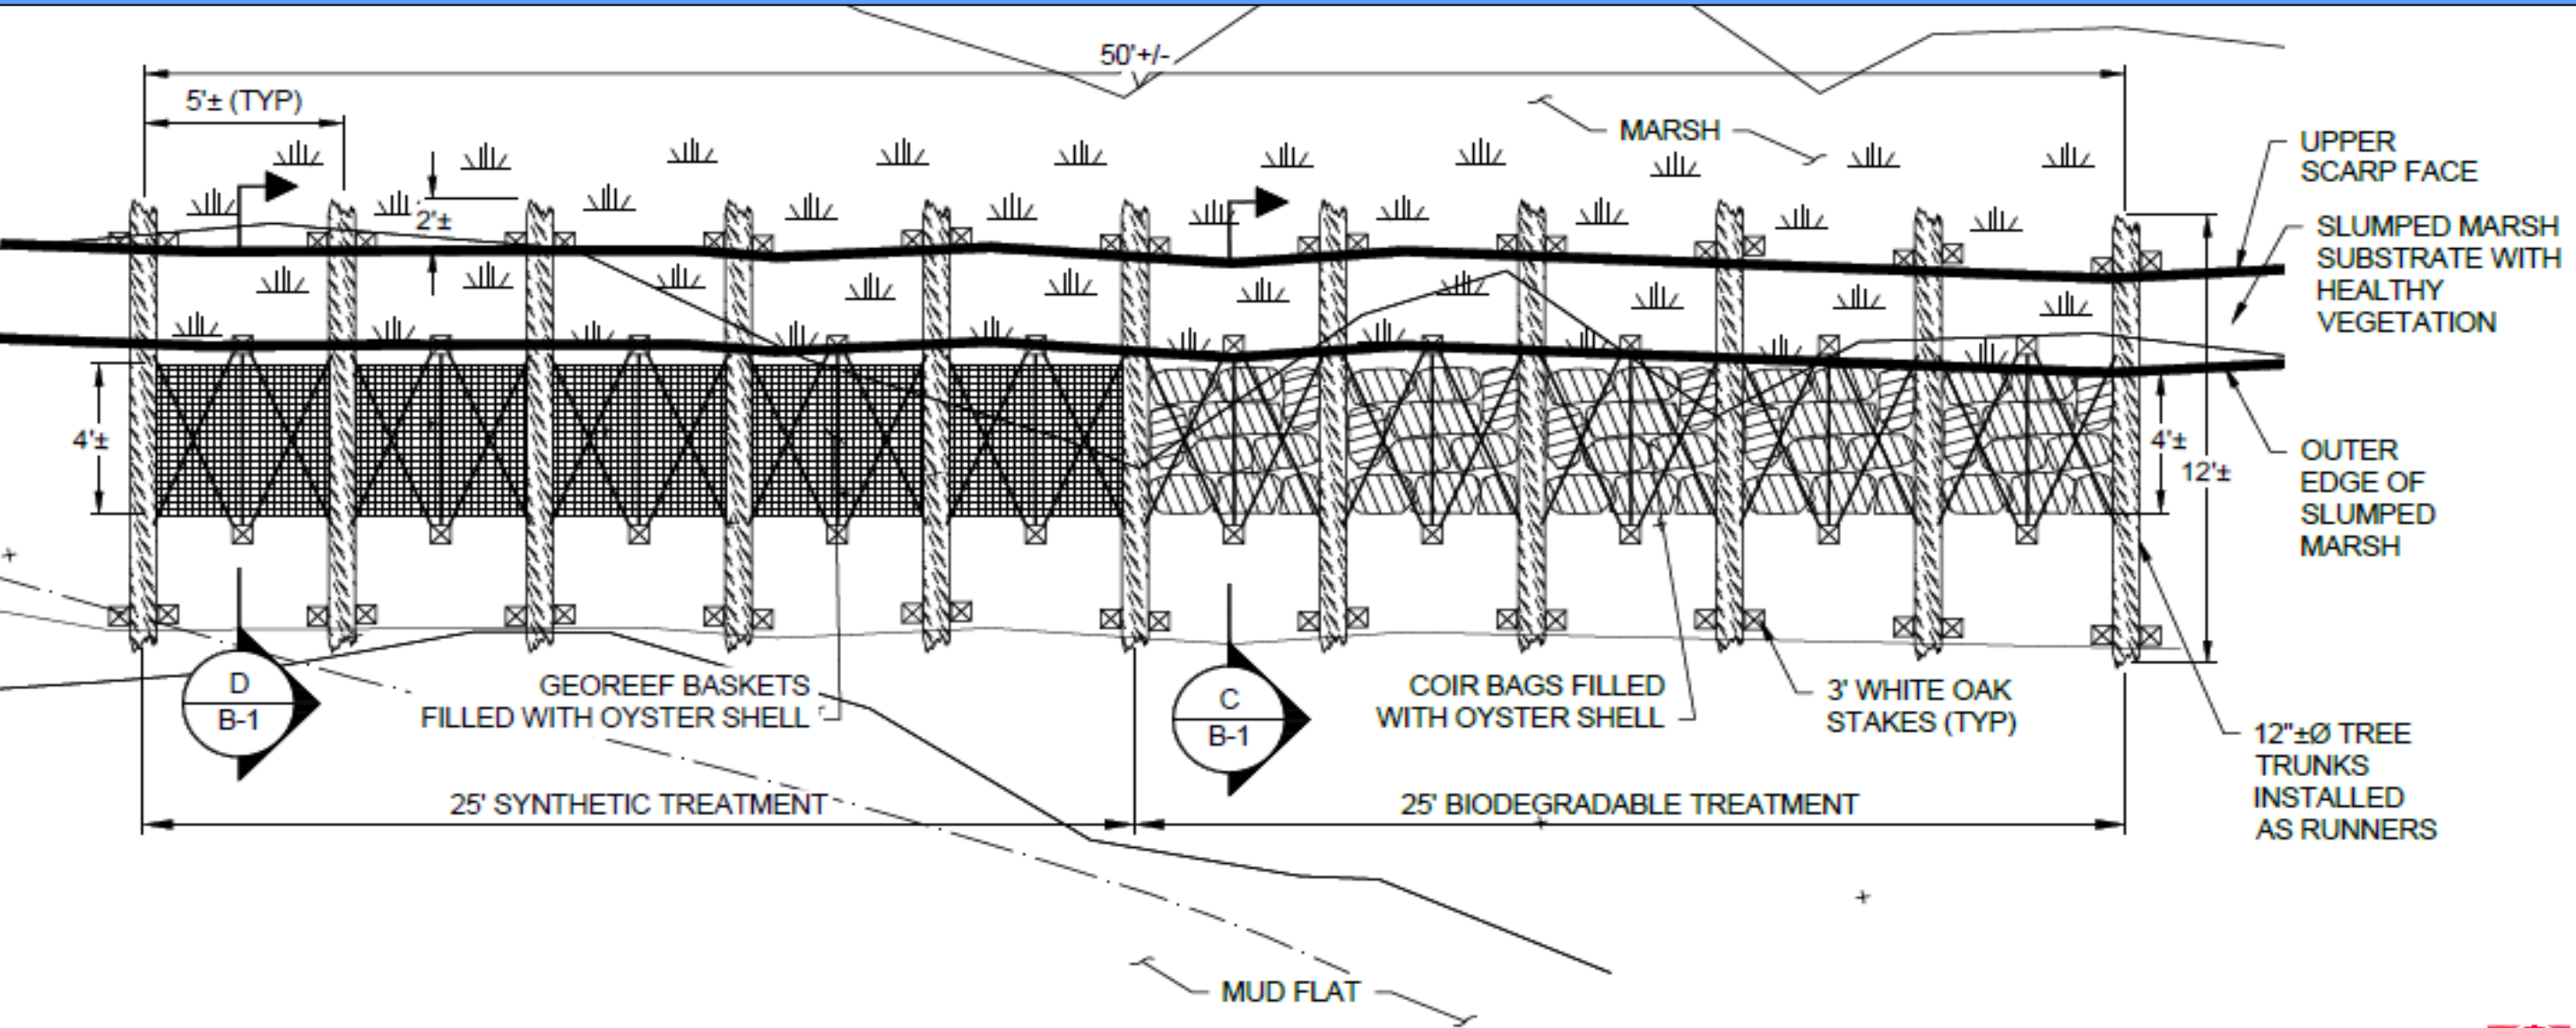
A
B-1 PLAN VIEW OF LIVING SHORELINE TREATMENT
SCALE: 1"=5'-0"

Solution: Integrate synthetic and biodegradable materials and trees

Maquoit Bay Conservation Lands

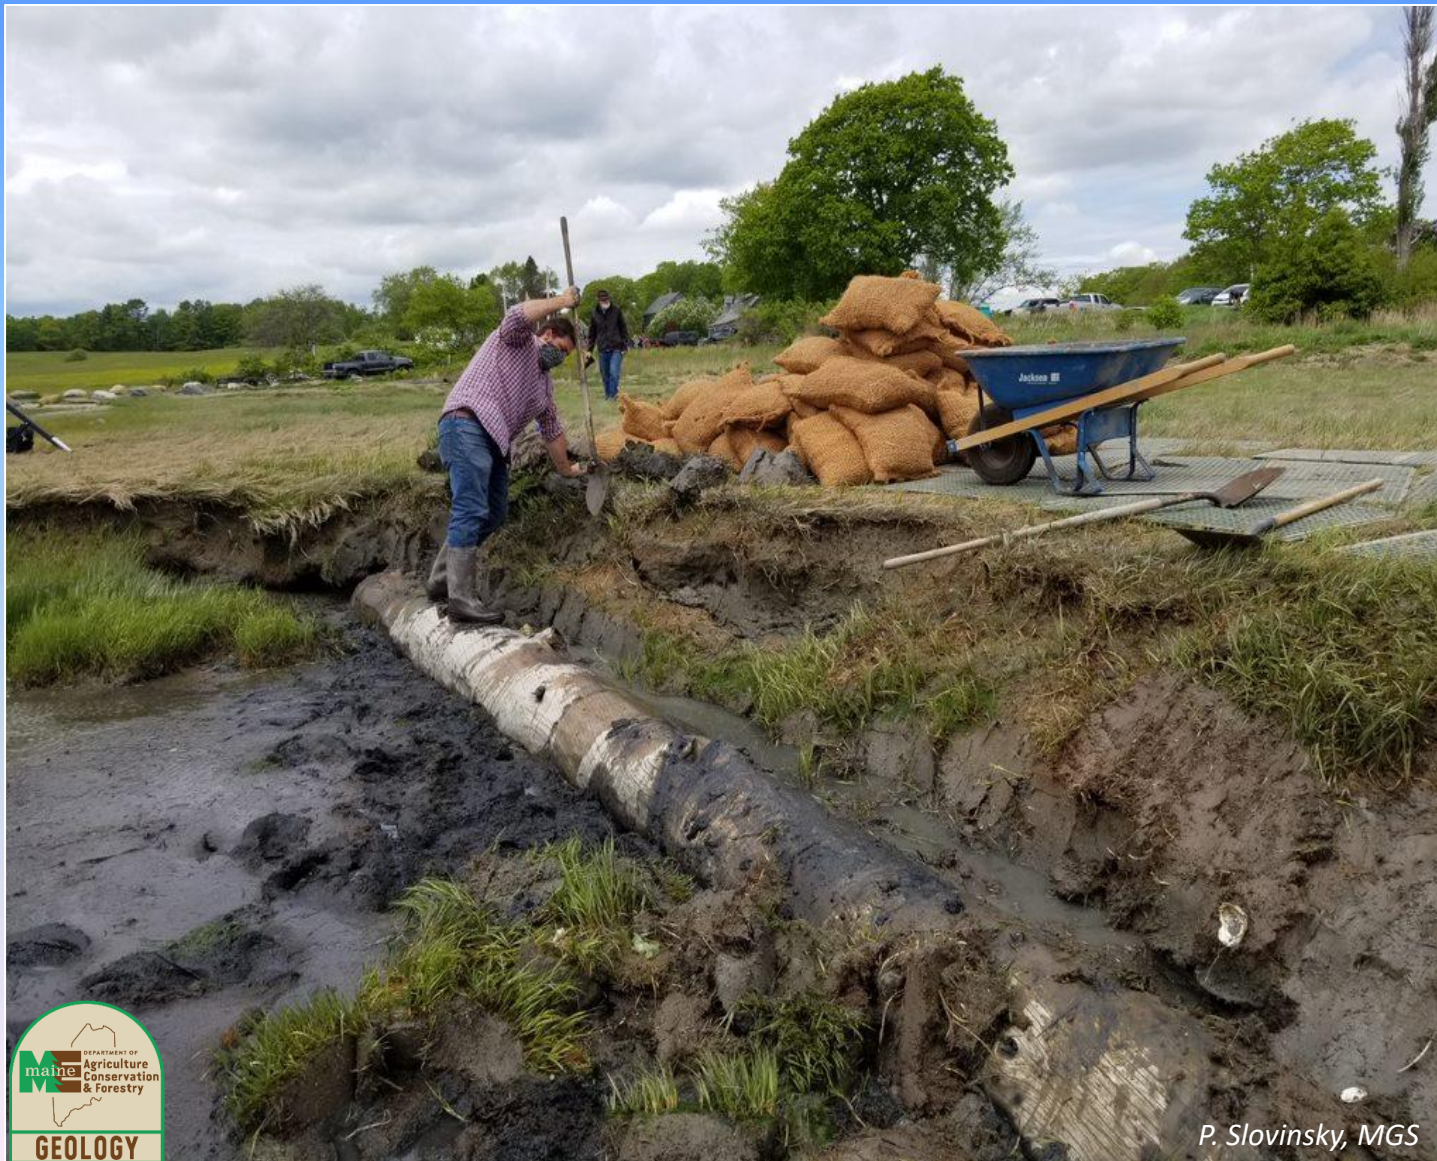
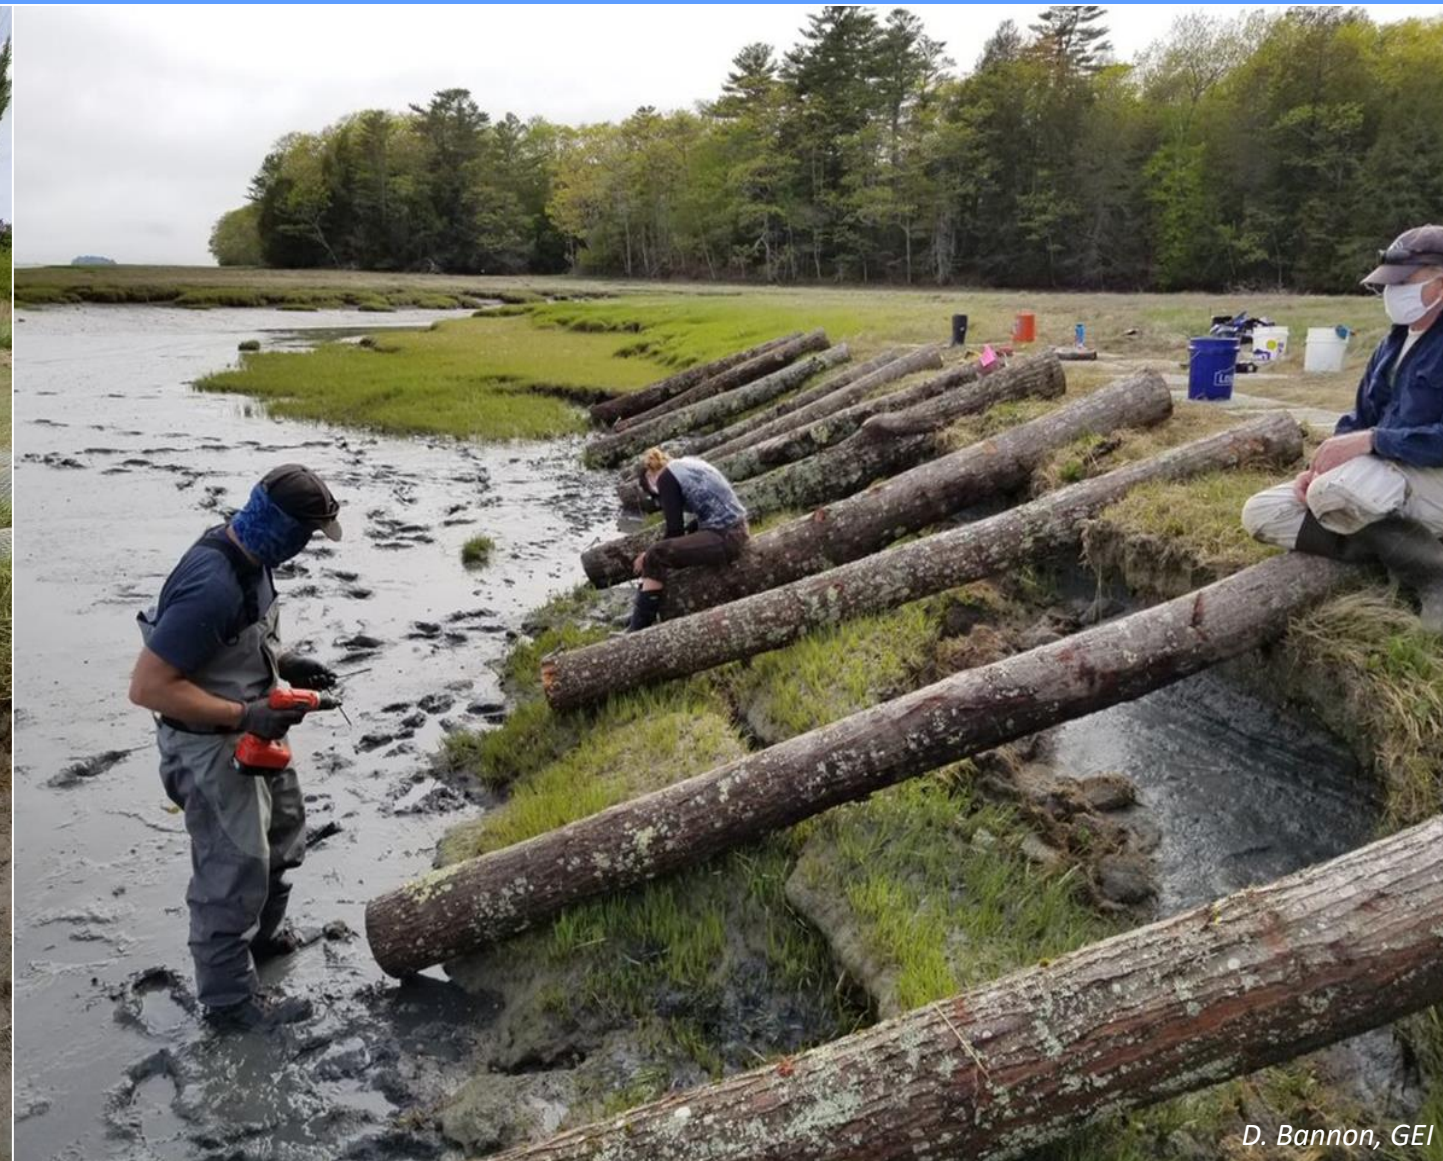
Integrate *trees* into demonstration treatments to break up ice

Wharton Point

Maquoit Bay Conservation Lands

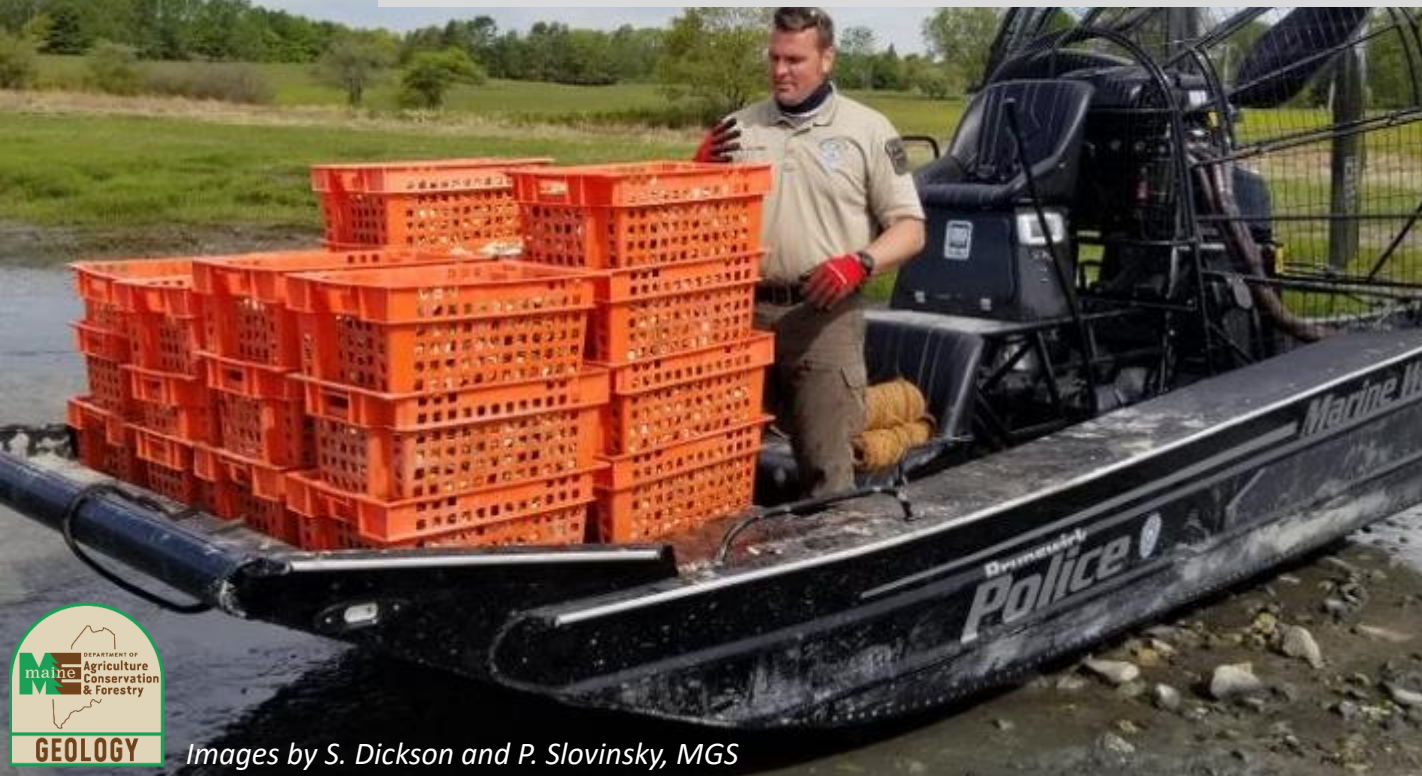
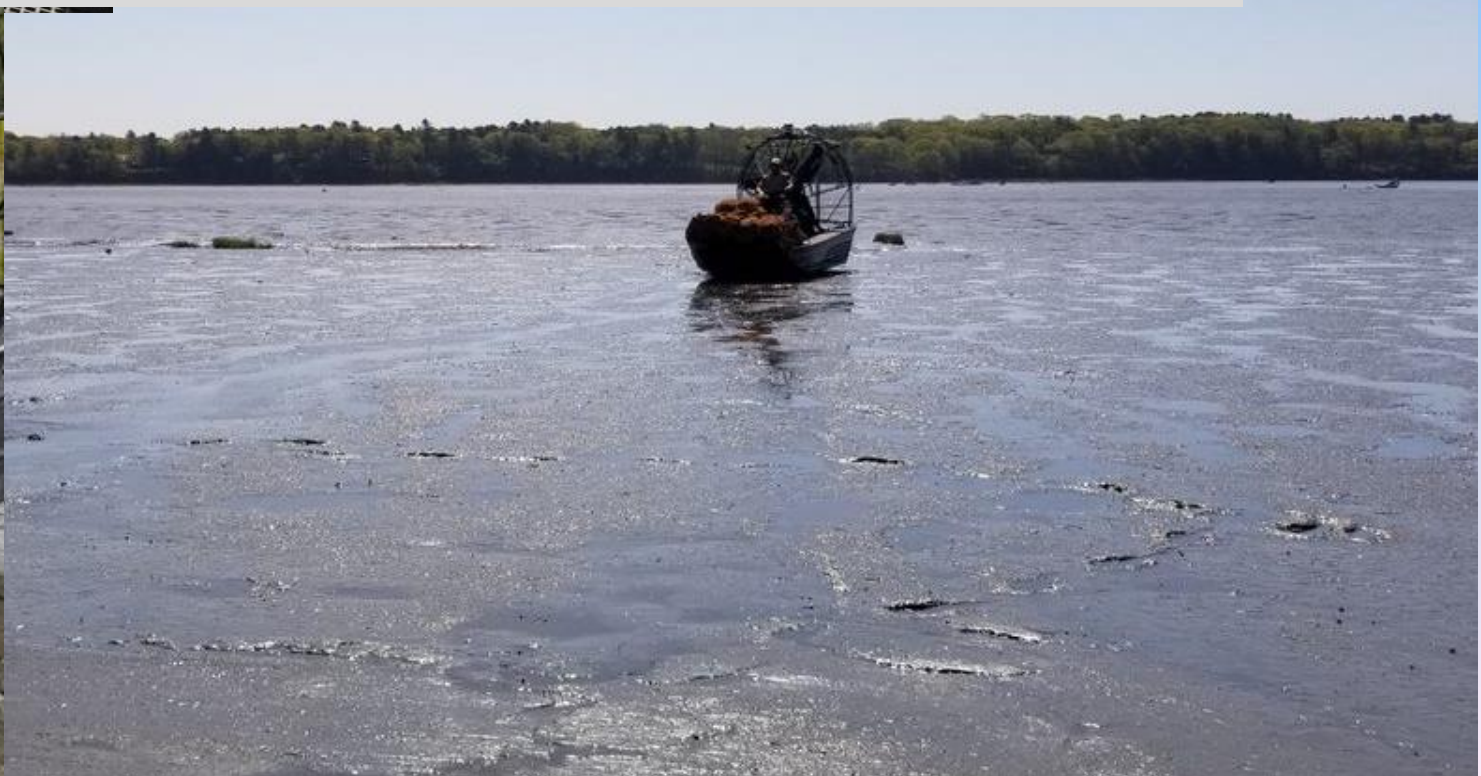
Challenge: delivering supplies while accounting for tides
Solution: Project partners, barges and airboats!

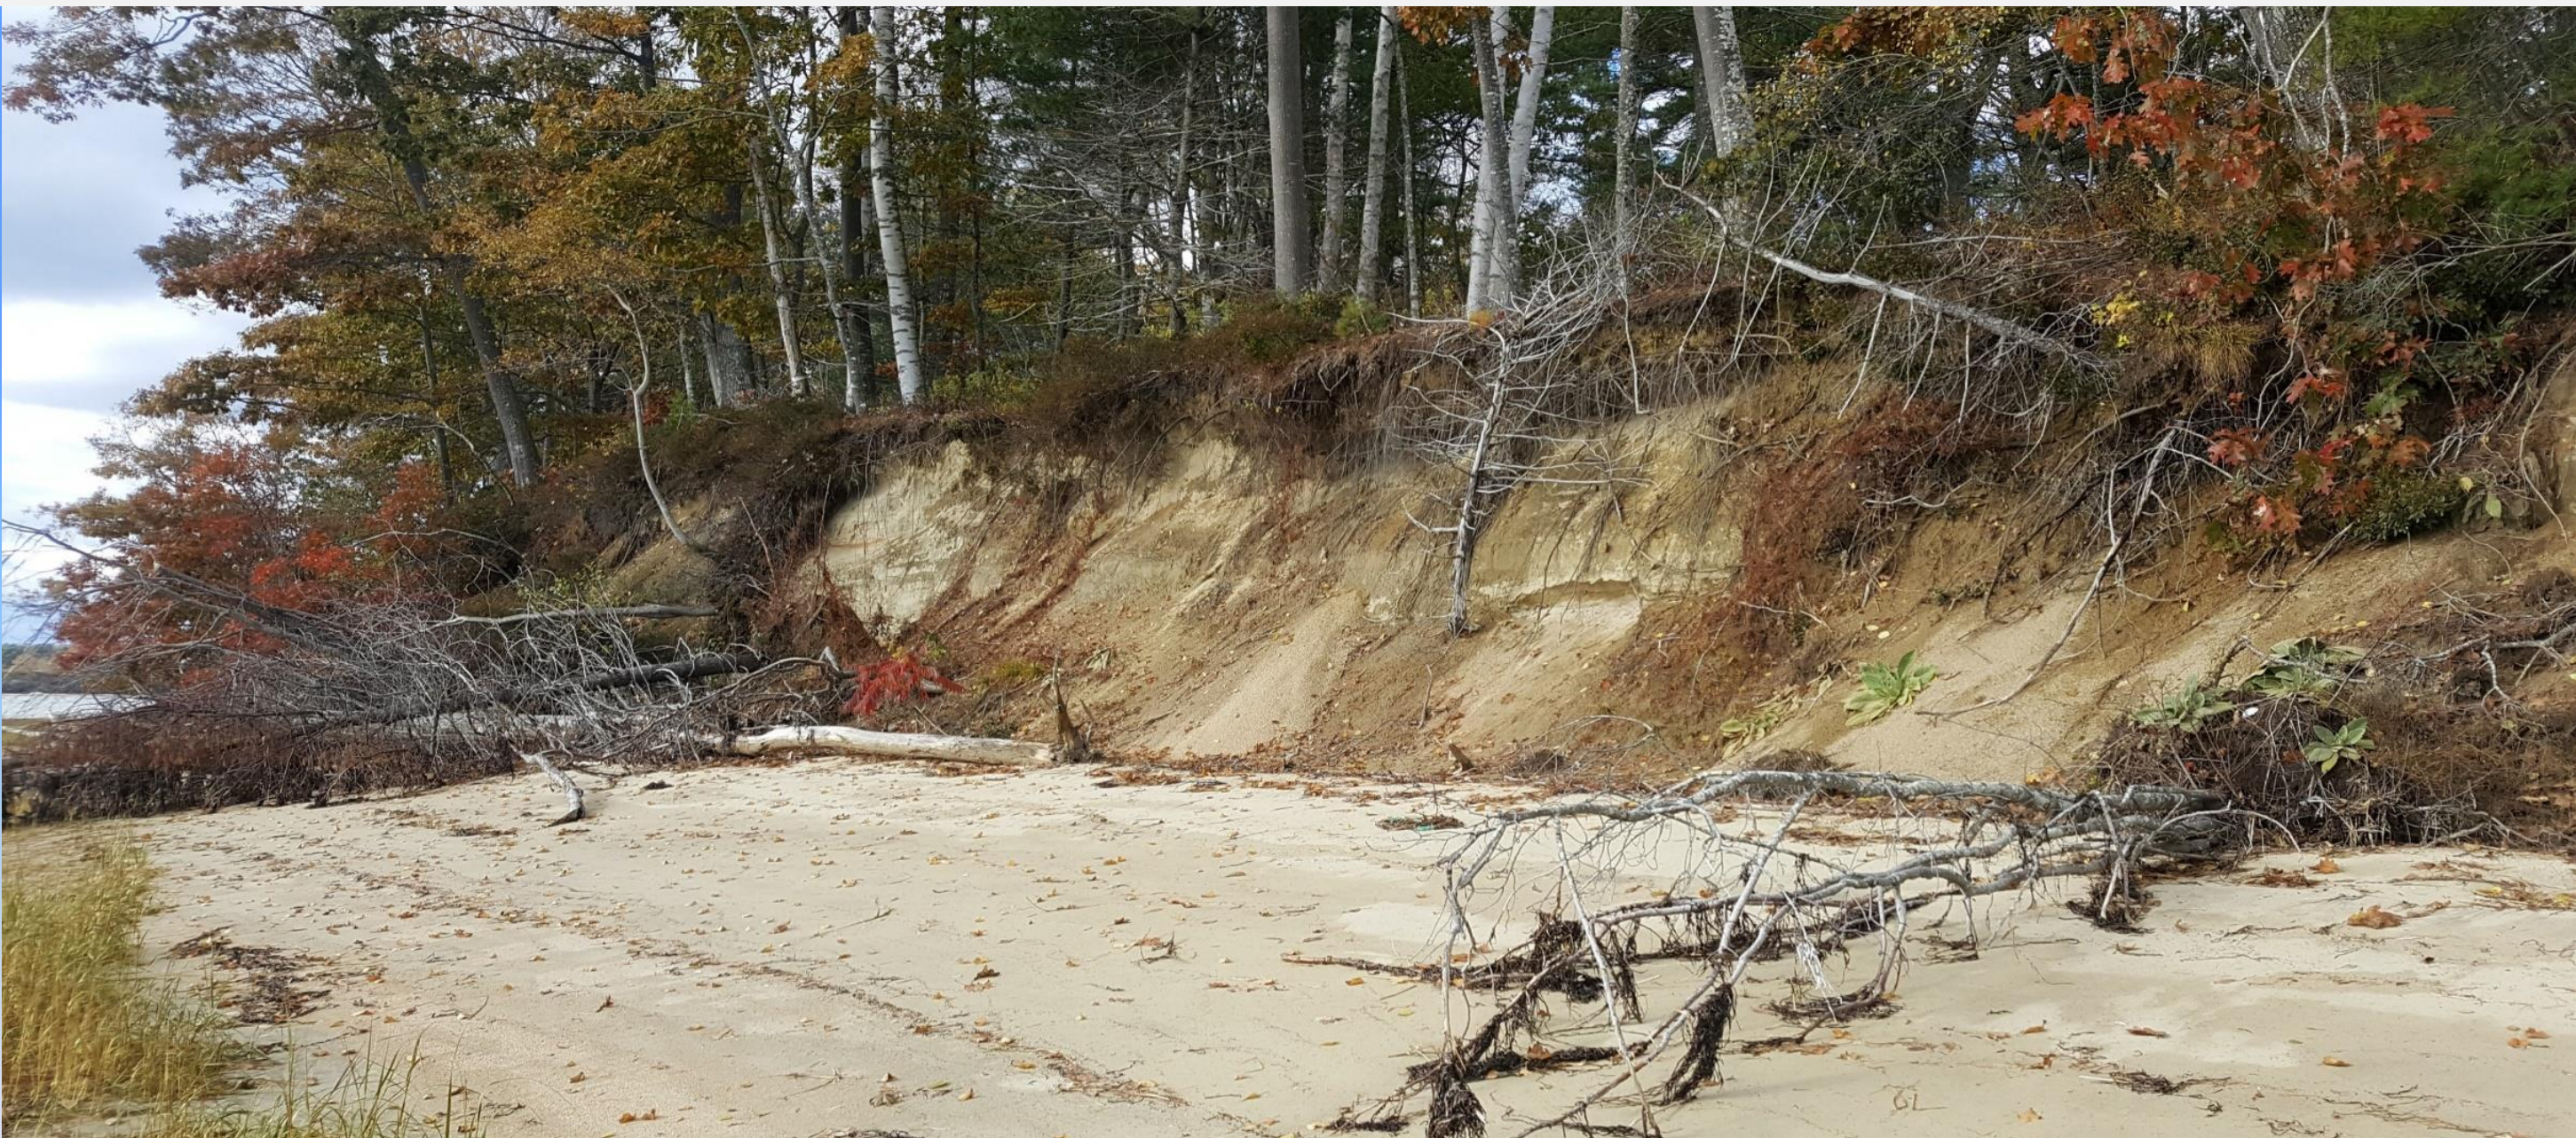
Lanes Island, Yarmouth, ME

Challenge: Use a living shoreline to stabilize an unstable bluff on an island using trees = not an inexpensive proposition

Solution? regrade bluff and beneficially reuse trees

Step failure released large amounts of sediment to the adjacent beach, as designed

Findings: log structure appears to be stable though sediment eroded. If project was constructed and plantings placed in late spring (as opposed to fall), it's possible that project would be performing a bit better, but the extent of high erosion along the 400-foot bluff would still likely have caused erosion of the site.

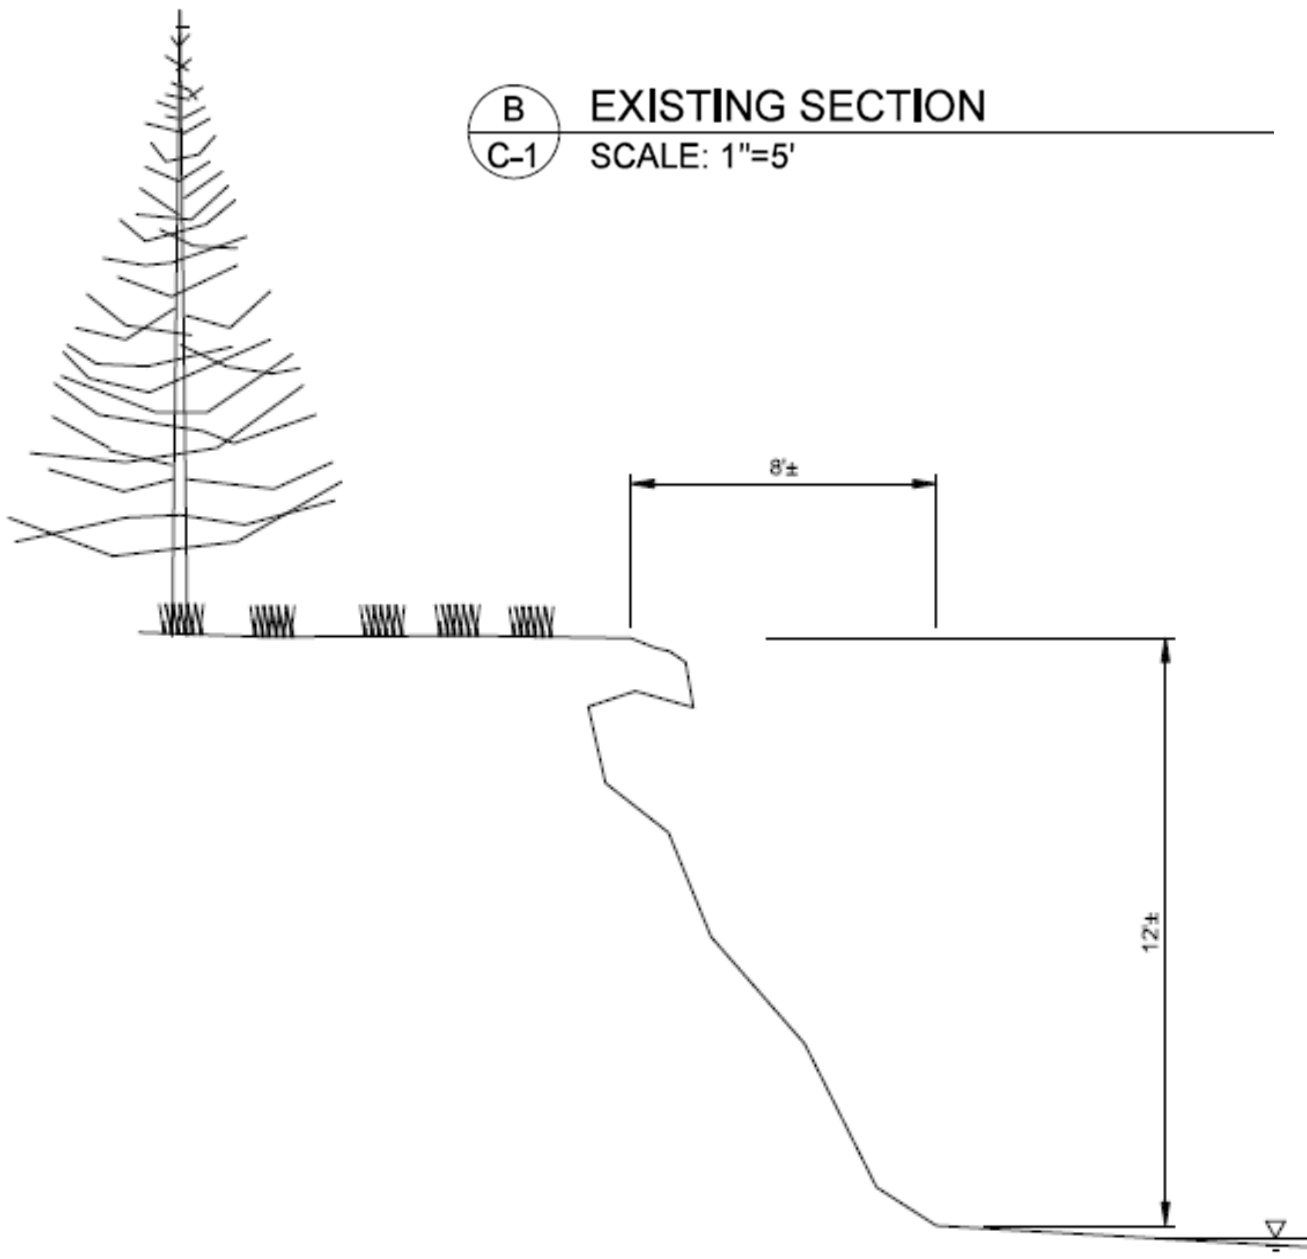
C PROPOSED SECTION
C-1 SCALE: 1"=5'-0"

Solution? regrade bluff and beneficially reuse trees
