Testing Biodegradable and Hybrid Methods for Shoreline Stabilization

Saco Watershed Collaborative

March 22, 2022

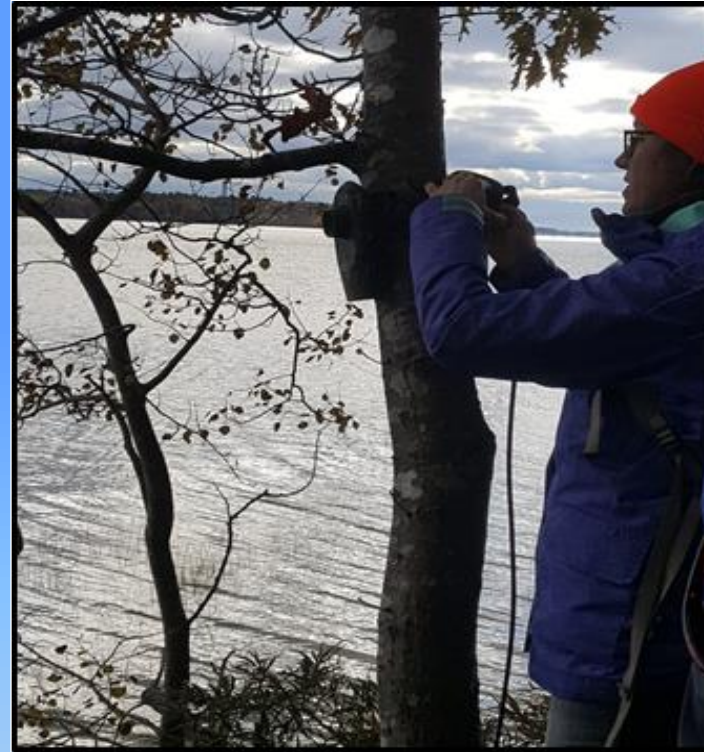
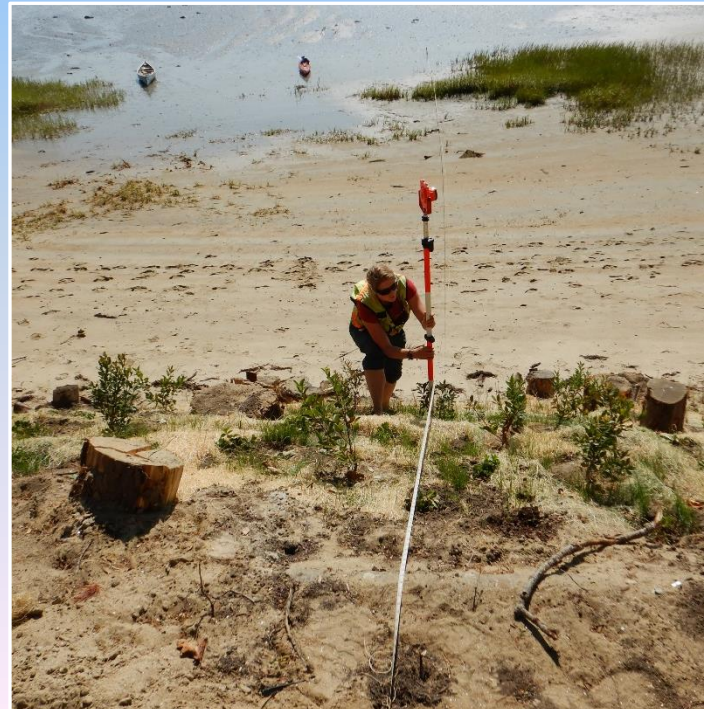
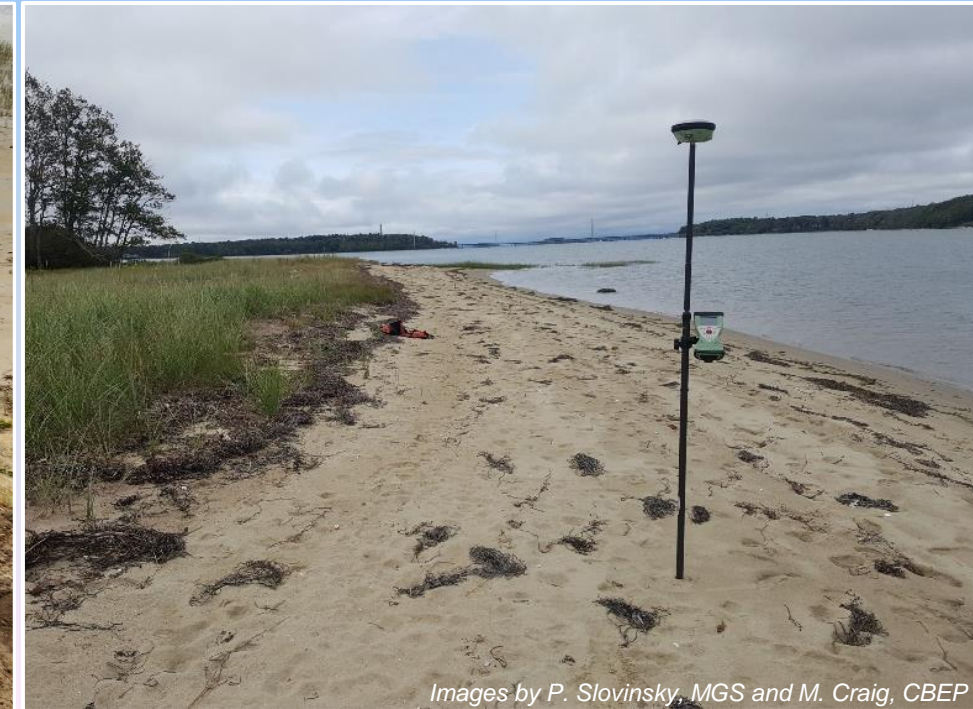
- 5-year monitoring follows an **EPA-approved QAPP** and regionally developed protocols
- Focuses on **geophysical environment, erosive forces, biota, vegetation, structural integrity/movement, and plastic degradation.**
- **Topographic transect** lines established at each site and natural control sites
- **Vegetative and biologic plots** collected along transects
- **Photo monitoring** including game cameras
- Detailed monitoring for **pre-construction, as-built** (post-construction), and scheduled for **spring/early summer** (April-June), **fall/late summer** (August-October), and **Winter** (as possible).

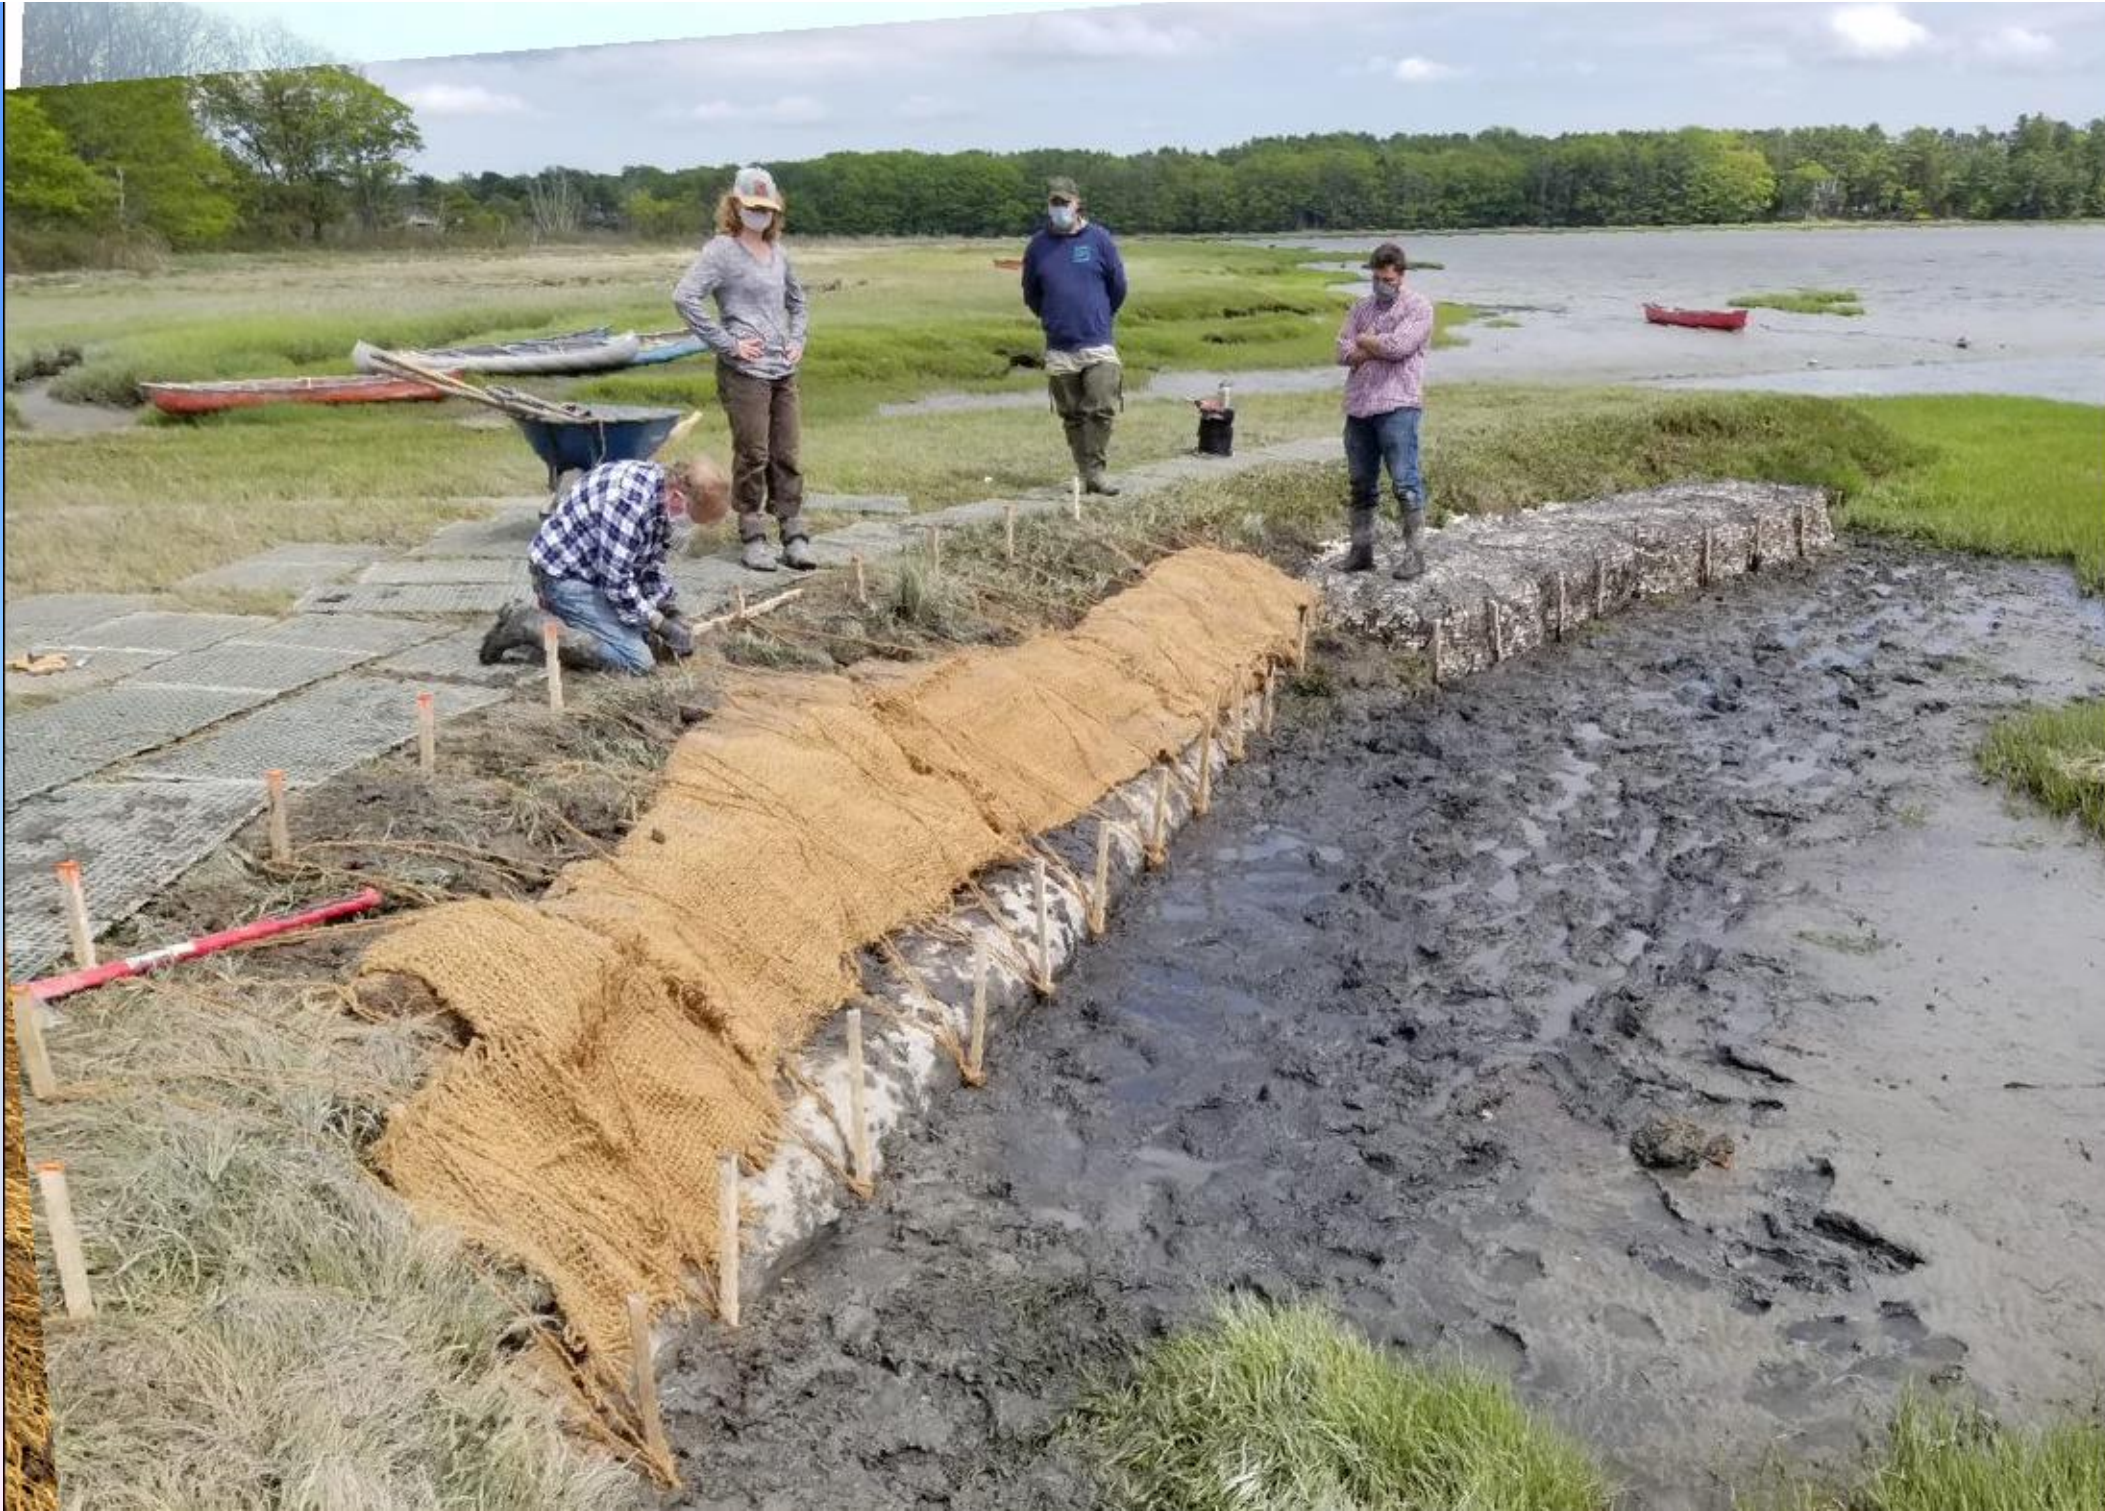
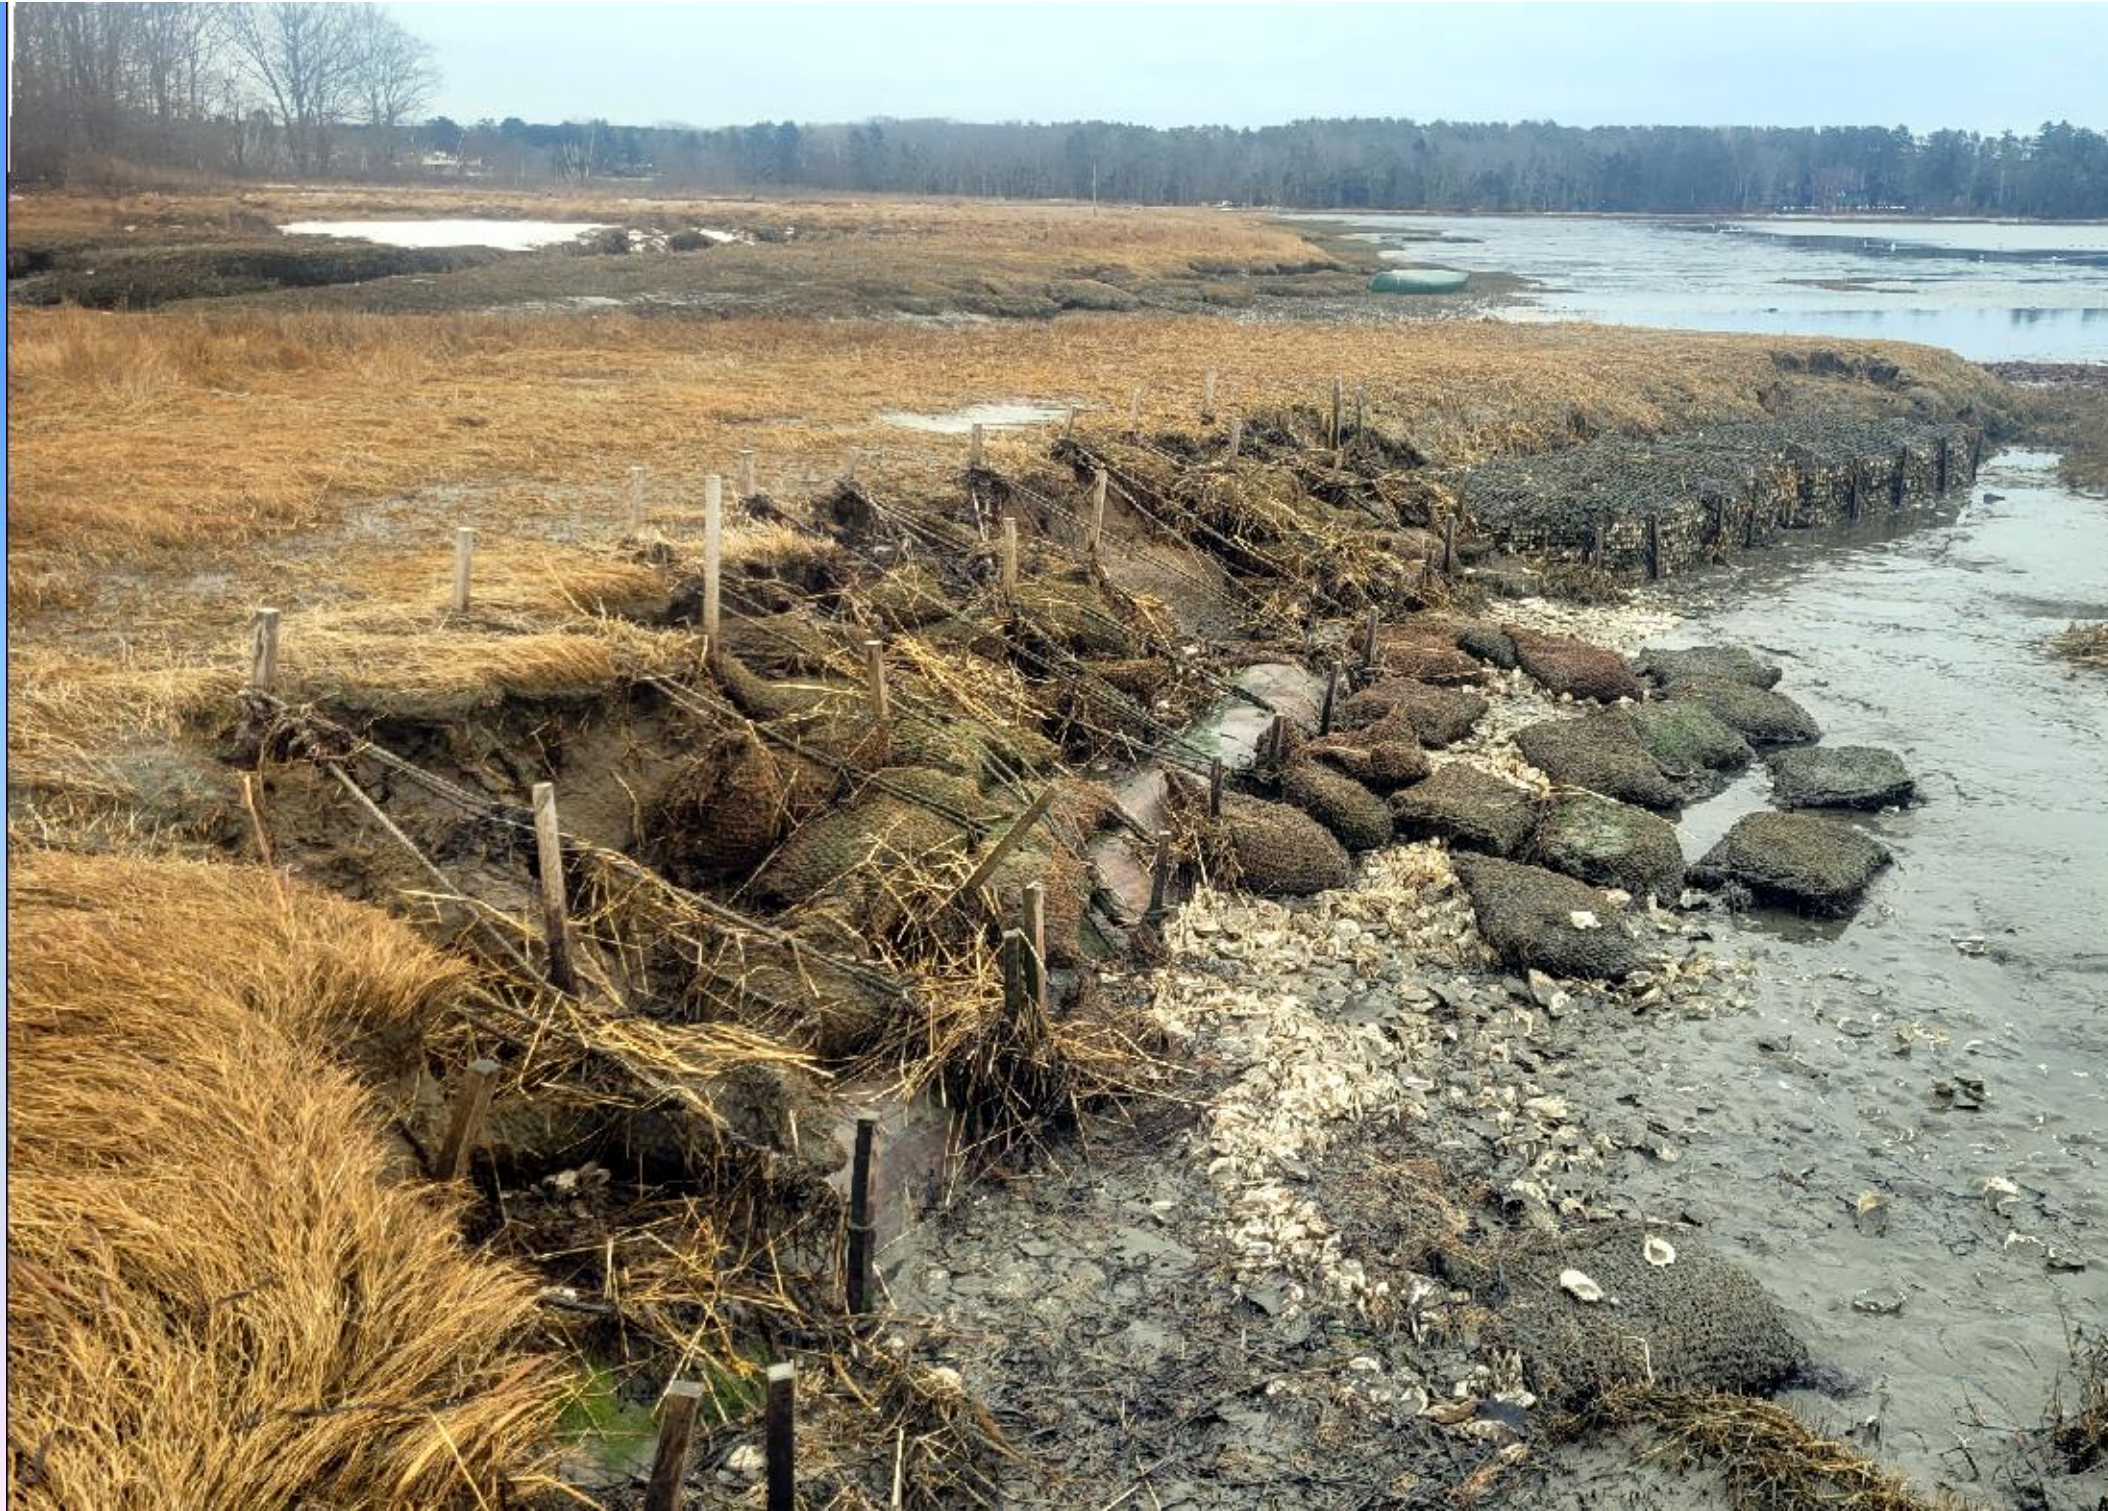
Wharton Point (completed late May/early June 2020)

Very minor settlement
Has not had to be re-staked/re-twined
No replacement needed
Marsh edge has settled on top of reef
Sedimentation, algae and wrack
Baskets have not degraded

Constant shifting
Re-twined *twice*
Replaced 45 bags (2/21, 8/21)
Marsh continues to be eroded above bags
Release of shell into intertidal as bags break
Bags appear to fall apart <2 years regardless of twining failure

Findings: *twining needs to be of a stronger material. Tie-down methods employed do not hold bags in place well. Individual light (<30 lb) bags are not robust enough to survive storm battering.*

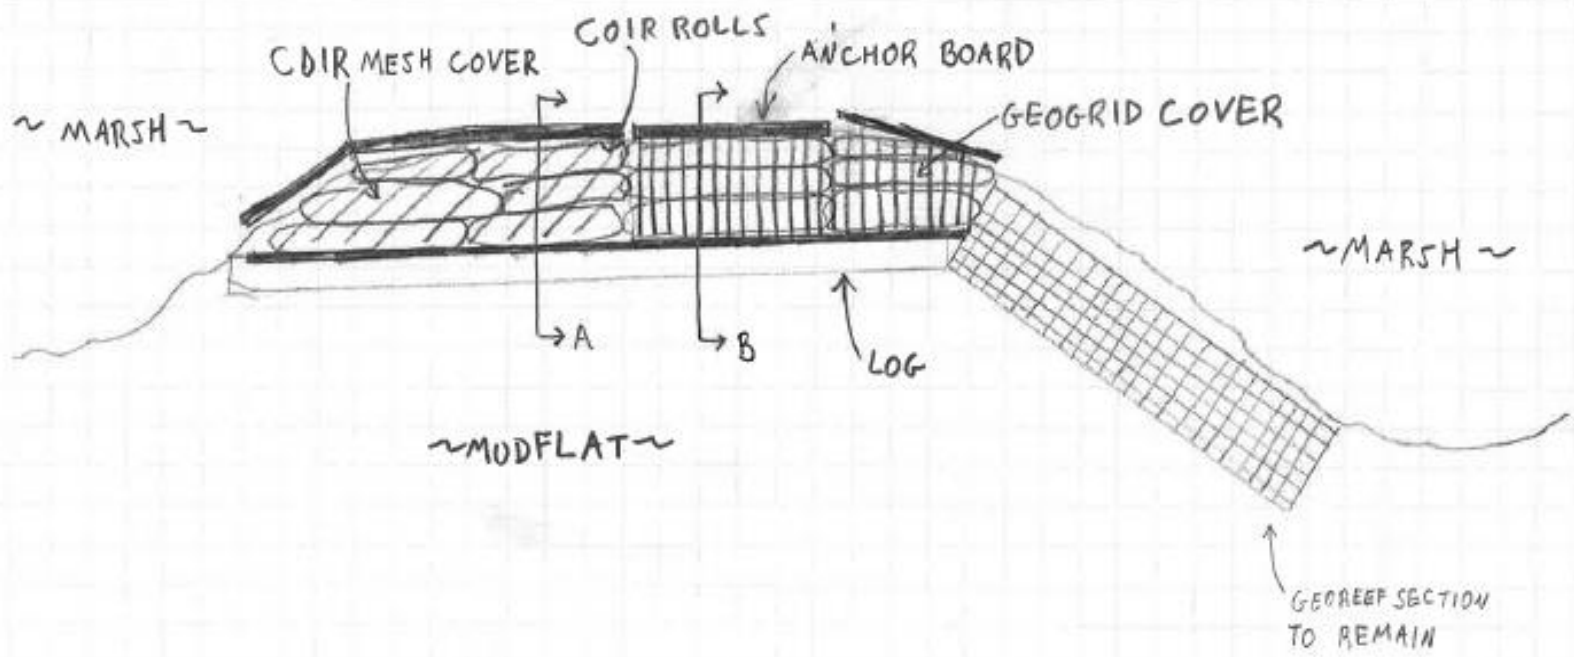
PLAN

BOTTOM ANCHOR BOARD DETAIL

SECTION A/B

TOP ANCHOR BOARD DETAIL

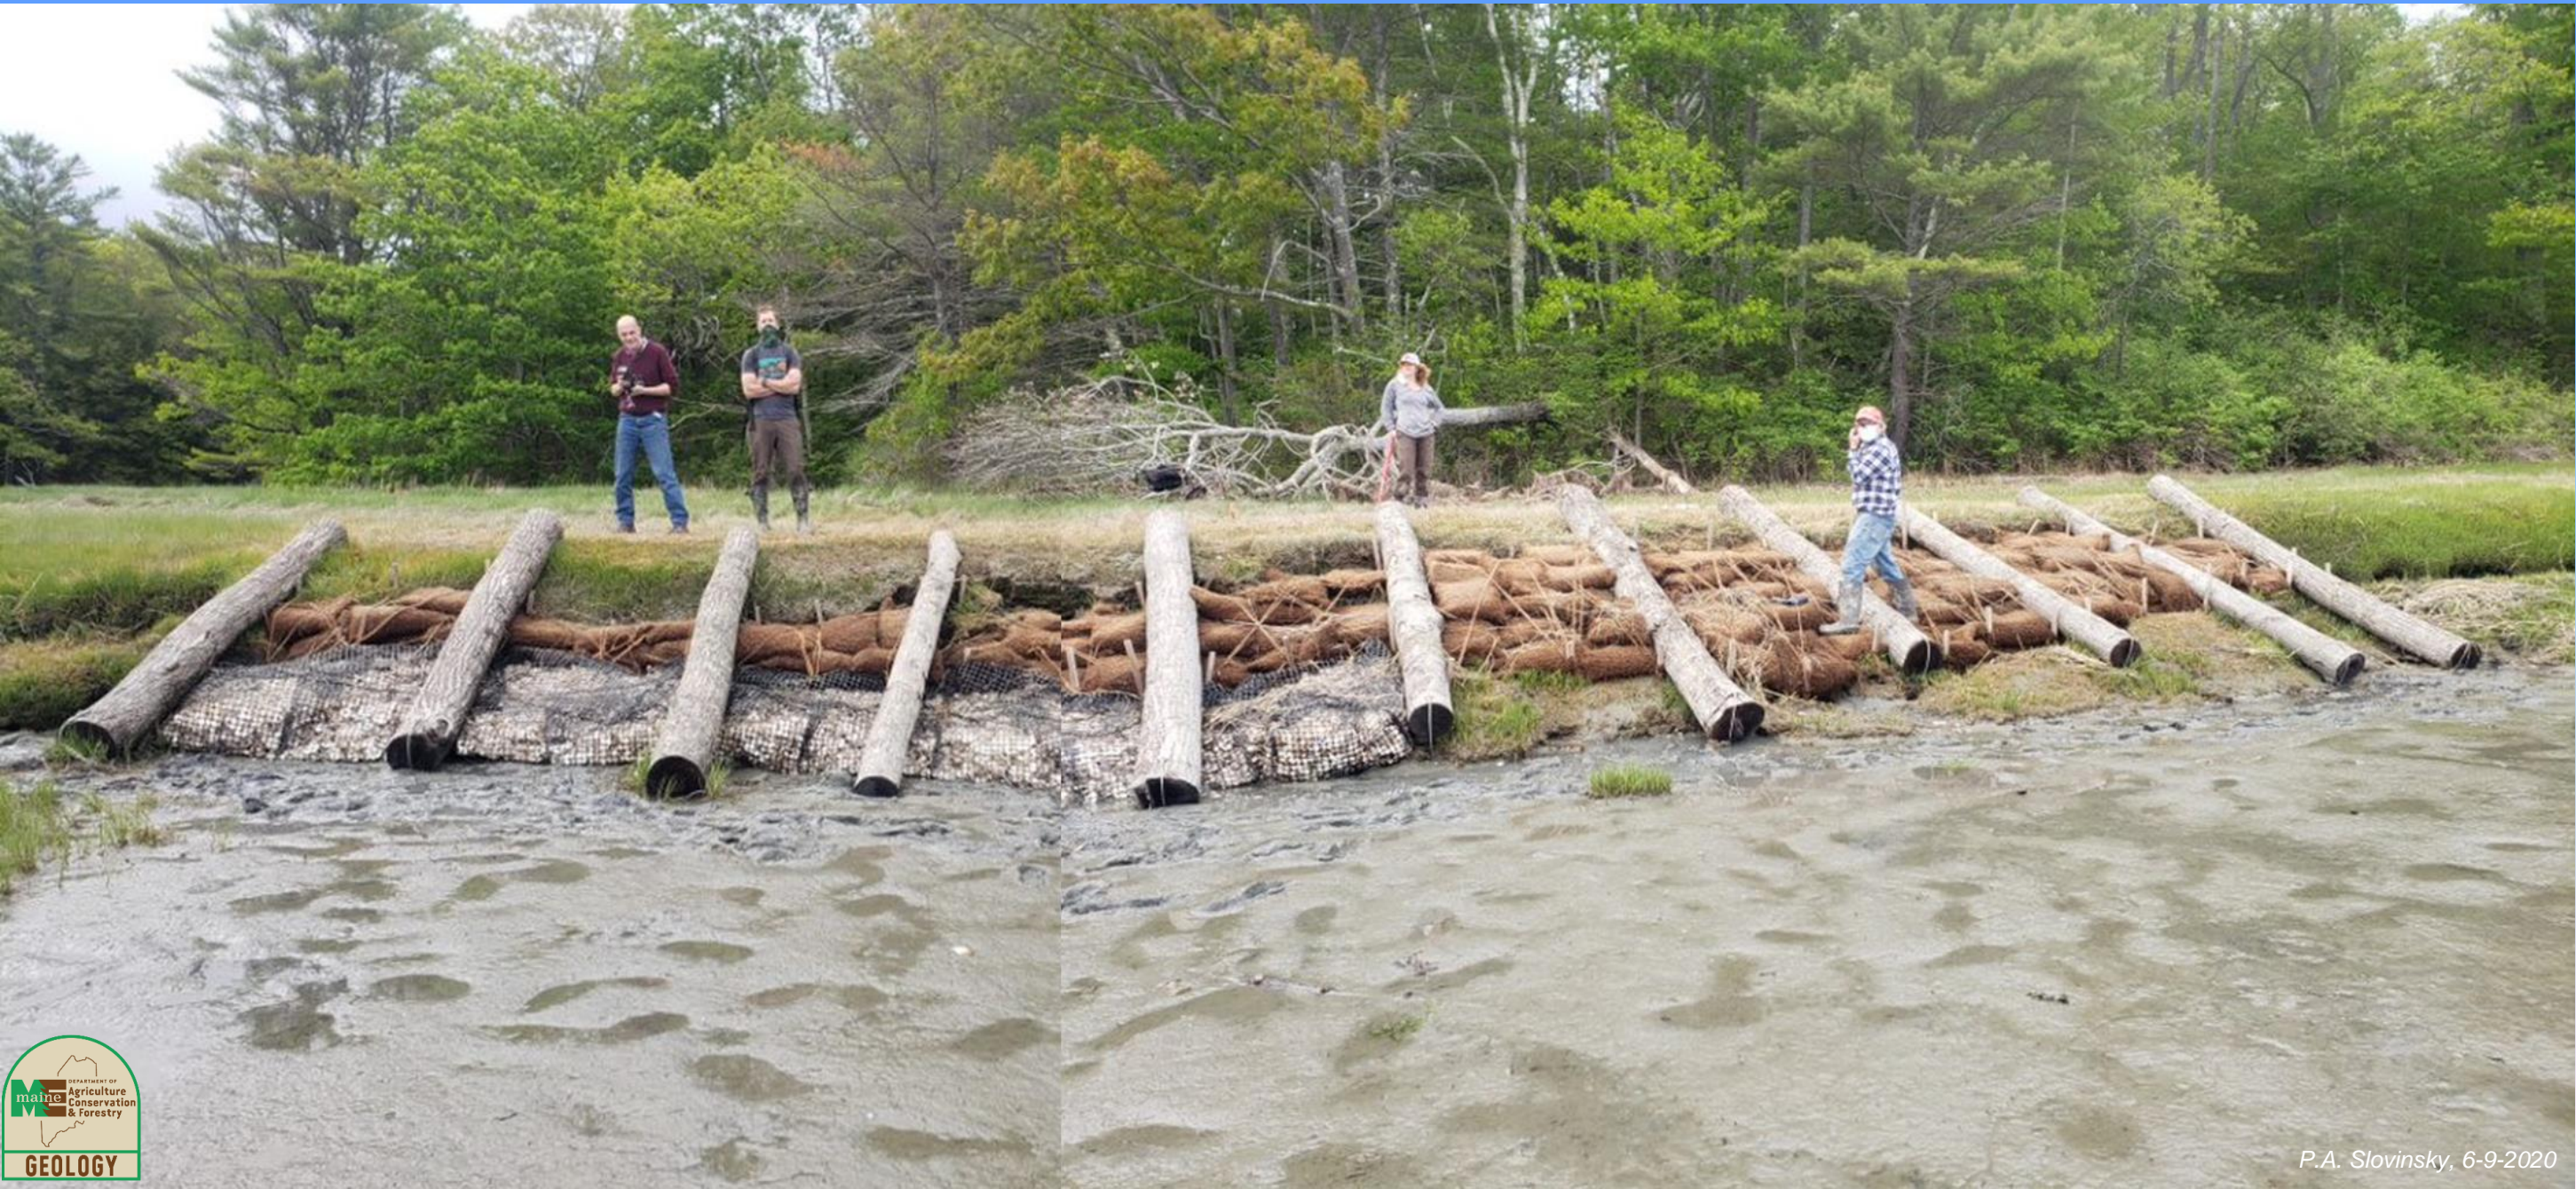
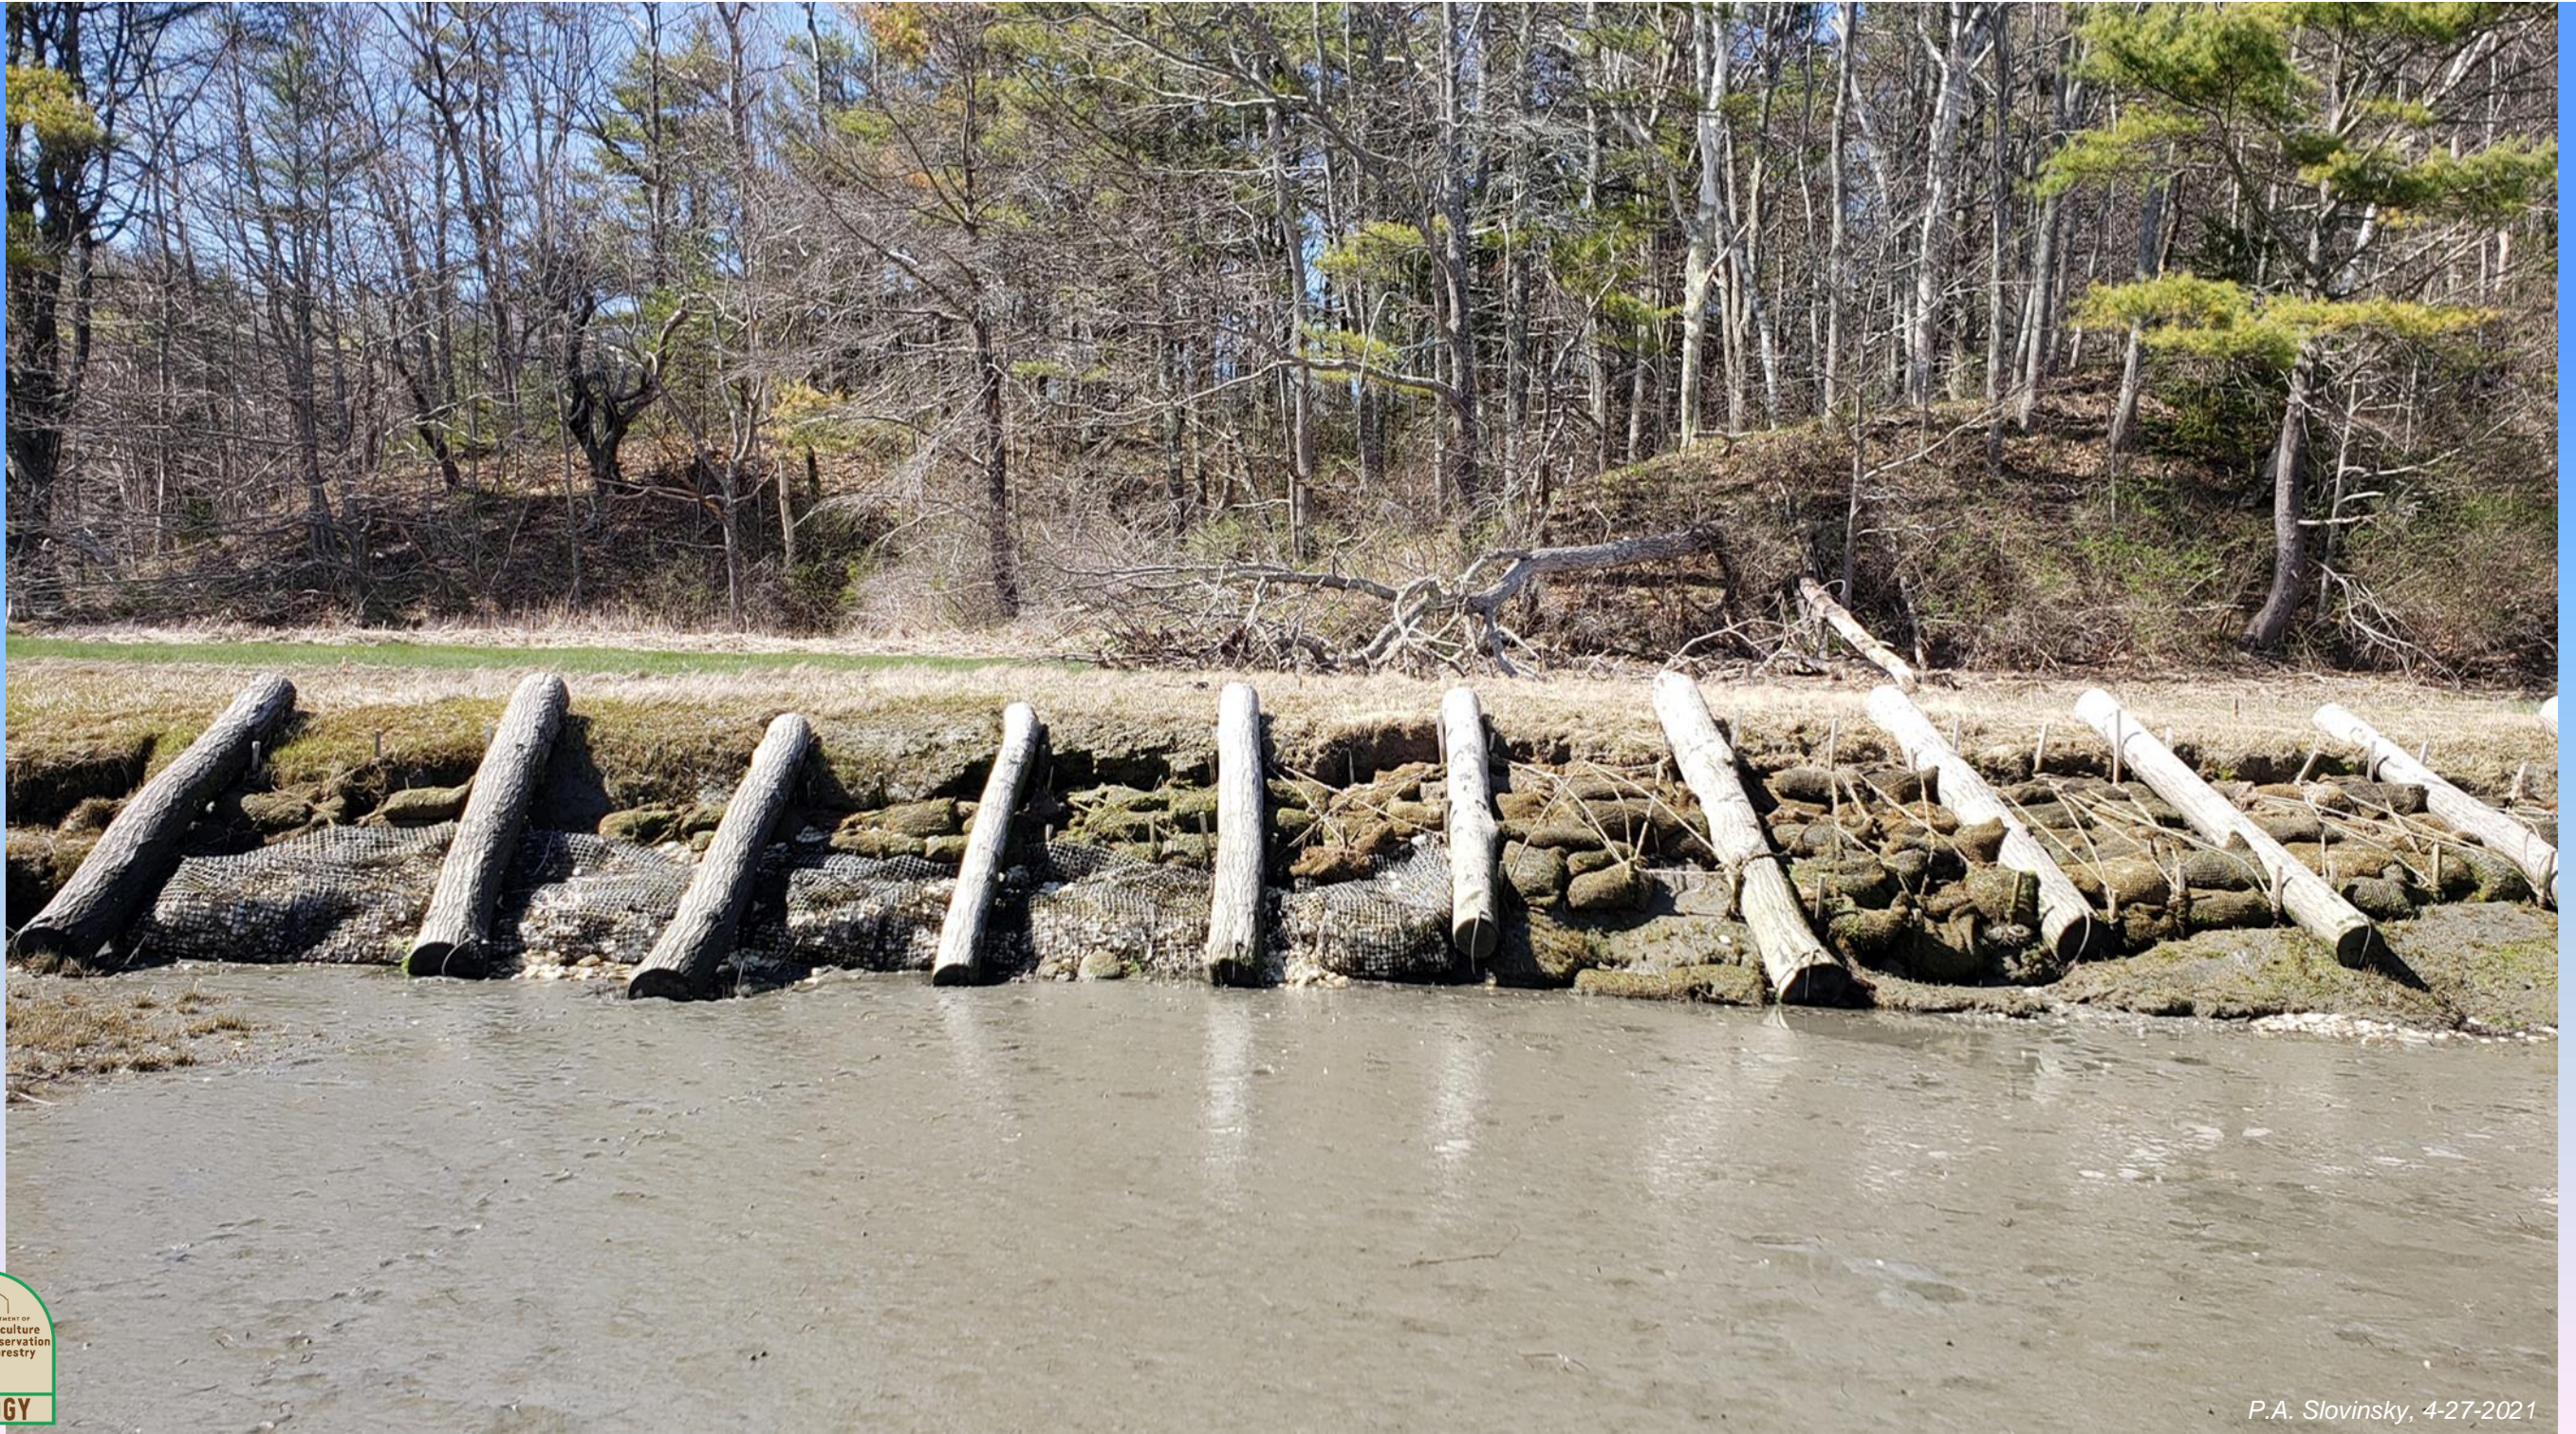
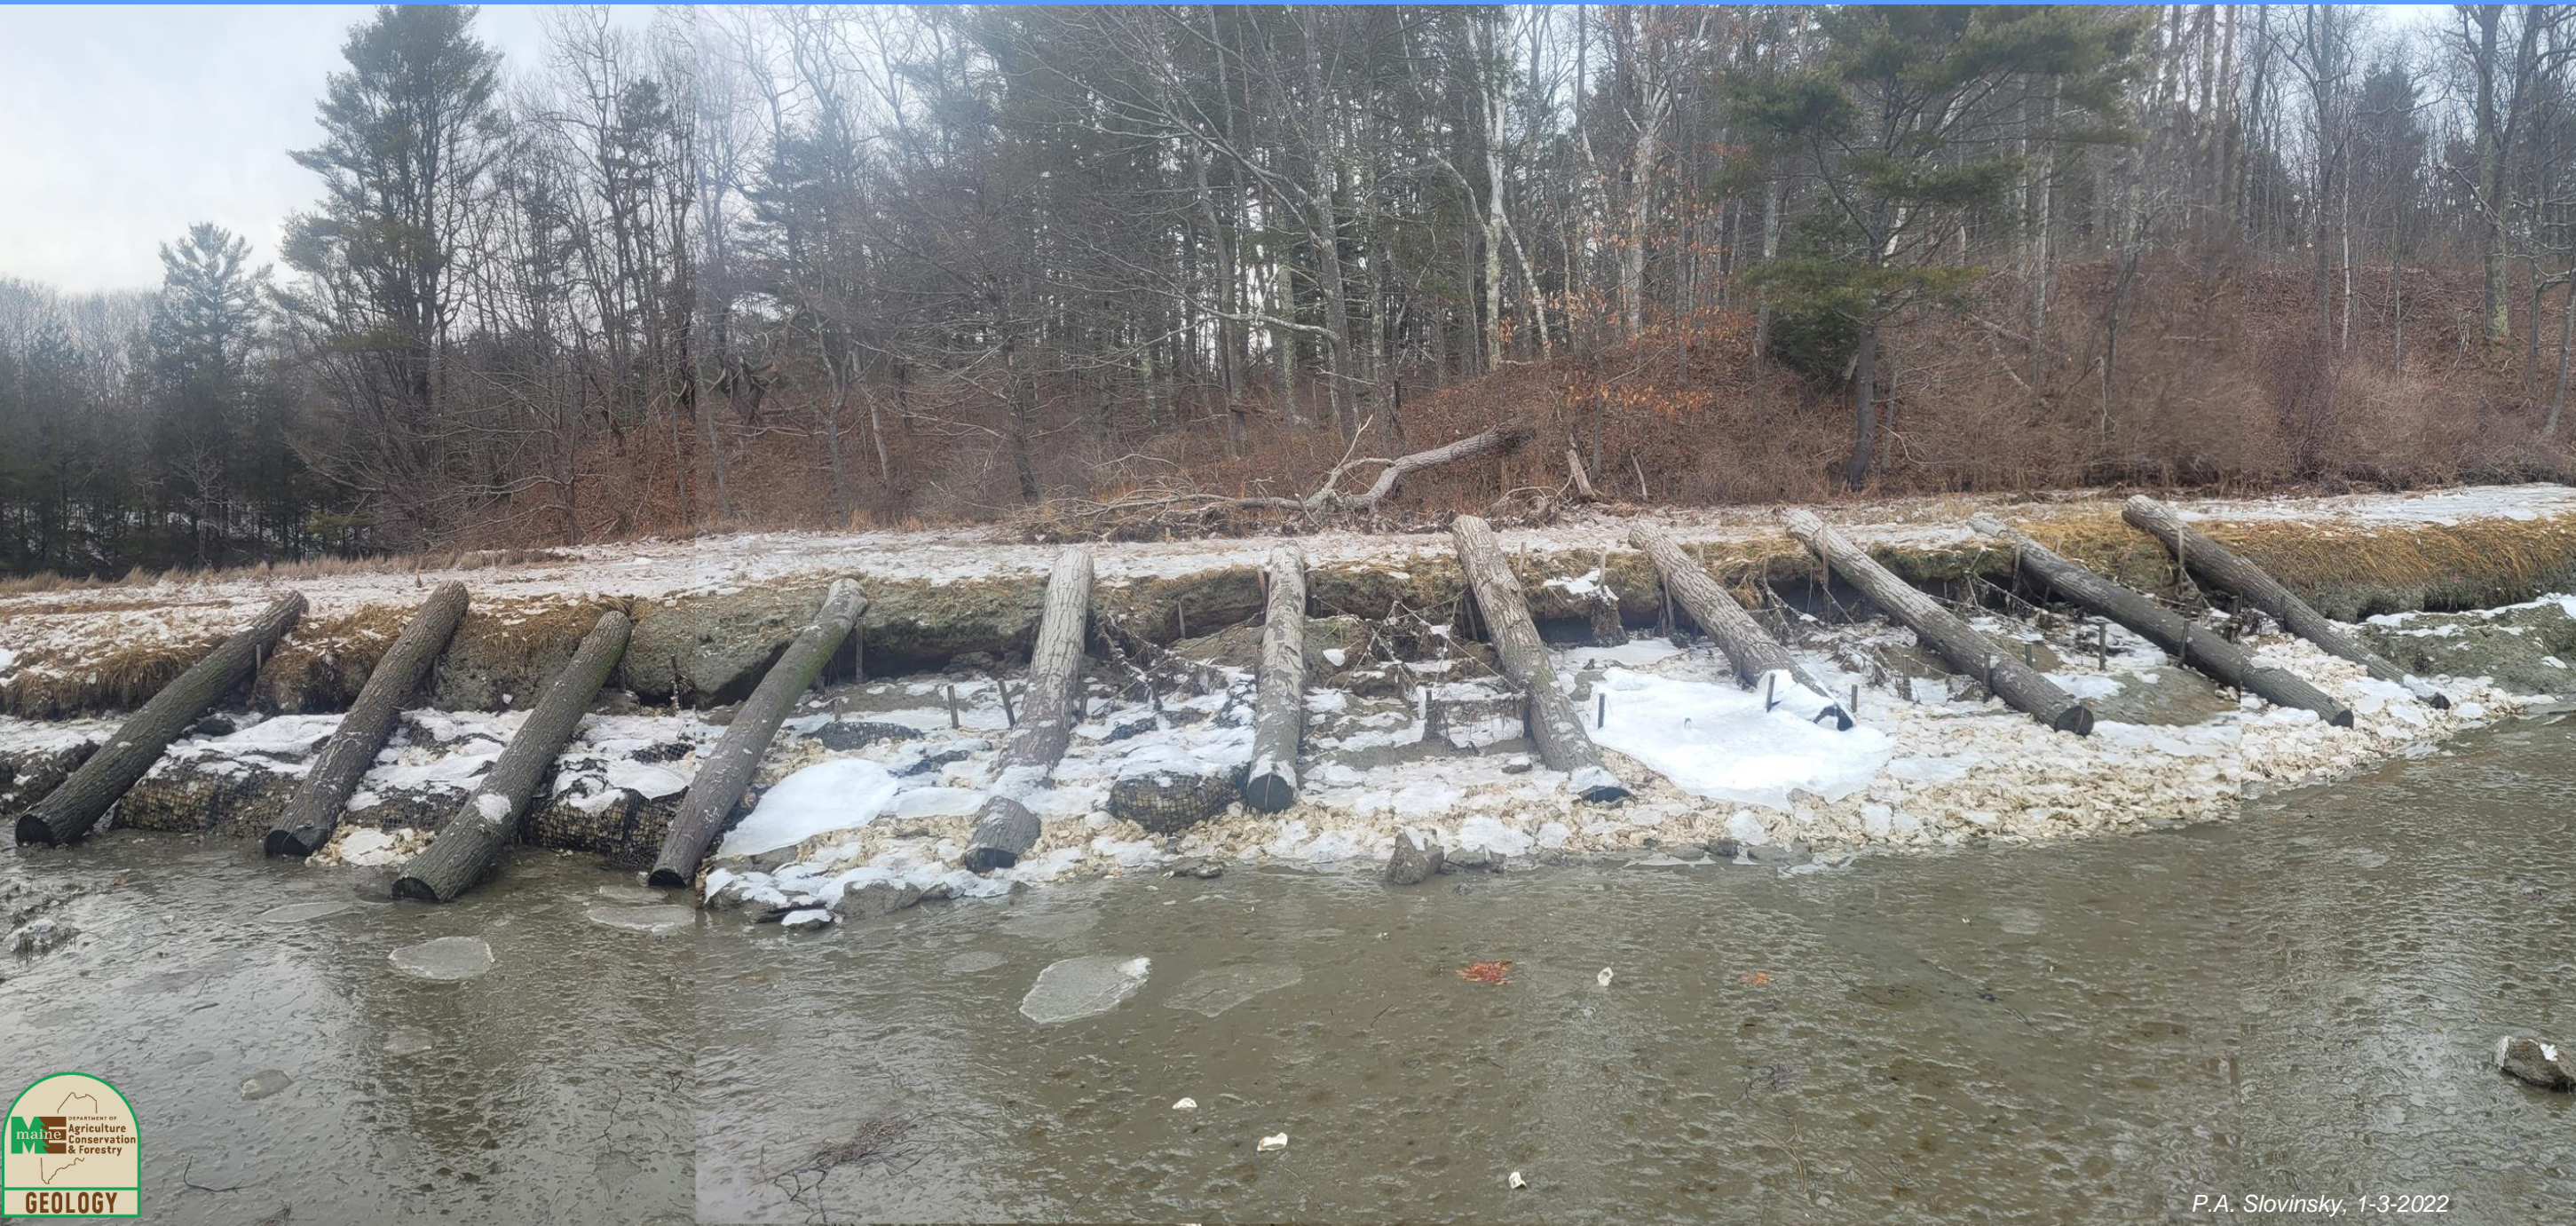
Maquoit Bay Conservation Lands (completed late May/early June 2020)

Minor settling
No need to re-stake/re-twine
No need to replace
Marsh edge settled on top
Sedimentation, algae and wrack
Baskets have not degraded
Storm resistant

Minor shifting
Re-twined once
Replaced 5 bags (4/21)
Marsh eroded above
Sedimentation, algae and wrack
All bags degraded and released shell into intertidal
Fairly storm resistant

Findings: *twining needs to be of a stronger material. Although only had to replace a few bags due to storms, all bags have biodegraded < 2 years. Logs could be anchored a different way in the future (wrapped around log ends instead of attached to log ends)*

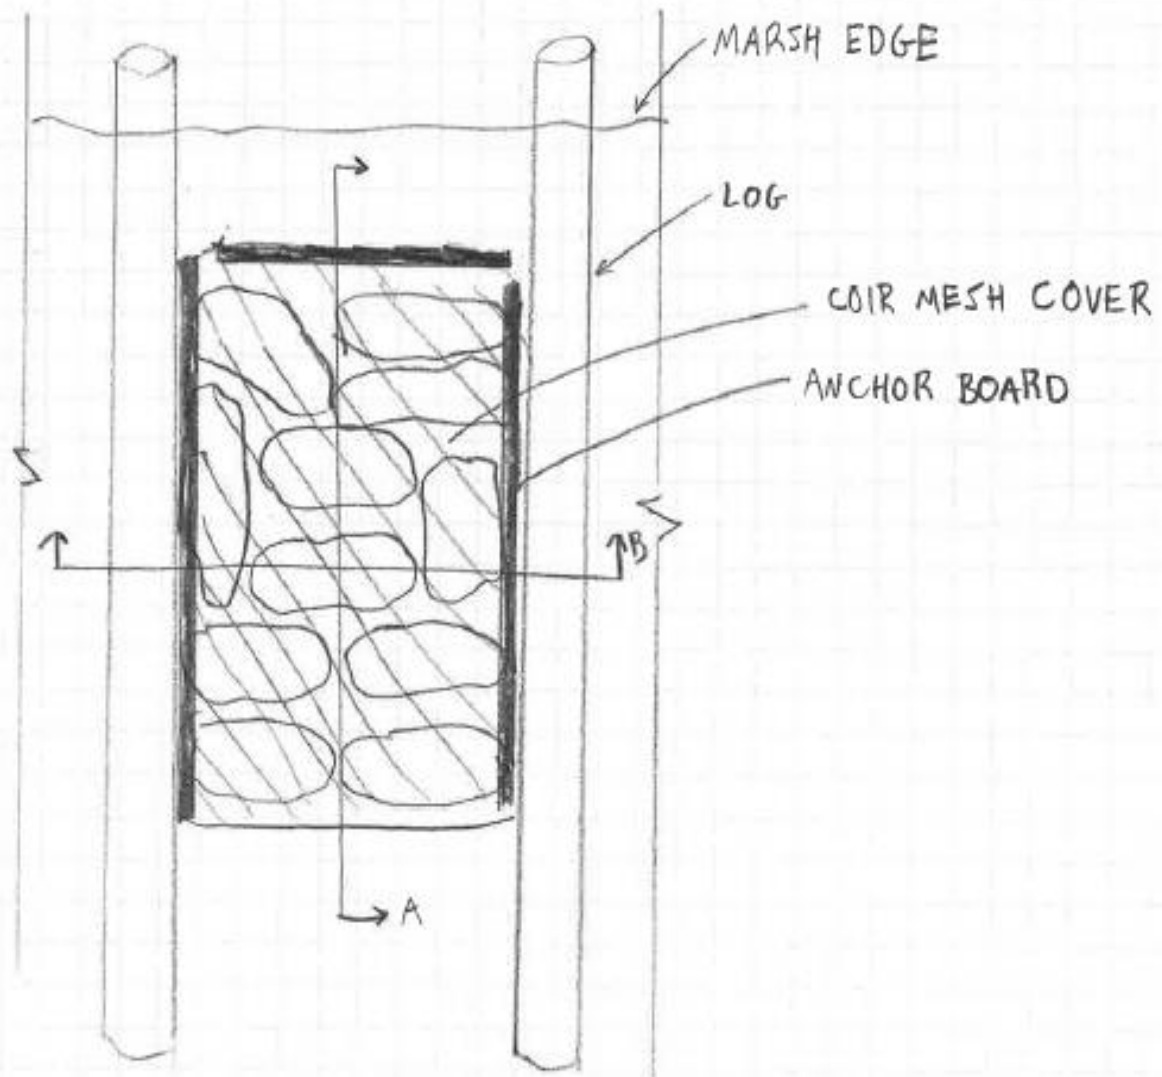
PLAN

SECTION A

SECTION B

Minor twisting/settling
No need to reanchor
No need to replace
N/A
