Testing Biodegradable and Hybrid Methods for Shoreline Stabilization

Saco Watershed Collaborative

March 22, 2022

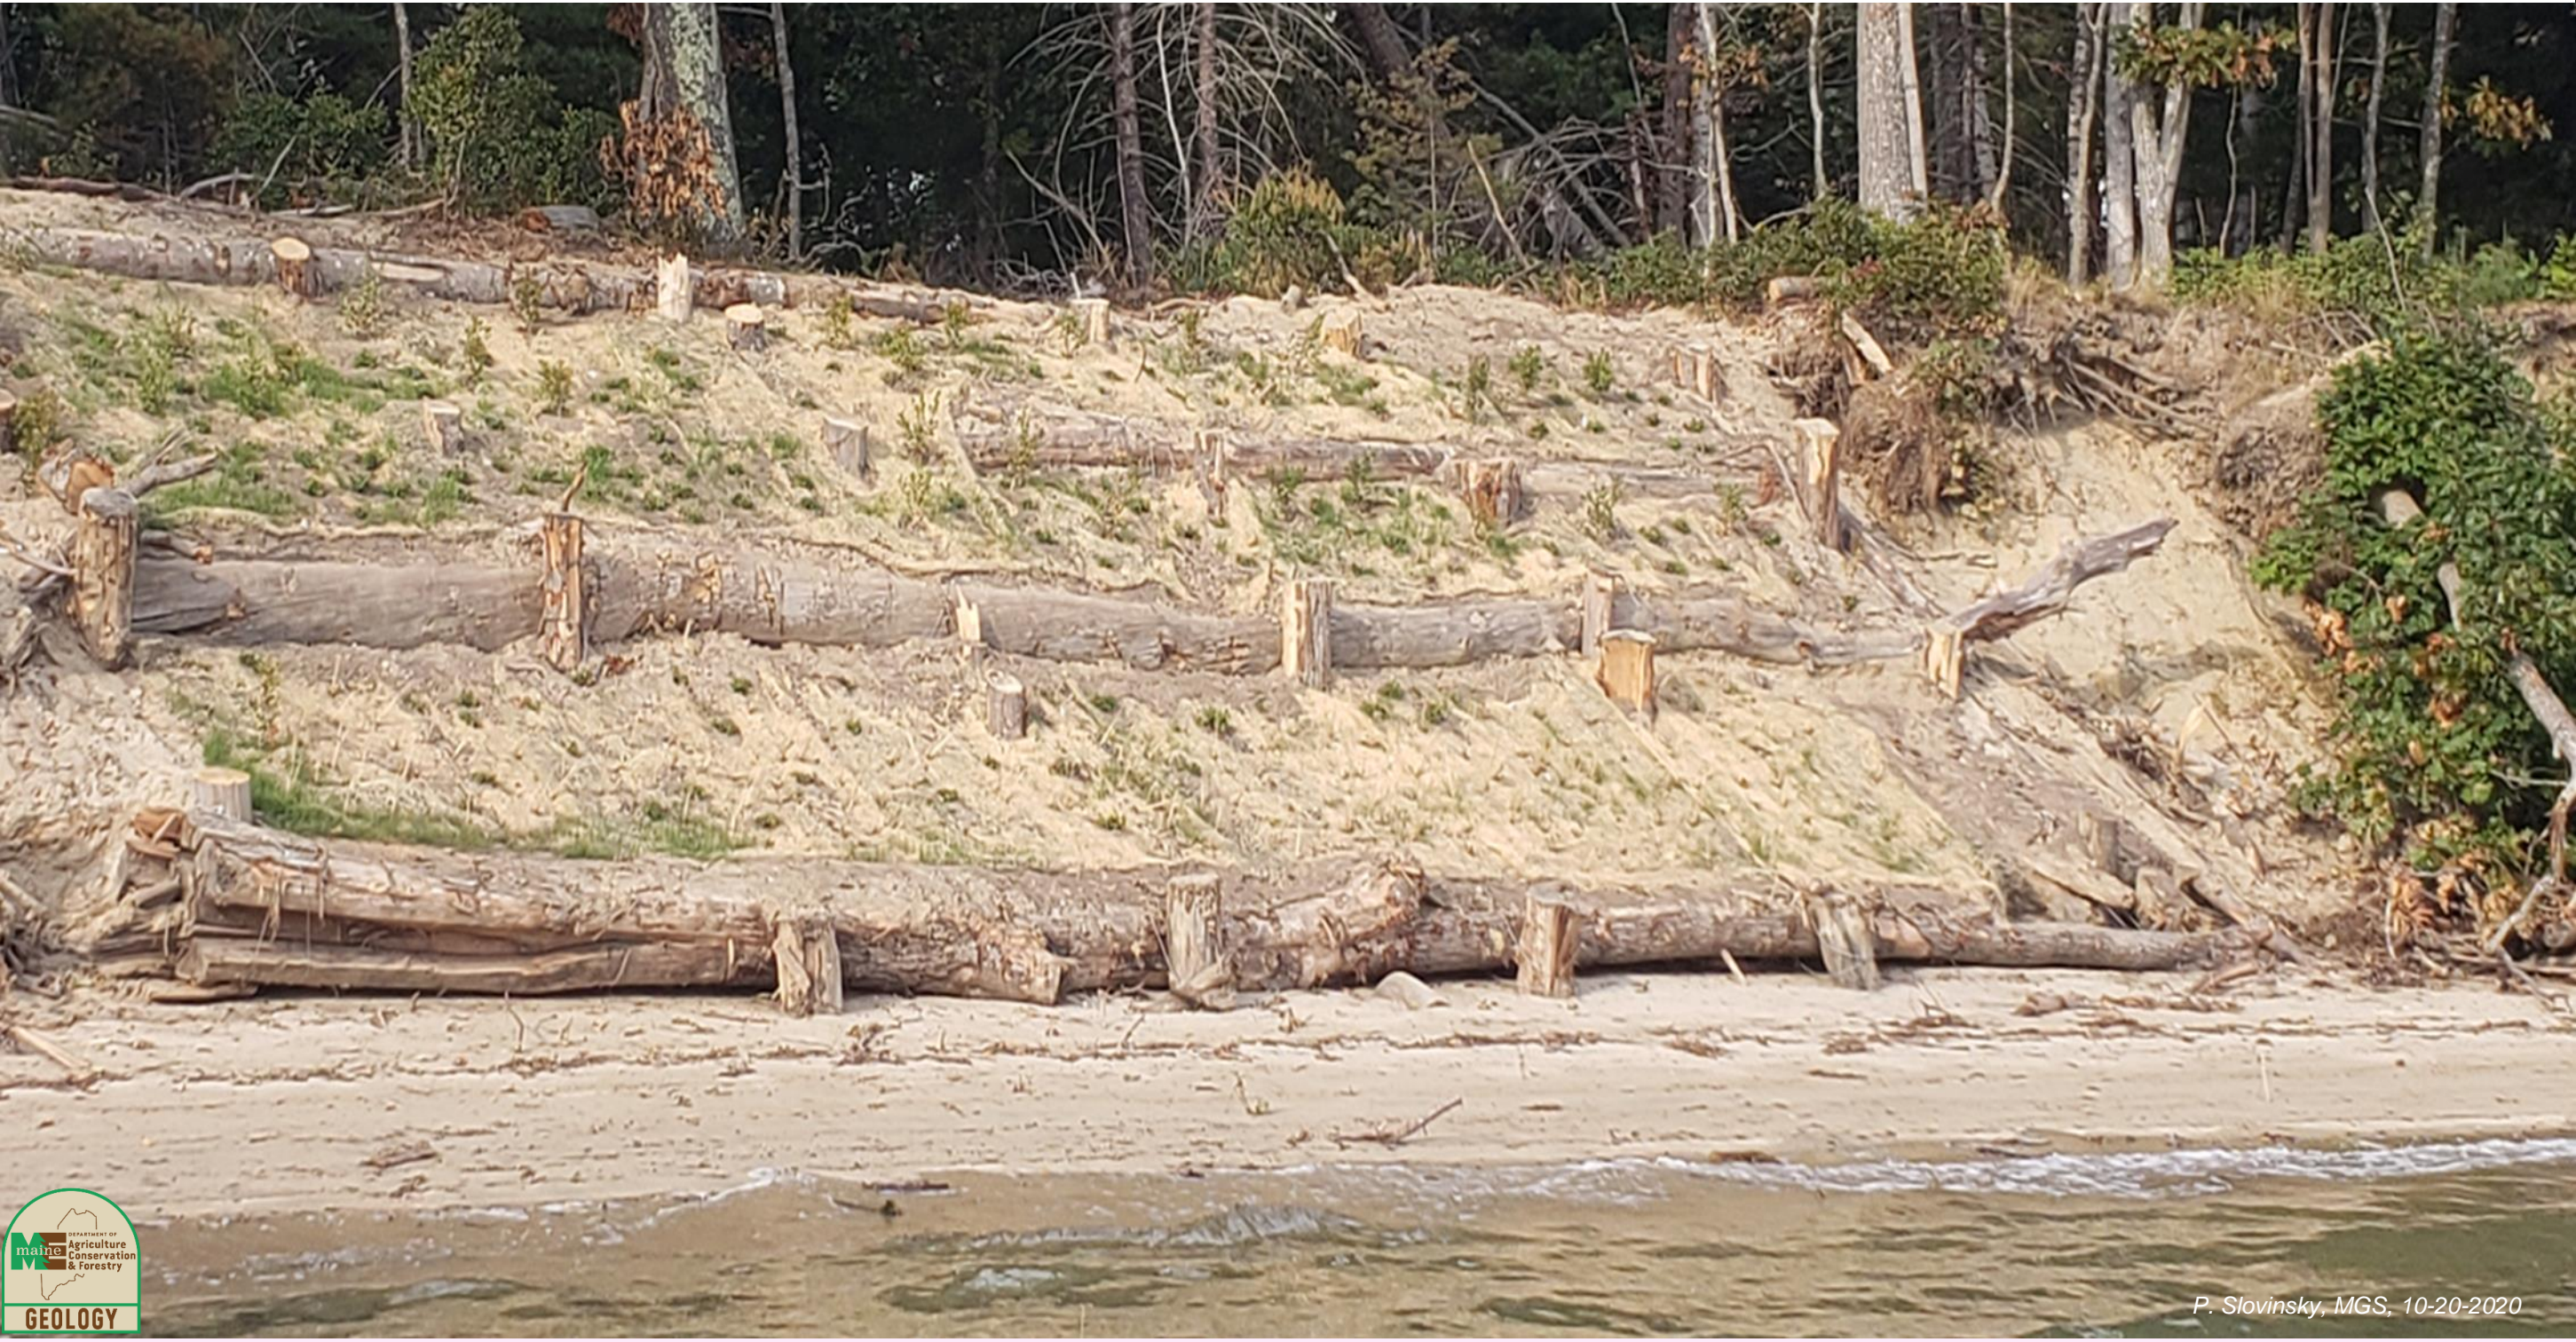
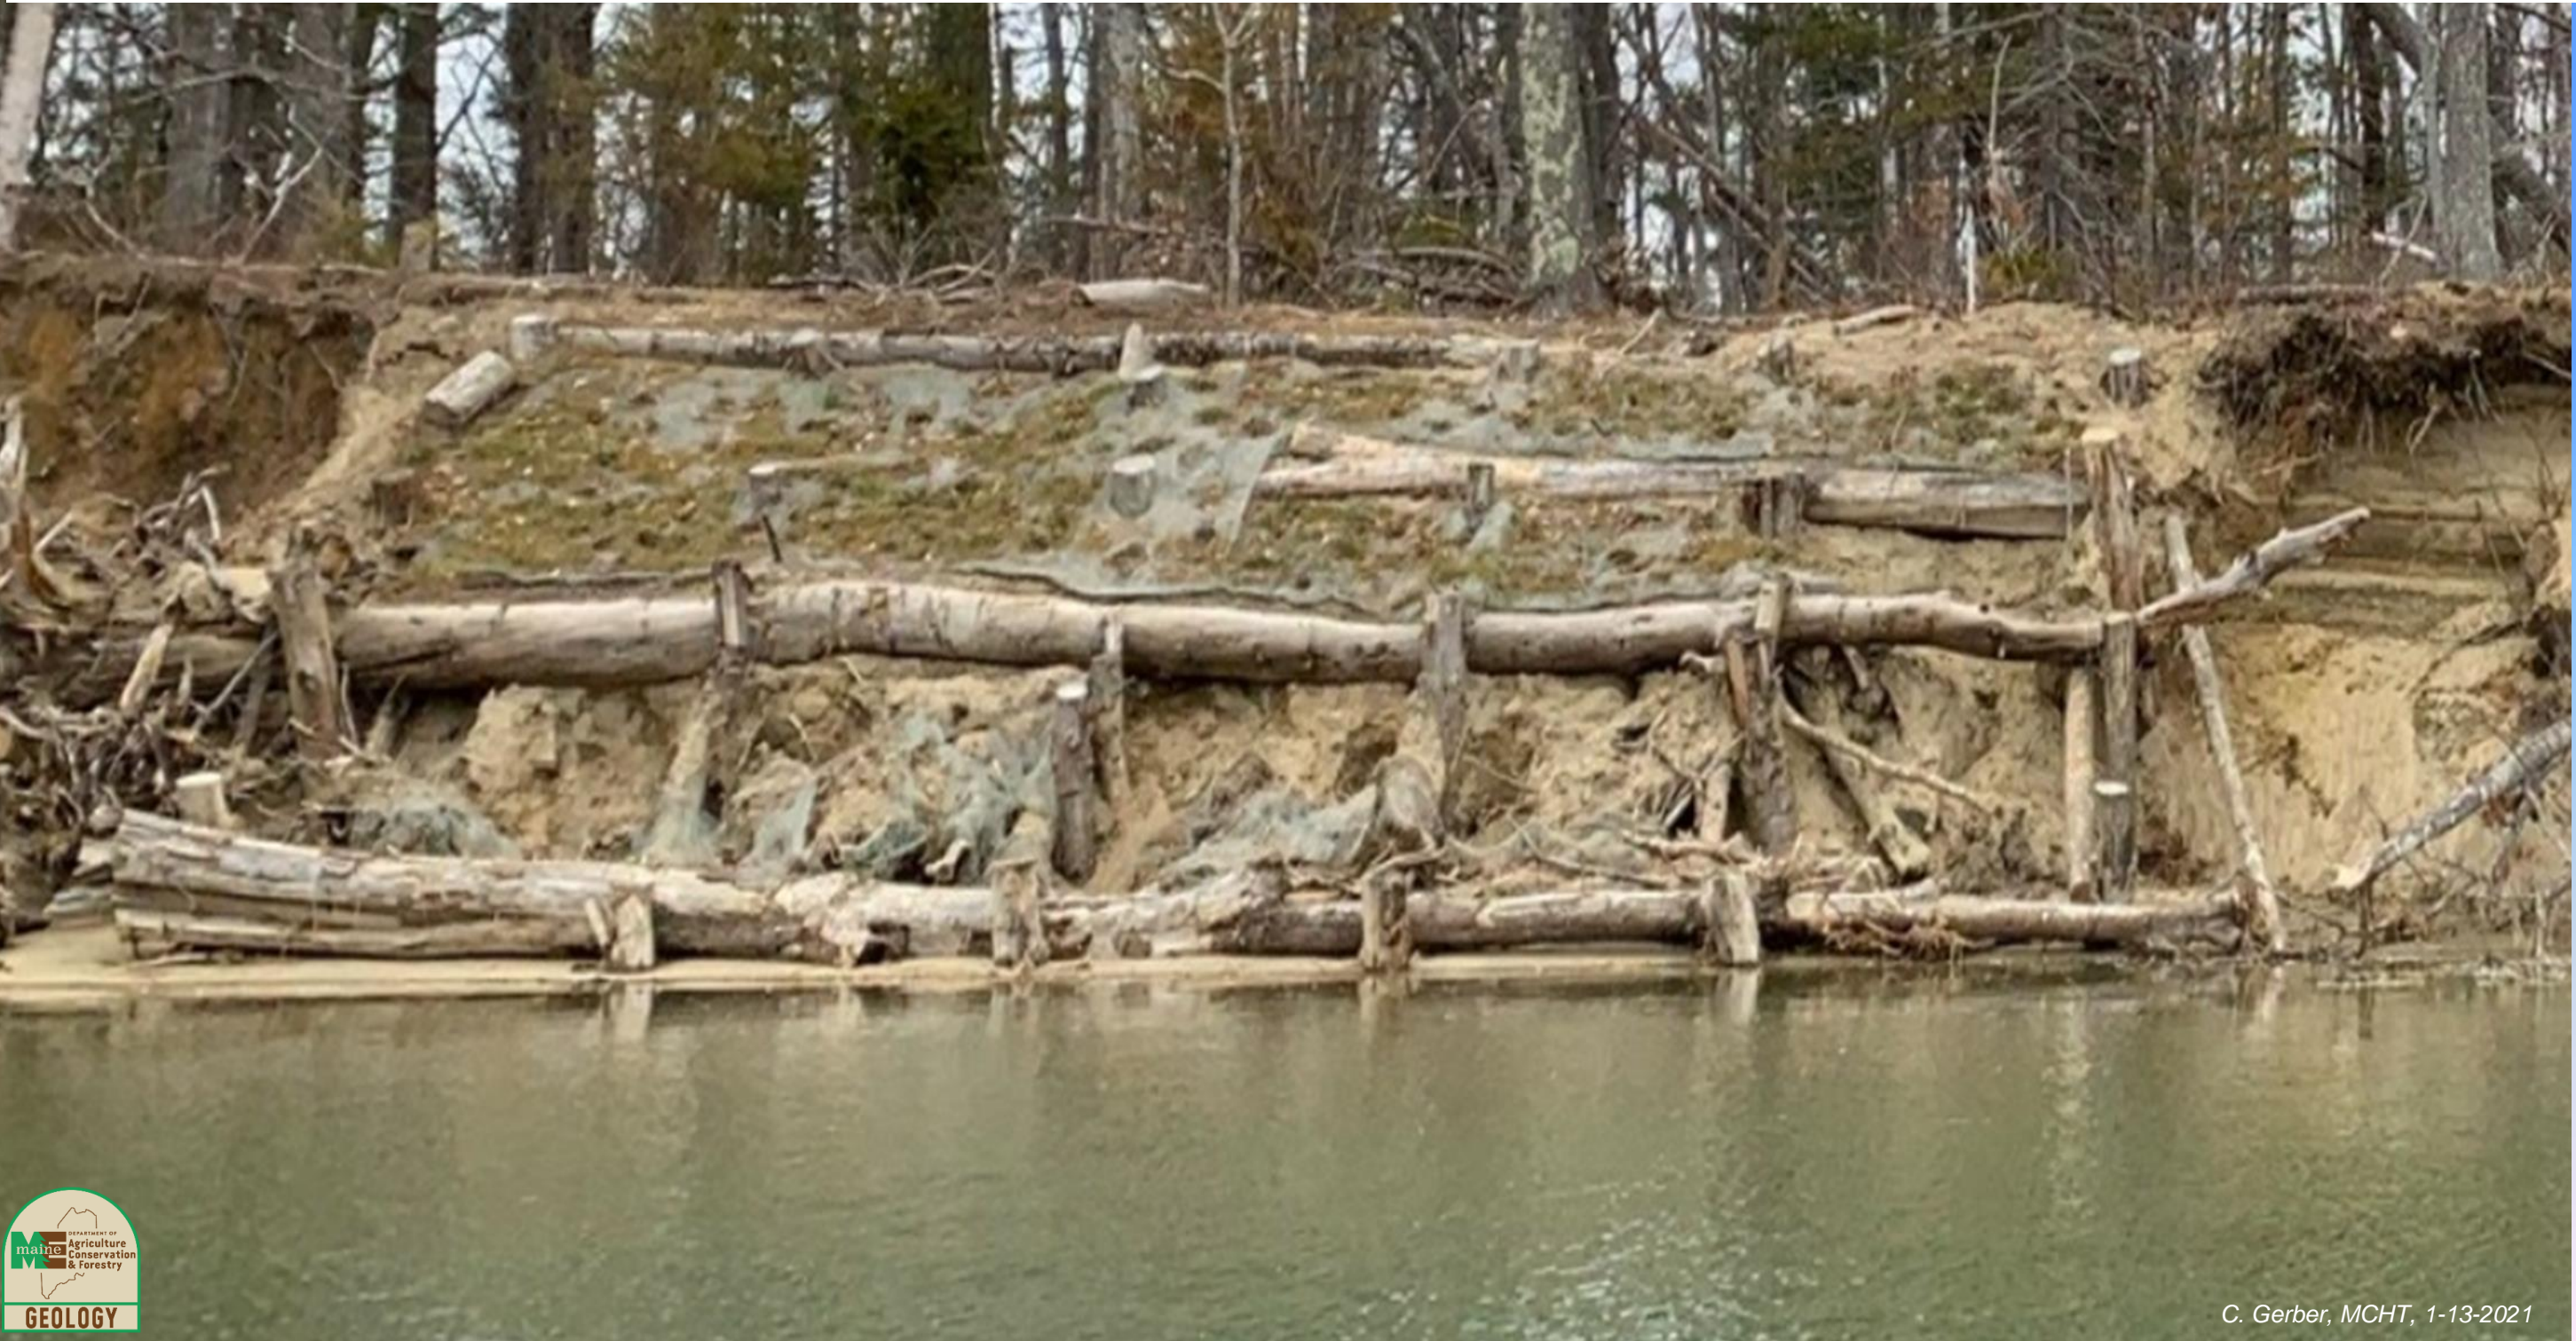
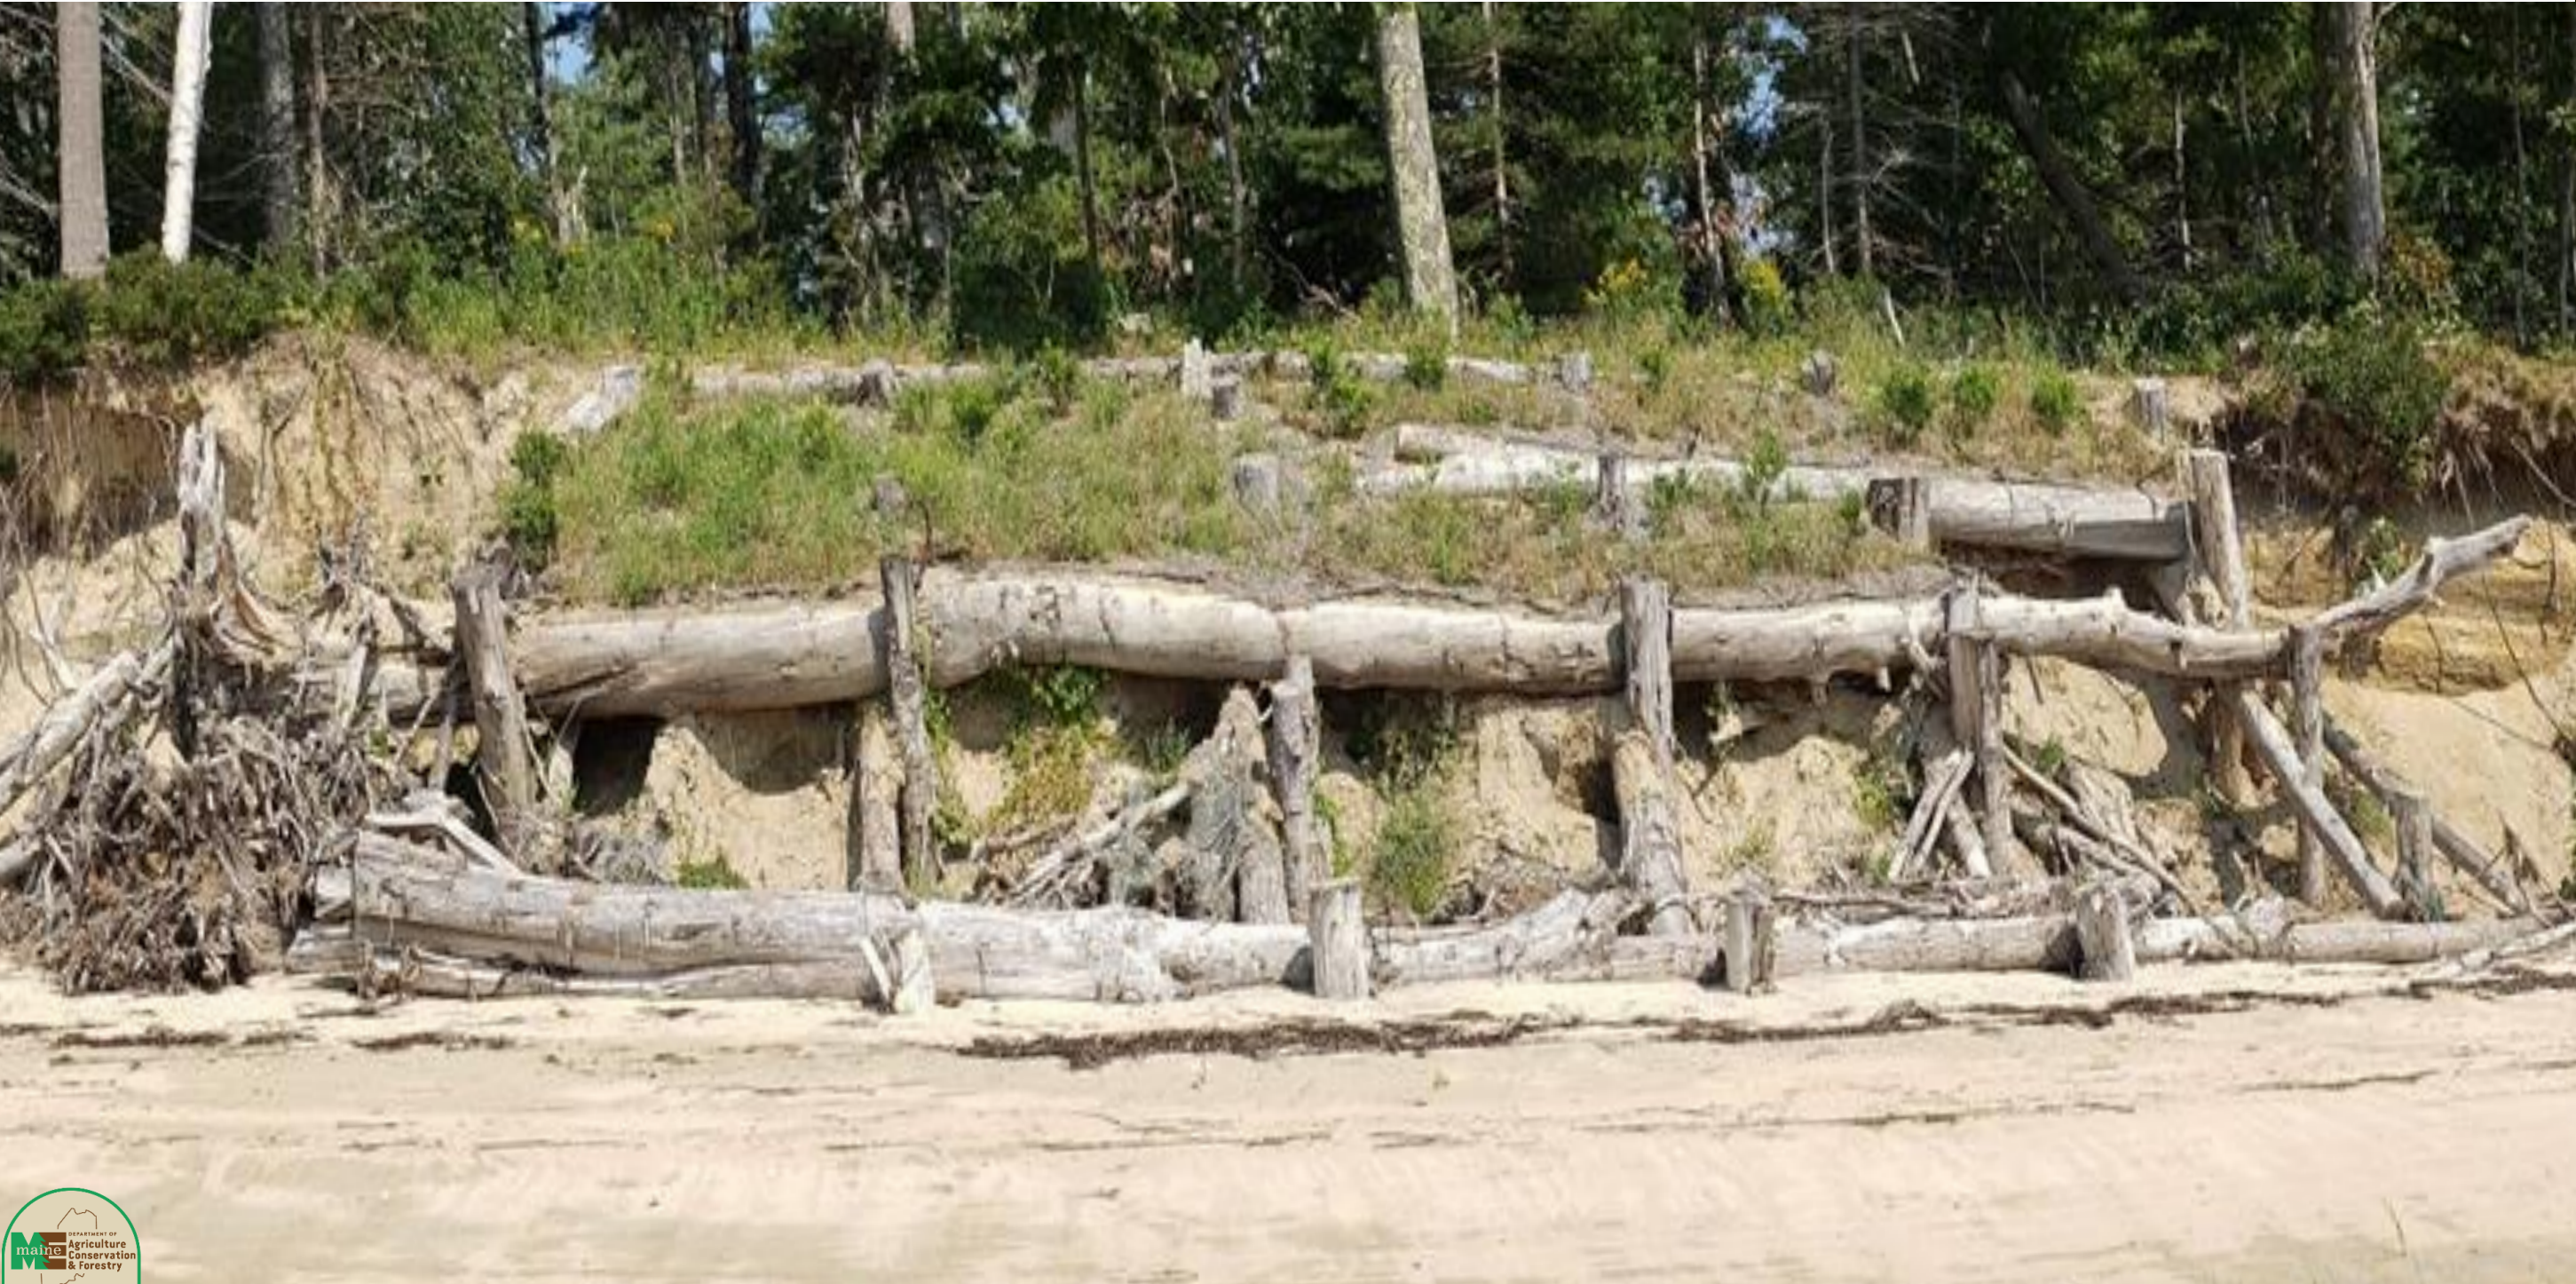
Lanes Island (completed mid-September 2020)

Extensive erosion along entire island (10-15 feet of bluff erosion measured as of 8/2021)

Loss of first “step” and some end-effect erosion

Sacrificial sediment placed above the HAT was lost within a month

Step failure released large amounts of sediment to the adjacent beach, as designed

Findings: log structure appears to be stable though sediment eroded. If project was constructed and plantings placed in late spring (as opposed to fall), it's possible that project would be performing a bit better, but the extent of high erosion along the 400-foot bluff would still likely have caused erosion of the site.
